**FINAL PROJECT
REPORT #00042134-04-103A
Volume I**

**FRP Reinforcement for
Concrete: Performance
Assessment and New
Construction**

**Volume I: Sierrita De La Cruz Creek
Bridge**

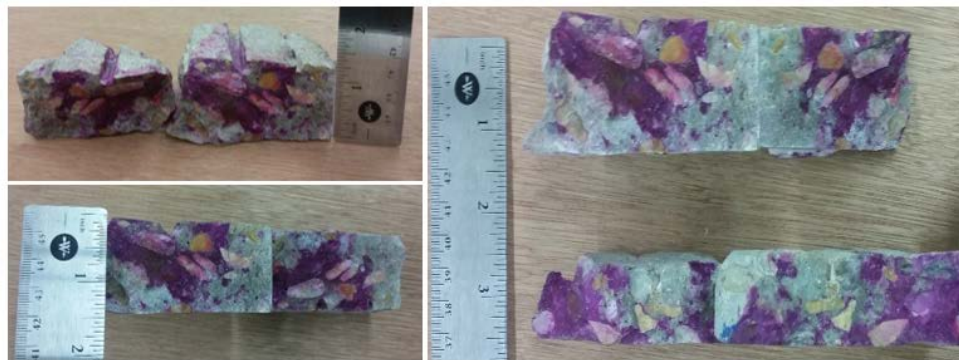
Figure 10: Carbonation depth measurement of the concrete cores

Irregular carbonation fronts were observed in all three tested samples with maximum depth between 1 to 1.25 in (25.4 to 31.8 mm). The carbonation depth was an approximate range sufficient to start the corrosion in carbon steel rebars.

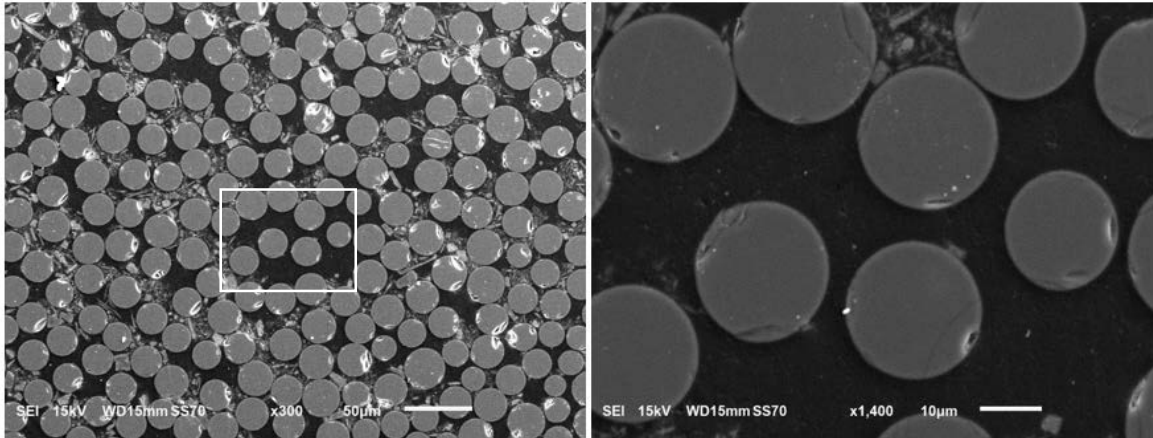
Figure 11: SEM images of the fibers at magnification levels of 300x (left) and 1400x (right)

SEM analysis confirmed that there was no sign of deterioration in the GFRP coupons. Glass fibers were intact without loss of any cross-sectional areas. Fibers were surrounded by the resin matrix and no gap nor sign indicating the loss of bond between resin and fibers, was observed.

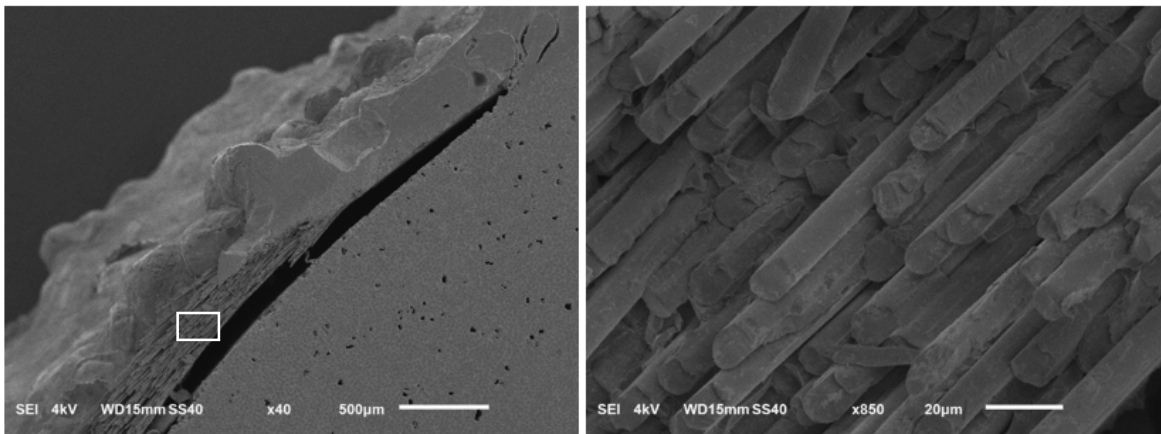
Figure 12: Crack at the edge of the bar at magnification levels of 40x (left) and 850x (right)

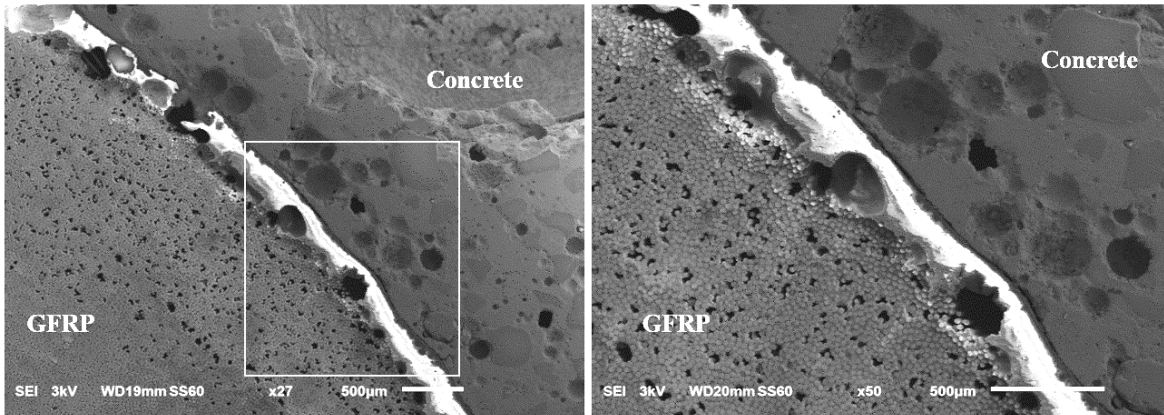
Additionally, GFRP to concrete interfacial bond was maintained properly and no sign of bond degradation nor loss of contact was observed as presented in Figure 14. The visible interfacial damage may be the result of sample preparation and drying in the SEM chamber [4].

Figure 14: SEM images of the concrete-GFRP interface at magnification levels of 27x (left) and 50x (right)

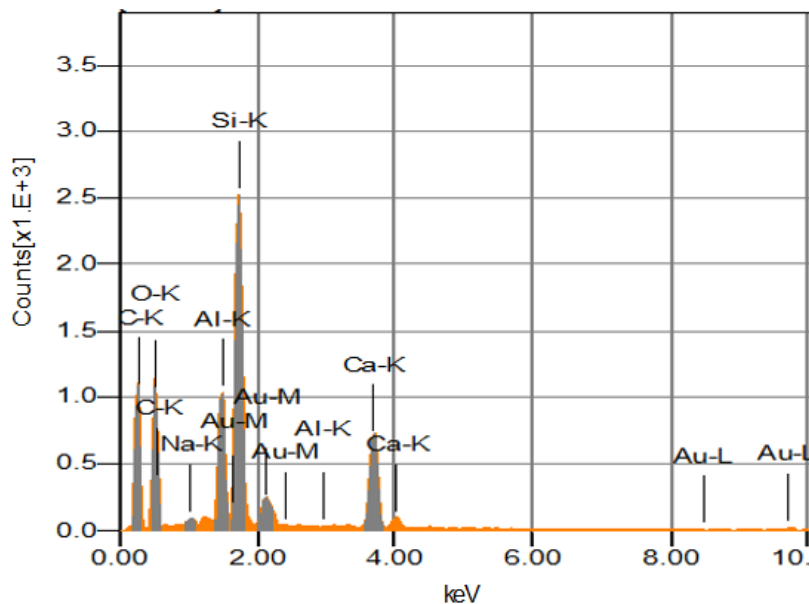
Figure 15: Result of the EDS analysis performed on GFRP bars after 15-years of service

Si, Al, Ca (from glass fibers) and C (from the matrix) were the predominant chemical elements in the extracted samples which were also identical to the control samples. Although, there is a variation in fiber/resin constituents for GFRP bars produced in 2015 compared to the ones manufactured in 2000 (as provided in Table 1), the only difference in detected elements was the presence of Mg in control samples which was not found in extracted ones. Additionally, the presence of Na in the extracted samples was not a sign of degradation or alkaline attack since Na was observed in both control and extracted samples. It may be due to contamination during sample preparation.

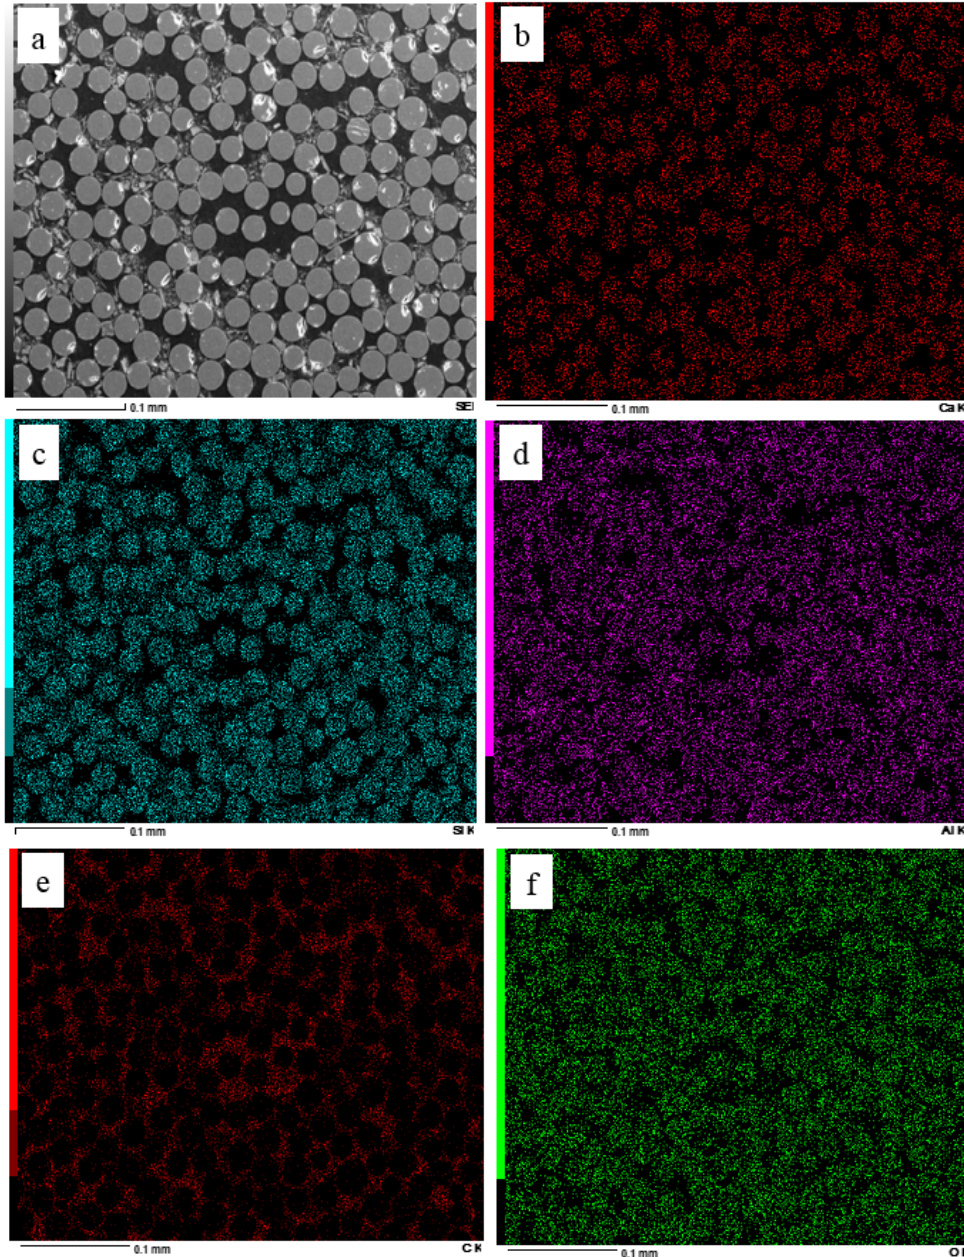
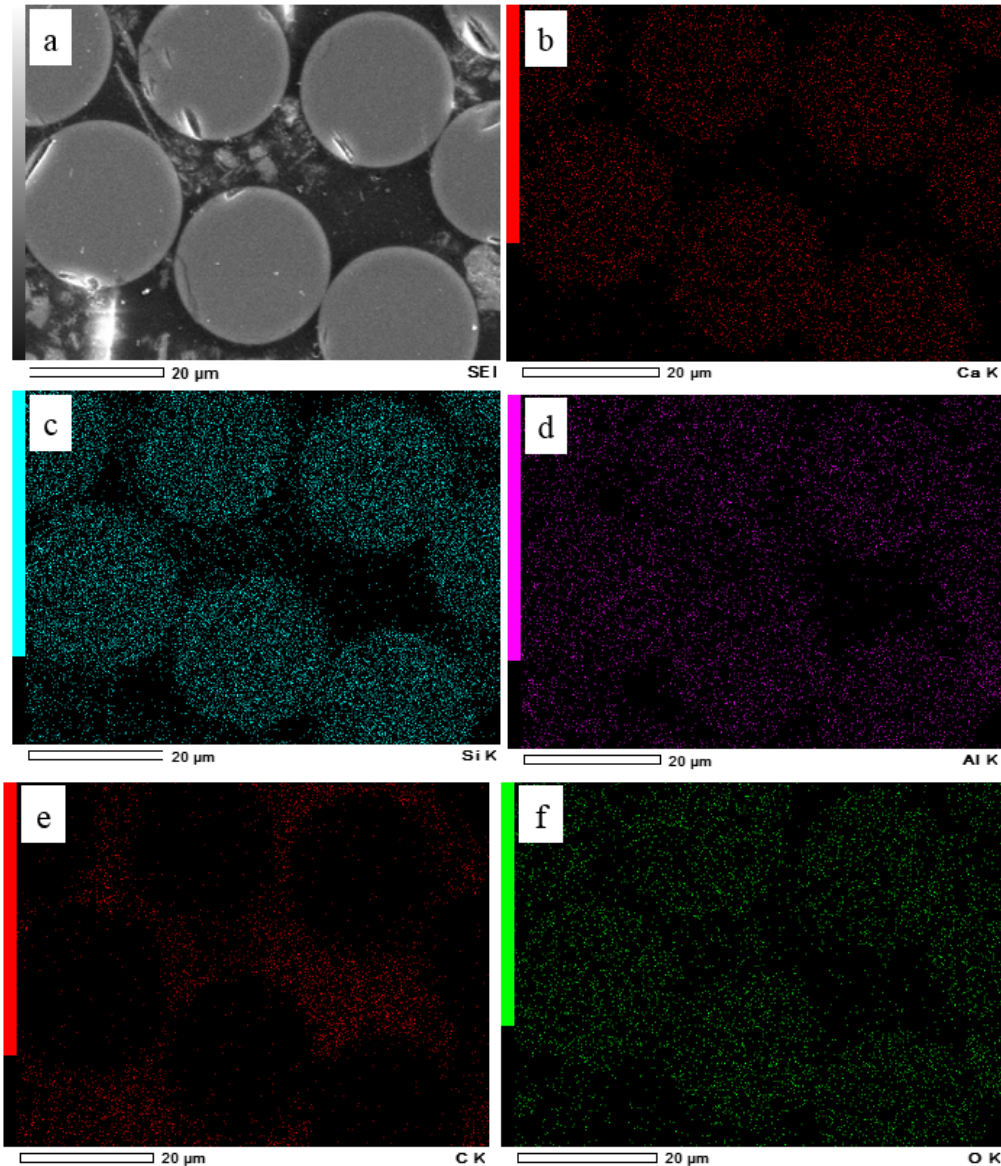
Figure 17: Elemental scatter in GFRP bars after 15 years of service at magnification level of 300x: SEM image of GFRP (a) and elemental distributions of: Ca (b), Si (c), Al (d), C (e), and O (f)

Figure 18: Elemental scatter in GFRP bars after 15 years of service in magnification level of 1800x: SEM image of GFRP (a) and elemental distributions of Ca (b), Si (c), Al (d), C (e), and O (f)

Comparing the result of EDS analysis performed on the in-service and control samples confirmed that no change in chemical composition of fiber and matrix occurred after 15 years of service and the silica was not dissolved in the alkaline environment of concrete. Additional EDS result performed on a different location of GFRP cross section is available in Appendix 2.

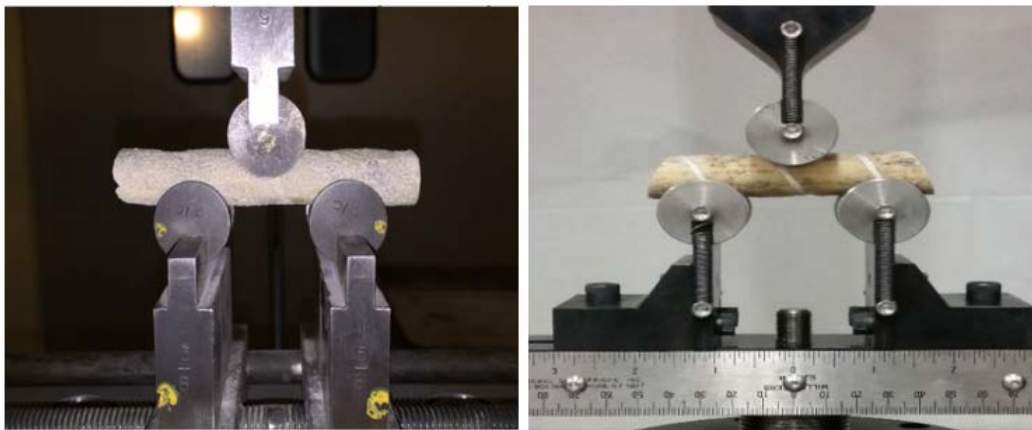
Figure 20: Interlaminar horizontal shear test of GFRP coupons after 15 years of service: No. 5 (left) and No. 6 (right) GFRP bars

An increase of 4% in the inter-laminar shear strength of No. 5 GFRP bar was observed. Since the interlaminar shear is dominated by the resin, the increase may be a result of resin crosslinking over time. On the other hand, the inter-laminar shear strength of No. 6 GFRP bar decreased by 23% compared to average results of control samples. In both instances, since only one coupon was available for the in-service condition, additional testing is required to comment on the change or no change of interlaminar shear property.

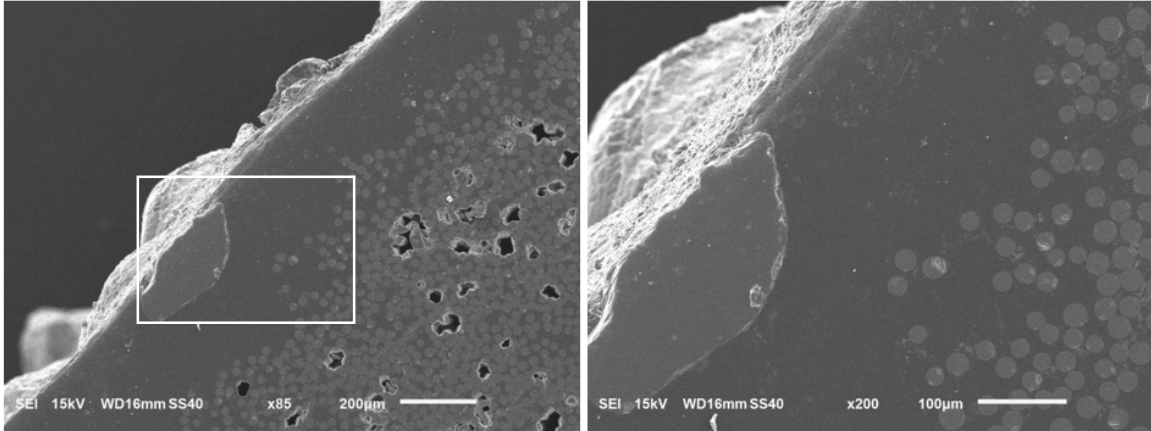
SEM images at edge of GFRP bar at magnification levels of 85x (left) and 200x (right)

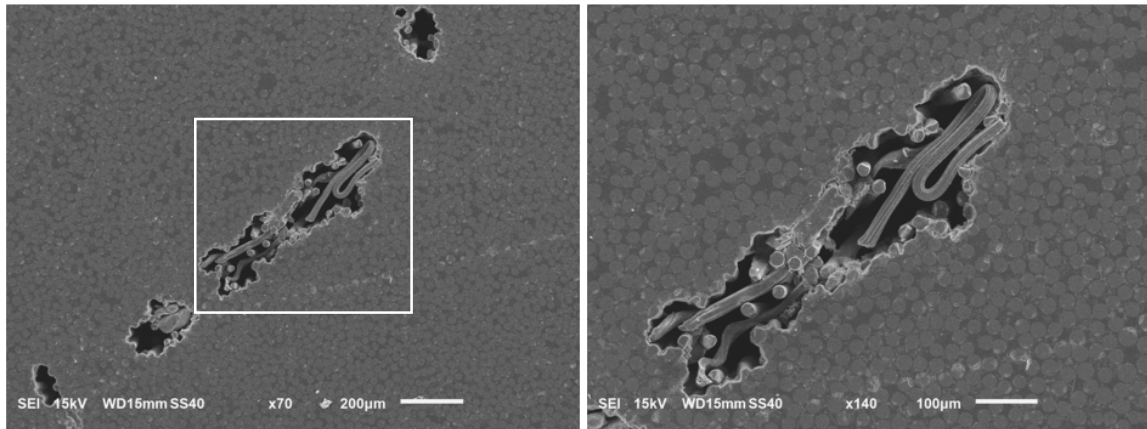
SEM images of a void at the center of the GFRP bar at magnification levels of 70x (left) and 140x (right)
