FINAL PROJECT REPORT #00059416

Durability of GFRP Bar Reinforcement Extracted from In-service Concrete Structures

Participating Consortium Member:
Missouri University of Science and Technology

RE-CAST:
REsearch on Concrete Applications for
Sustainable Transportation
Tier 1 University Transportation Center

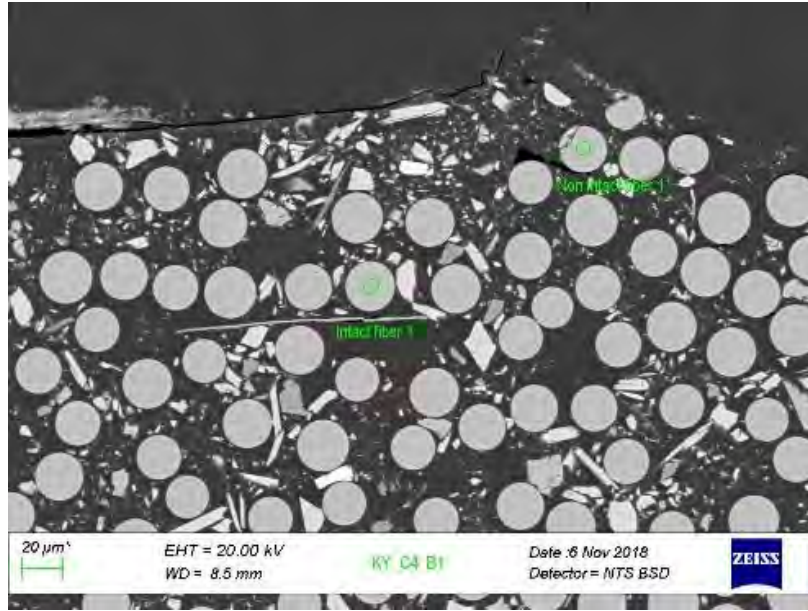
The results of each bridge are presented in Appendix V. *Fig. 49* shows an SEM image without any deteriorated fibers, while *Fig. 50* shows an SEM image with fibers possibly deteriorated by concrete exposure.

Fig. 50–Sample from Roger’s Creek Bridge - few fibers may be negatively affected by concrete exposure

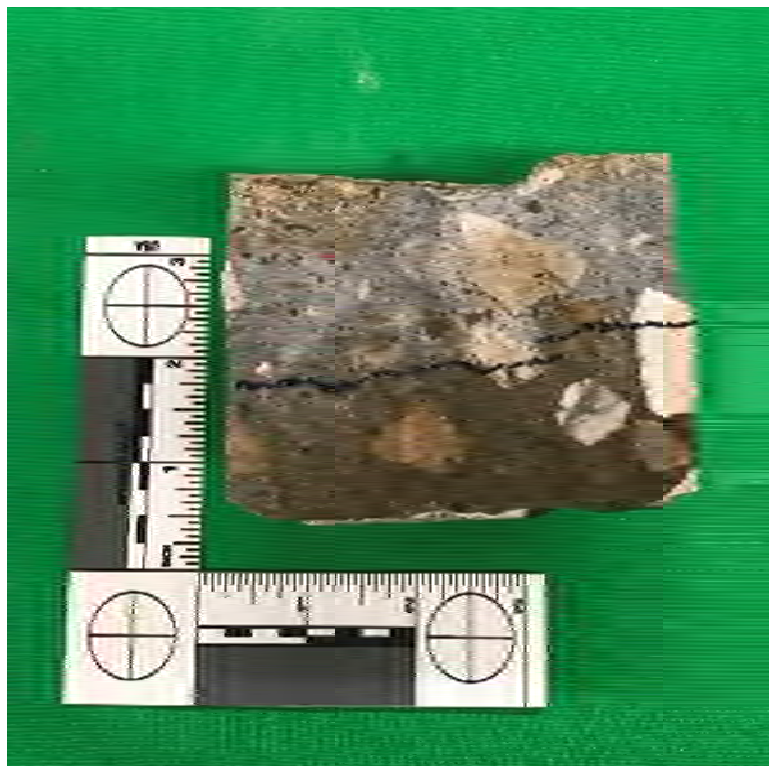
Fig. 55 shows the worst case scenario, where the chloride penetration was approximately 2.5 in. (64 mm) and *Fig. 56* shows the best-case scenario, where no visual chloride penetration was observed. The test results of the individual bridges are reported in Appendix IV.

Fig. 55–Cuyahoga Bridge sample with visual chloride penetration

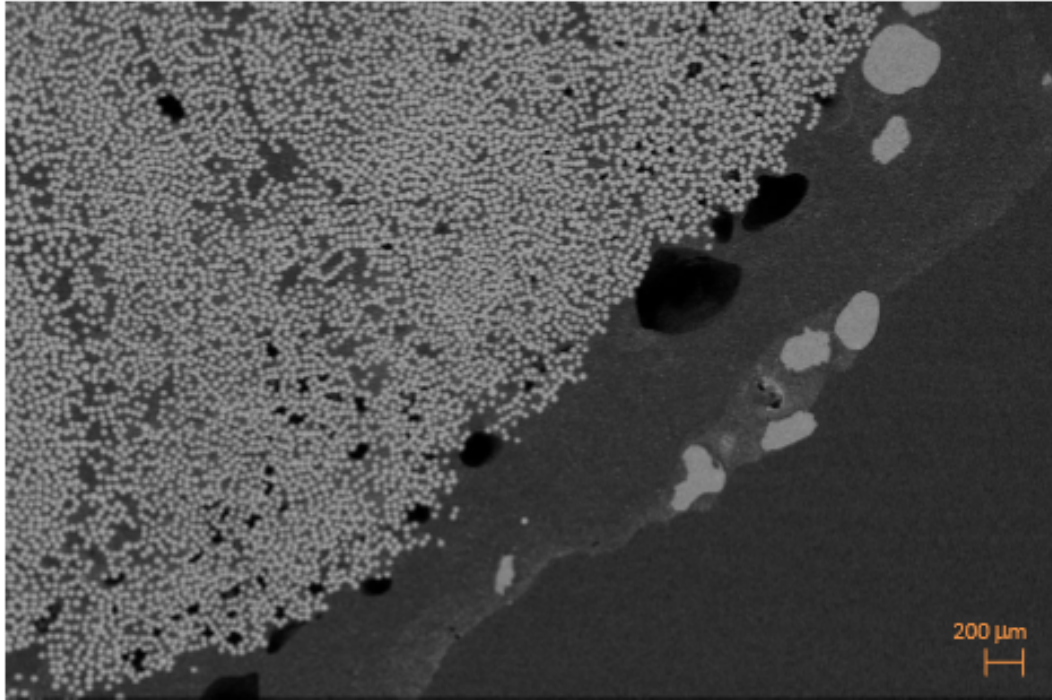
Fig. 32: OH2_C5_B2

SEM imaging for *Cuyahoga Bridge* was performed at Owens Corning. GFRP rebar extracted from Cuyahoga bridges show some damage on 0.05 to 0.12 % of the glass fibers. This is much less than expected or predicted by accelerated test methods, and has a negligible impact on mechanical properties. The affected fibers were typically on the outer edge of the rebar. The results of each bar is shown in Fig. 32 through Fig. 35.

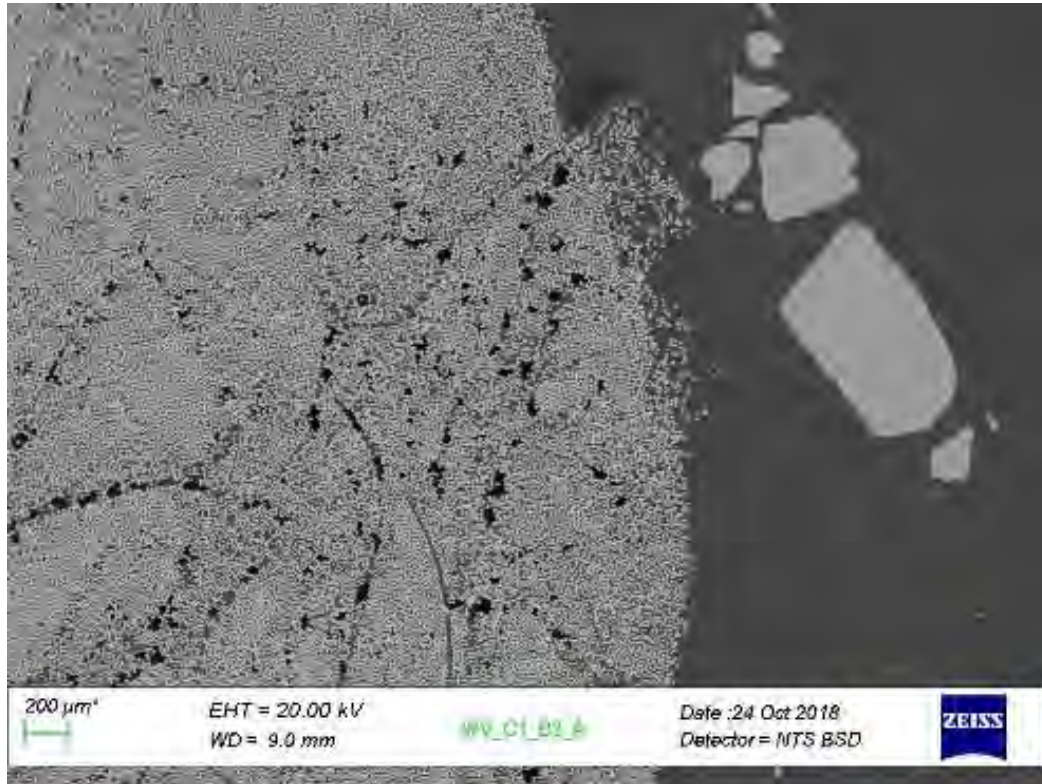
Fig. 36. WV_C1_B2A

SEM imaging for *McKinleyville Bridge* was performed at Owens Corning. Nearly no negatively affected fibers were observed on the interior or exterior of in-service rebar. The few negatively affected fibers appear to have physical damage from specimen preparation as they are near resin voids. The SEM images of each bar is shown in Fig. 36 through Fig. 80.

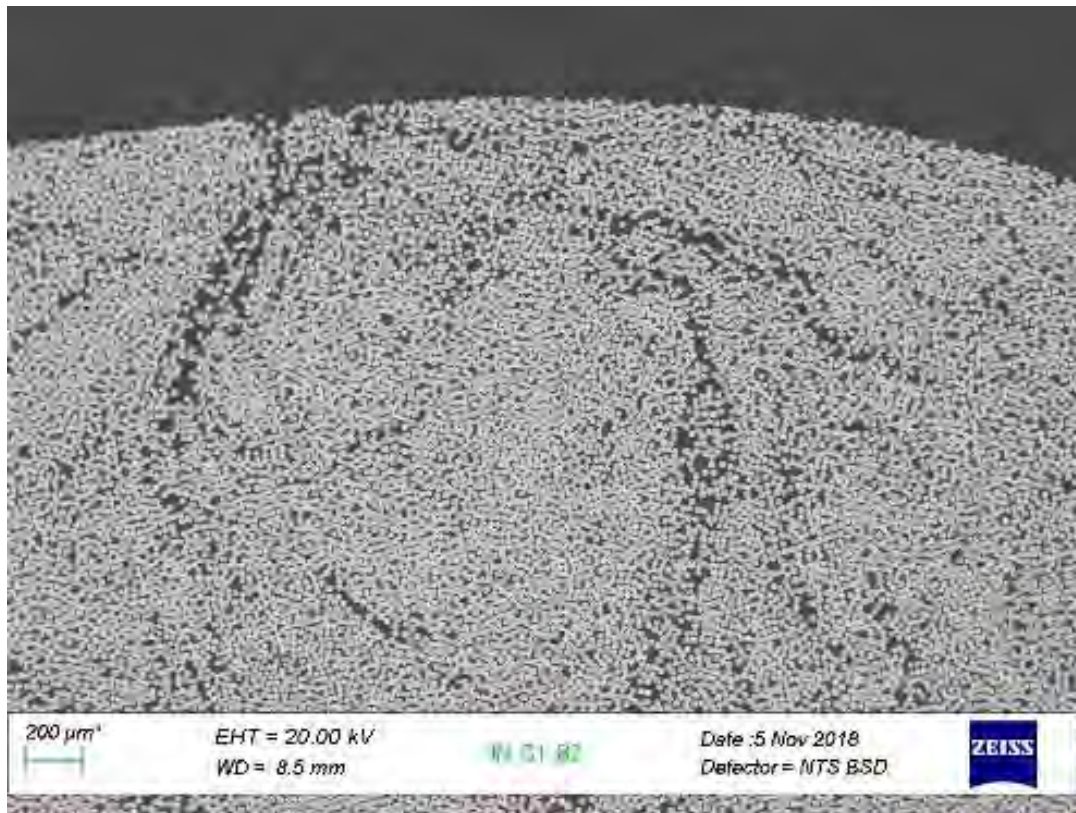
Fig. 81. IN_C1_B2

SEM imaging for *Thayer Road Bridge* was performed at Owens Corning. A few negatively affected fibers were observed but appeared to be isolated on the outer perimeter of in-service rebar. The affected fibers only indicated physical damage, likely from manufacturing process. Extrapolated damage was not visible in this sample. Swirls observed in optical microscopy can be seen in low magnification images and are related to resin rich areas. The SEM imaging of each bar is shown in Fig. 81 through Fig. 98.

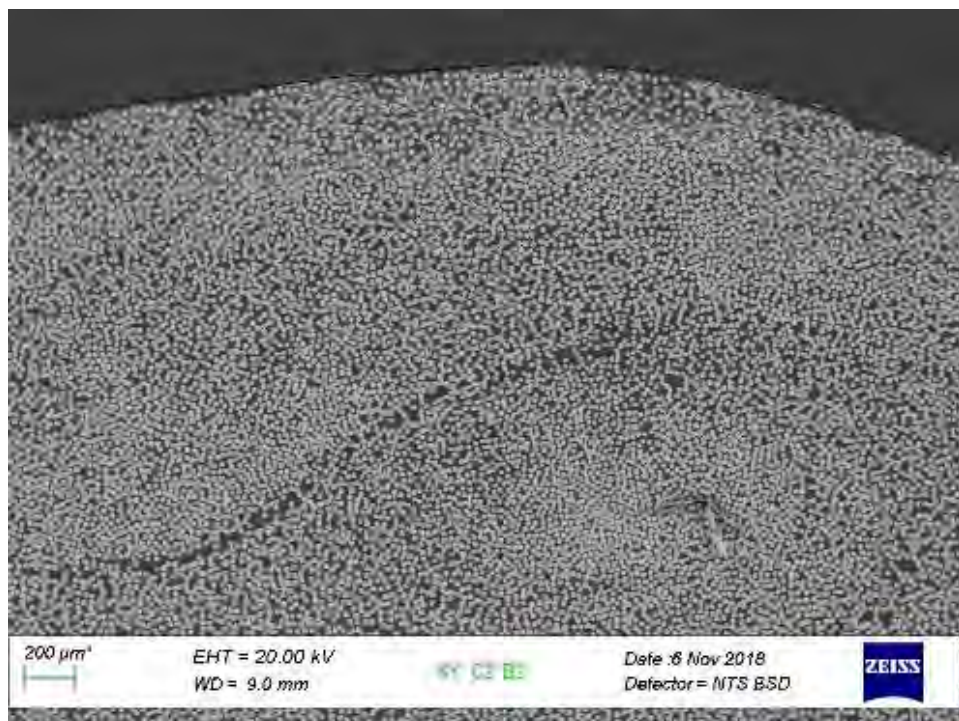
Fig. 99. KY_C2_B2

SEM imaging for *Roger's Creek Bridge* was performed at Owens Corning. The fibers from *Roger's Creek Bridge* showed some evidence of being negatively affected by concrete exposure. Of the few negatively affected, they were located on the exterior or near large cracks. The number of affected fibers is expected to be similar or less than the Cuyahoga or Gills Creek samples. The SEM imaging of each bar is shown in Fig. 99 through Fig. 109.

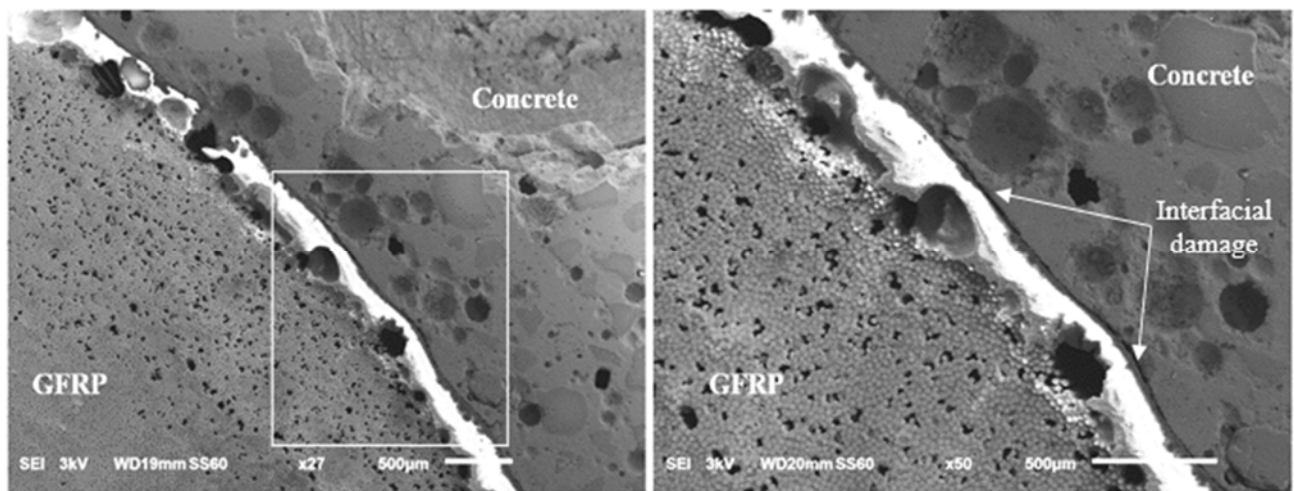
GFRP-to-concrete interfacial bond appeared to be maintained properly and no sign of bond degradation nor loss of contact was observed as presented in Fig. 112. As documented by others (Aftab A. Mufti et al., 2007), the visible interfacial damage was the result of sample preparation and drying in the SEM chamber.

Fig. 112. SEM images of concrete-GFRP interface at magnifications of 27x (left) 50x (right)

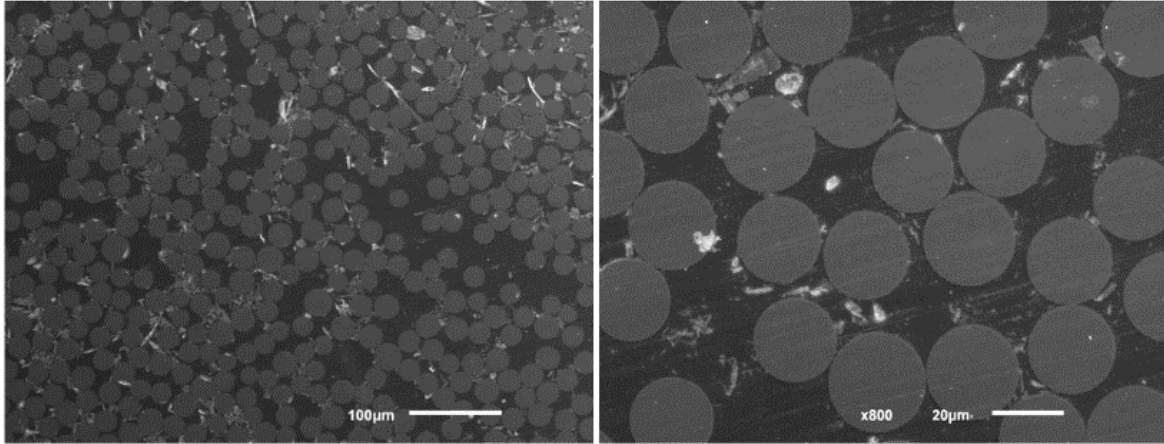
SEM analysis suggests that there was no apparent sign of deterioration in the GFRP coupons. No damage was observed in the matrix and at the matrix-fiber interface. Glass fibers appeared to be intact without no loss of cross-sectional area.

Fig. 113. SEM image of GFRP bar after 16 years of service in Walker Bridge at magnifications of 200x (left) and 800x (right)

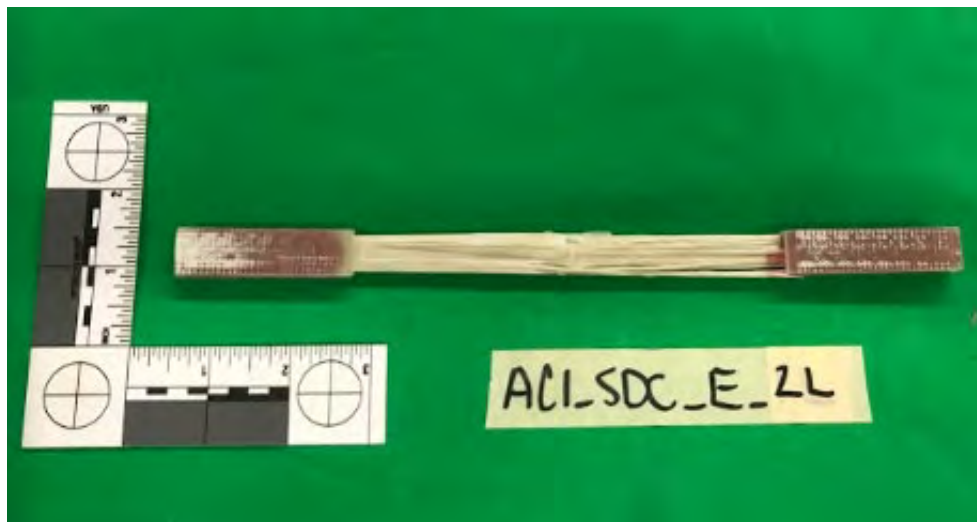
Sierrita de la Cruz Creek coupon 2 from the left side of the rebar failed with the splitting of gage at various points at a peak load of 3,649 lbs. (16 kN) and a peak strain of 16,200x10⁻⁶. The coupon before testing and after failure are shown in Fig. 12 and Fig. 13, respectively. The strain values were recorded with both strain gauges and extensometer; however, the extensometer was removed at 3,500 lbs. Therefore, the stress strain curve uses the values obtained from the strain gauge. The stress strain curve for this bar is shown in Fig. 14. A summary of the tensile test results is shown in Table 4.

Fig. 13. Coupon E_2L after failure

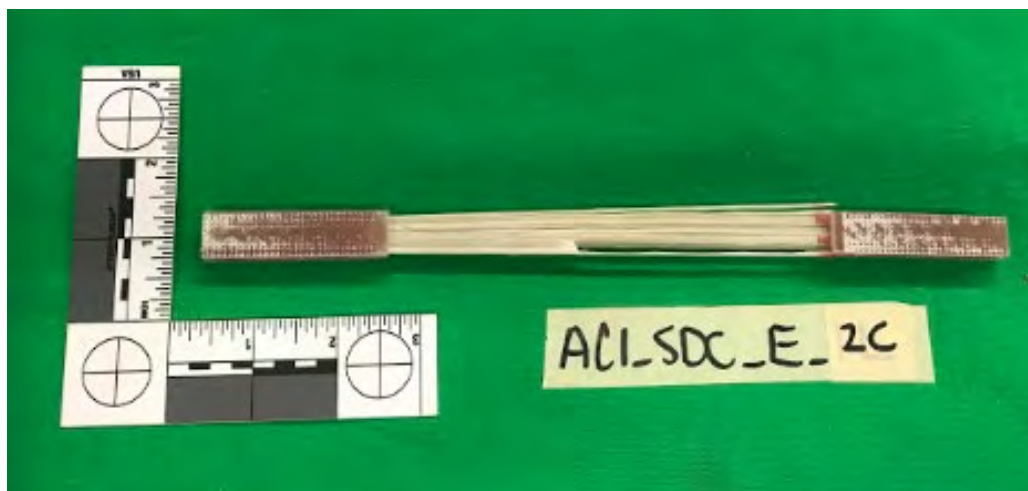
Sierrita de la Cruz Creek coupon 2 from the center of the rebar failed at the lateral grip on the top at a peak load of 4,475 lbs. (20 kN) and a peak strain of 15,300x10⁻⁶. The strain values were recorded with both strain gauges and extensometer; however, the extensometer was removed at 3,500 lbs. Therefore, the stress strain curve uses the values obtained from the strain gauge. The stress strain curve for this bar is shown in Fig. 17. A summary of the tensile test results is shown in Table 5.

Fig. 16. Coupon E_2C after failure

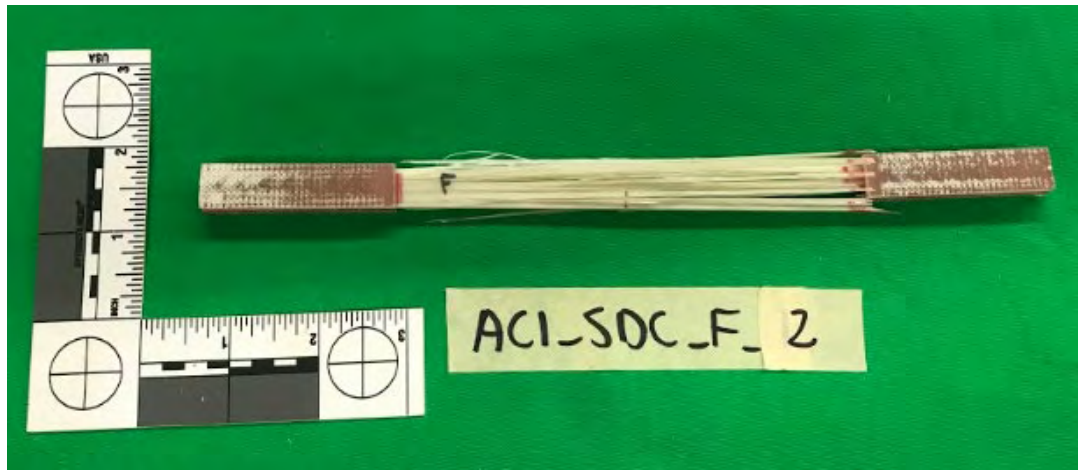
Pristine coupon 2 failed with the splitting of gage at various points at a peak load of 4,609 lbs. (20 kN). The coupon after failure is shown in Fig. 33. Due to test issues, the strain for this bar could not be recorded, however, a stress curve is shown in Fig. 34. A summary of the tensile test results is shown in Table 11.

Fig. 33. Coupon F_2 after failure
