FINAL PROJECT REPORT #00042134-04

FRCM and FRP Composites for the Repair of Damaged PC Girders

Participating Consortium Member:
University of Miami

FRCM and FRP were used for the strengthening of intentionally damaged AASHTO Type III prestressed concrete (PC) girders taken from I-81 overpass near Arcadia, VA. Experimental and theoretical analyses were performed to demonstrate the ability of these two repair methods to restore moment capacity compromised by the loss of four and eight 9.5-mm (3/8-in.) diameter prestressing tendons. All experimental tests on PC girders were conducted at Virginia Tech and reported in details elsewhere. This document presents some of the experimental findings and shows additional and original analytical considerations on the performance of the repaired girders. In particular, it offers a comparison between theoretical results according to AASTHO LRFD Bridge Design Specifications (2010) and experimental tests. Finally, design methodology including ACI 318 (2011), ACI 549.4R (2013) and ACI 440.2R (2008) are used to calculate factored resistance design values that are compared to experimental values.

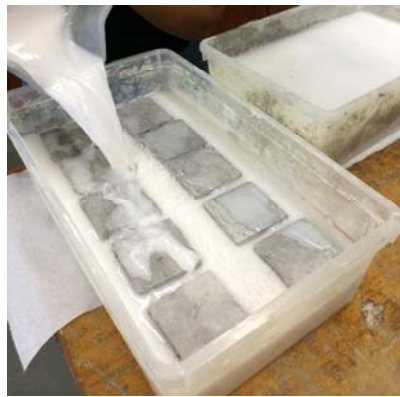
Figure 2-4 –Cubes in Limewater Conditioning

The purpose of this test is to evaluate the compressive strength of X Mortar 750 used for FRCM strengthening application as per AC434 Section 4.3 and reference standard ASTM C109/C109M. Ten (10) - 2 in. (5.1 cm) cube samples were cast in cube molds as per ASTM C109. Cube specimens were prepared by hand tamping the mortar in two layers, after mechanically mixing the mortar. Immediately upon completion of molding, the mold was placed in a moist room for curing for 24 hours with their upper surfaces exposed to the moist air but protected from dripping water. Specimens were removed from the molds after the first day of curing and exposed to a limewater conditioning environment for 7 days and 28 days, 5 samples for each conditioning time (Figure 2-4).

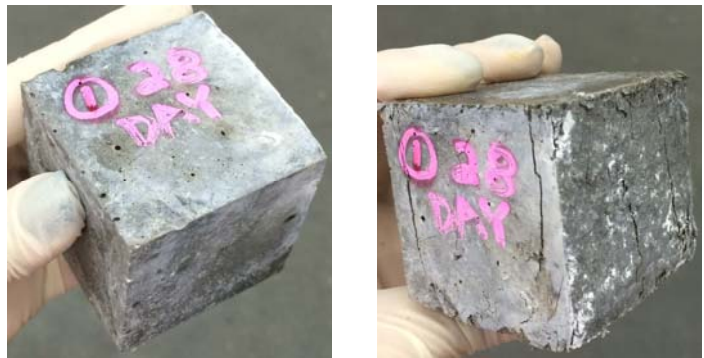
Figure 2-7 –Repair Mortar Cube Failure Mode

Specimens were removed from the molds after the first day of curing and exposed to a limewater conditioning environment for 7 days and 28 days, five samples for each conditioning time (Figure 2-6). Uniaxial compression load was applied to the cube specimens using a screw type universal test frame as seen in Figure 2-5. Similar to the Matrix Mortar Compression test, the load was applied to the cube faces that were in contact with the mold surfaces. The test was performed under displacement control at a rate of 0.025 in./min (0.635 mm/minute). Required minimum compression breaking strengths are 2,500 psi (17 MPa) at 7 days of age and 3,500 psi (24 MPa) at 28 days of age (AC434 Section 4.3). All cubes failed in compression as expected and reflected in Figure 2-7. The cube compressive strength (f_c) was determined by dividing the average area (A) to the face of the cube where the load was applied by the maximum load applied (P_{max}).

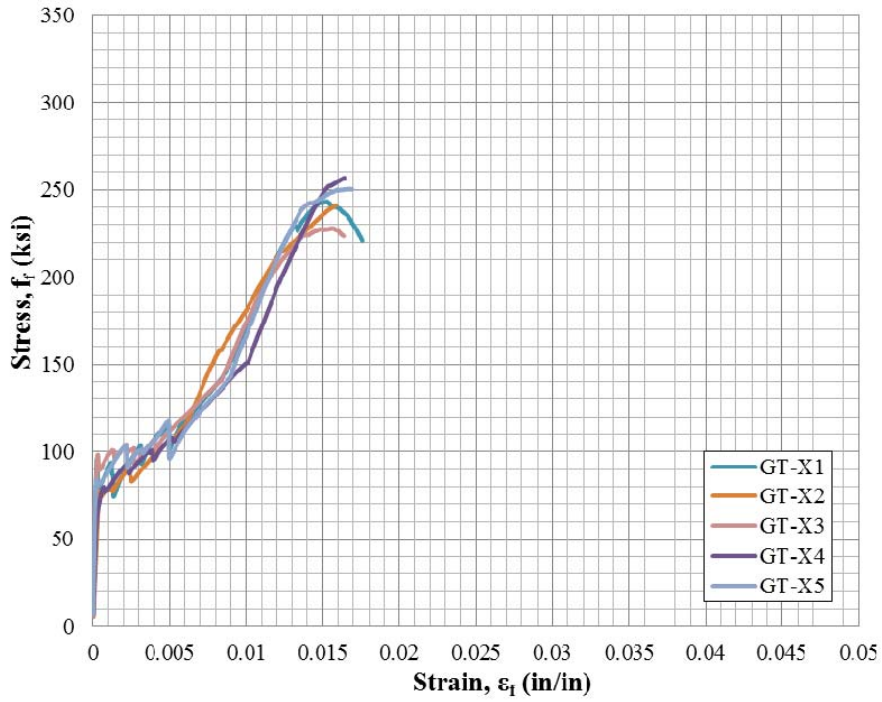
Figure 2-12 – Stress vs. Strain Behavior of One Ply Direct Tension Tests (1 ksi = 6.895 MPa)

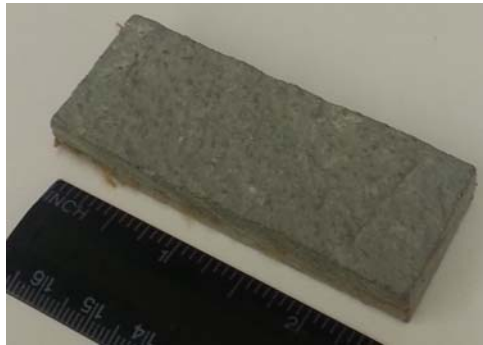
Figure 2-15 –Interlaminar Shear Specimen

The purpose of this test is to evaluate the interlaminar shear strength of the FRCM composite system under control ambient conditions. Tests are performed as per AC434 Section 4.2.4 for Composite interlaminar shear strength and reference standard ASTM D2344/D2344M-00 (2006) Standard Test Method for Short-Beam Strength of Polymer Matrix Composite Materials and Their Laminates. Ten (10) - 2.5 in. x 1 in. (63.5 mm x 25.4 mm)specimens were prepared as per AC434 Section 8.3.3 Figure 2-15; five one ply samples and five two ply samples

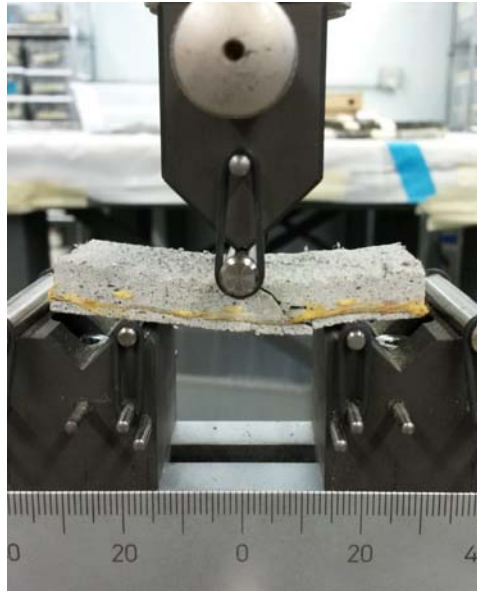
Figure 2-16 –Interlaminar Shear Test Set-up

A three point bending fixture per ASTM D2344 specifications was used to test the specimen (Figure 2-16). A flexural load was applied using a screw driven Instron Universal Test Frame with a maximum capacity of 30 kip (130 kN). Deflection was measured from the cross-head displacement. All data was gathered using Instron’s Bluehill software and data acquisition system. The test was performed under displacement control at a rate of 0.05 in./min (1.0 mm/minute).

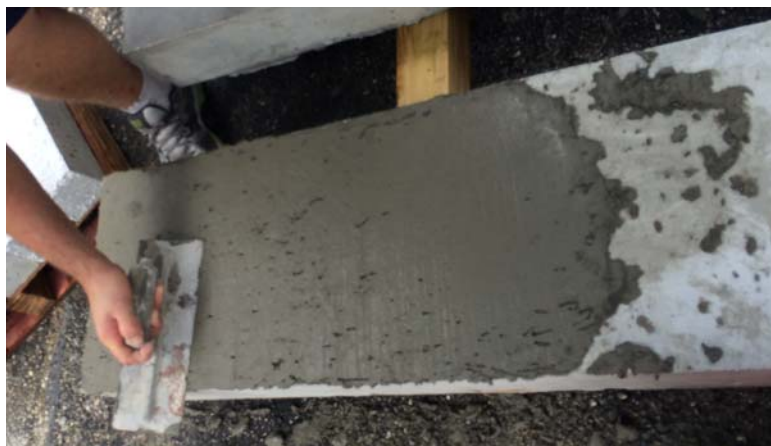
Figure 2-17 – Repair Mortar Application

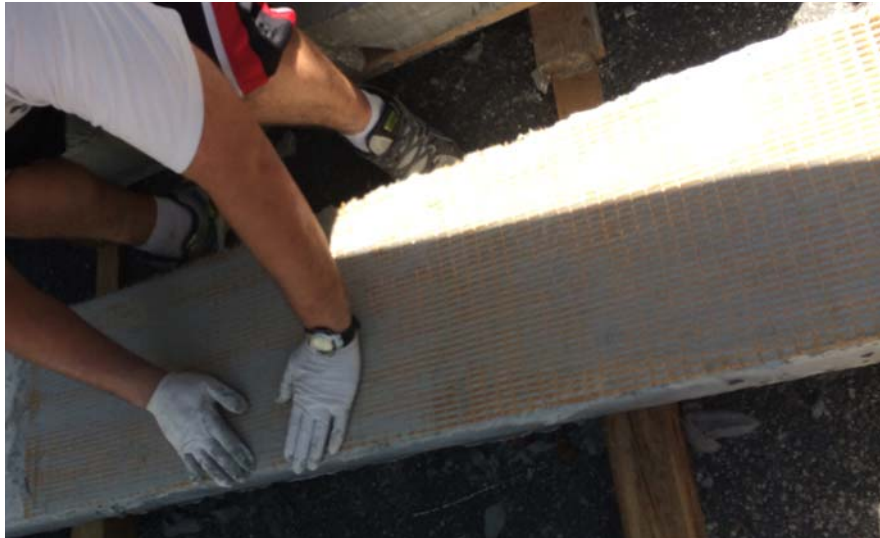
Figure 2-18 – FRCM Application Over Repair Mortar

The repair mortar was cured for 48 hours before the FRCM system was applied (Figure 2-18). The slab was then strengthened with a single ply of FRCM as per Section 2.2. Tests were conducted 28 days after installation and curing of the FRCM systems.

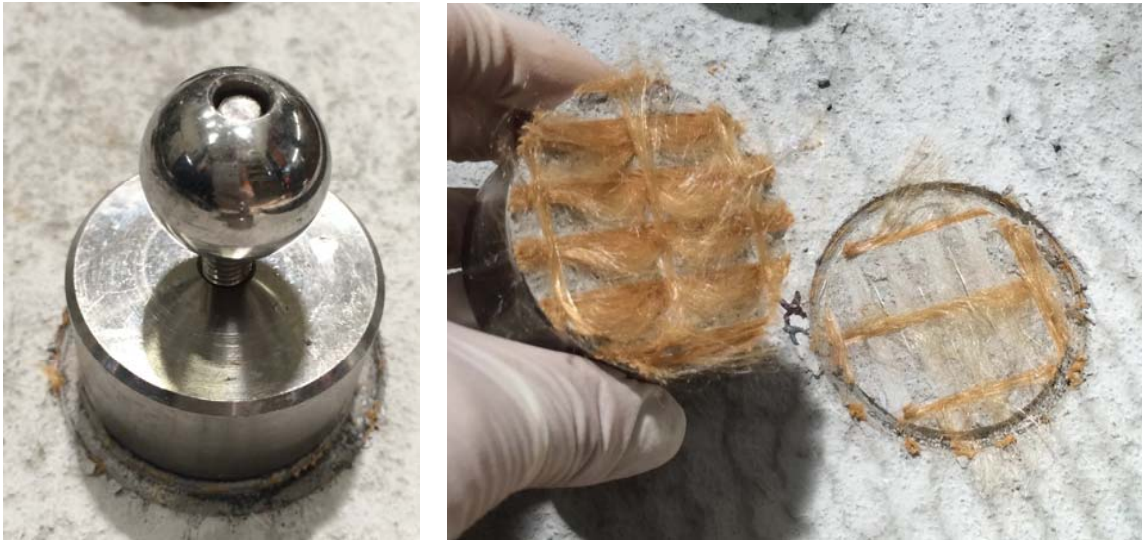
Figure 2-22 –Bond Strength Over Repair Mortar Primary Failure Mode

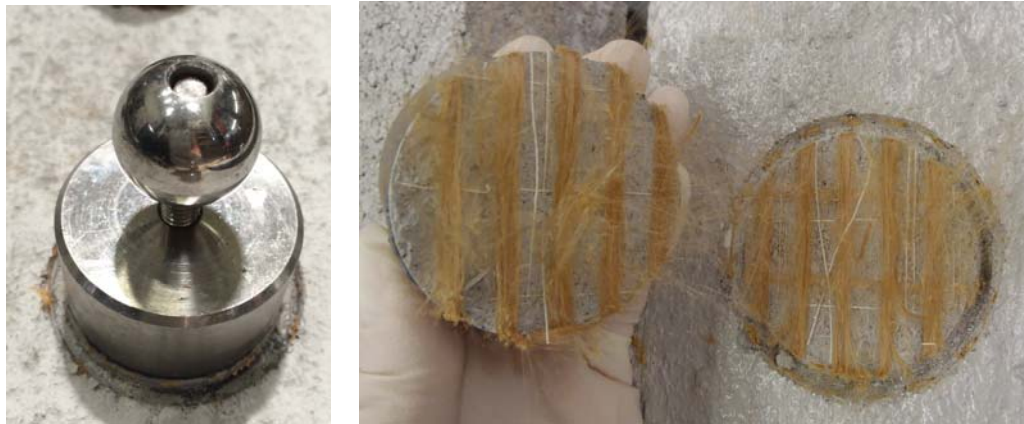
Figure 2-25 – Bond Strength Over Repair Mortar Primary Failure Mode

Tests for compression of mortar were performed per ASTM C109 where a uniaxial compression load was applied to the cube specimens using a screw type universal test frame as seen in Figure 2-5. Load was applied to the cube faces that were in contact with the mold surfaces. The test was performed under displacement control at a rate of 0.025 in./min (0.635 mm/minute). The primary failure mode of the bond tests occurred within the FRCM composite system, at the interface between the FRCM mortar and fiber mesh, herein referred to as failure type “C” (Figure 2-21 & Figure 2-25).

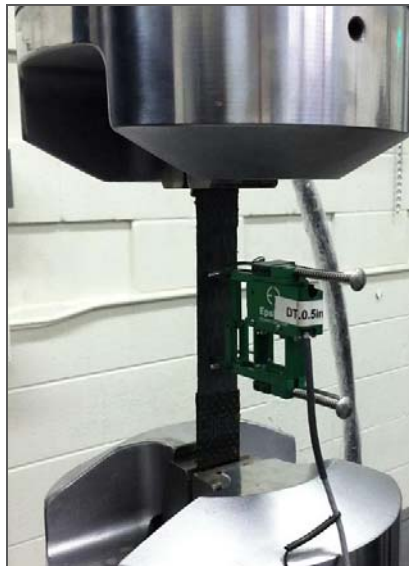
Figure 3-7 - Tensile Test Set-up

Specimens were obtained from 12 in. (305 mm) square FRP panels. The specimens were cut to the prescribed dimensions using a high precision diamond blade saw from different randomly selected panels, as prepared and referenced in Section 3.2. Tabs were installed as indicated in ASTM D3039 after sanding the ends of the coupon specimens. All specimens were conditioned under laboratory ambient conditions at room temperature $73 \pm 3^\circ\text{F}$ ($23 \pm 1^\circ\text{C}$) and $60 \pm 5\%$ relative humidity, for at least 24 hours prior testing. Uniaxial tensile load was applied to all specimens. Testing for the specimens was performed using a hydraulic type universal test frame with a maximum capacity of 55 kip (240 kN). Tensile load was measured with the internal load cell of each frame in compliance with ASTM E4-10 (Standard Practice for Force Verification of Testing Machines), while the extension (elongation) of the specimen was measured using a Class B-2 clip on extensometer with a 2.0 in (50 mm) gauge length, placed at mid-length of the coupon specimen. The extensometer was removed half way during the test to avoid damage of the instrument. Specimens were gripped with hydraulic wedge type grips at a pressure of 3000 psi (20.7 MPa) and 5000 psi (34.5 MPa) for FRP specimens with V-Wrap C200H and V-Wrap C400H, respectively. The test set up is shown in Figure 3-7. All data was gathered using a National Instruments data acquisition system at a data sampling rate of 100 Hz.

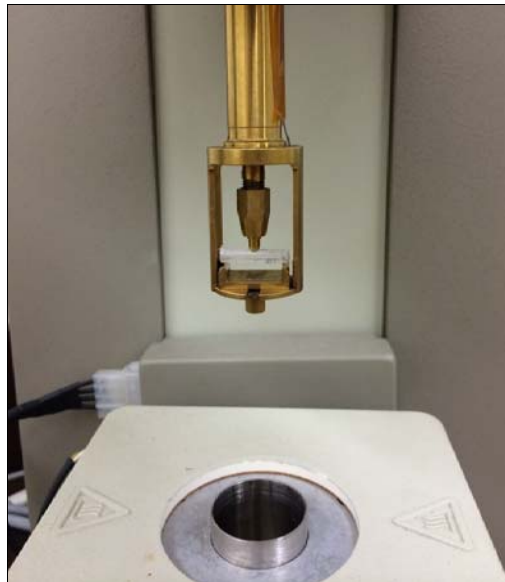
Figure 3-12 – T_g Test Set-up

A Dynamic Mechanical Analyzer (DMA) was used with a flexural set up to apply a forced oscillation with constant amplitude at a fixed frequency. The change of the loss modulus with the increasing temperature is obtained by the analysis of the flexural mechanical response and plotted in a graph to determine the T_g . The test set-up is shown in Figure 3-12. A heating rate of $1^\circ\text{C}/\text{min}$ ($1^\circ\text{F}/\text{min}$) and a frequency of 1 Hz was applied.

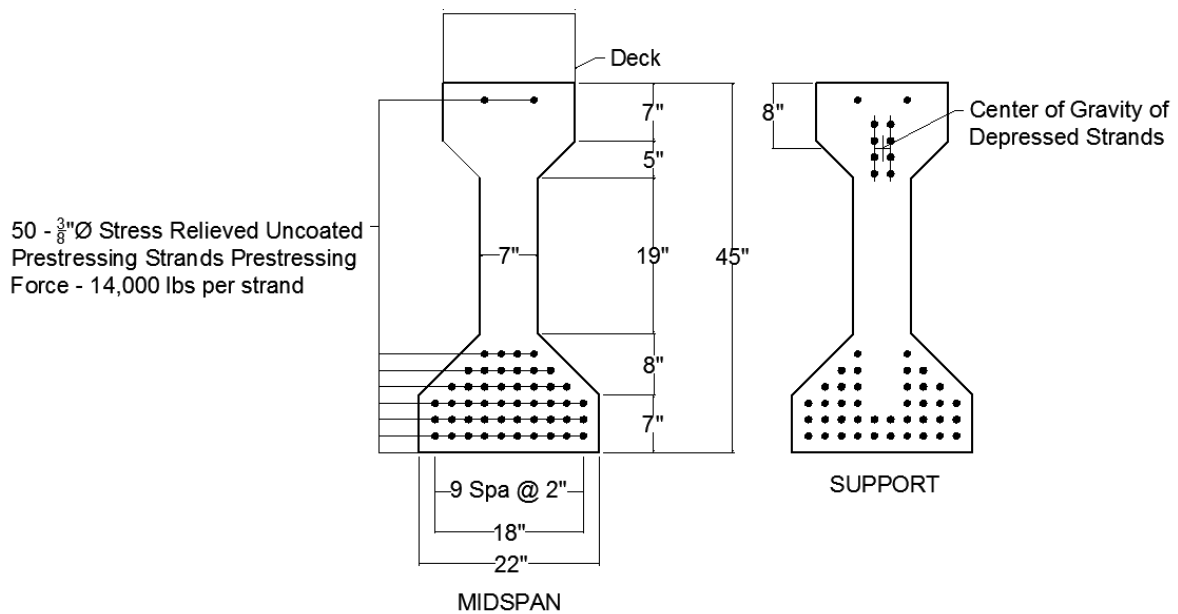
Figure 4-2 – Girder Dimensions and Prestressing Details of AASHTO Type III (1 in. = 2.54 cm)

The overall bridge cross sectional dimensions and prestressing configuration are given in Figure 4-1 and Figure 4-2. The prestressing configuration consists of a straight tendons of which 8 are harped at 23 ft-10 in. from each end. Material properties for the concrete slab, PC girder, and prestressing steel given in the construction documents are shown in Table 4-1. Each girder has varying slab dimensions.

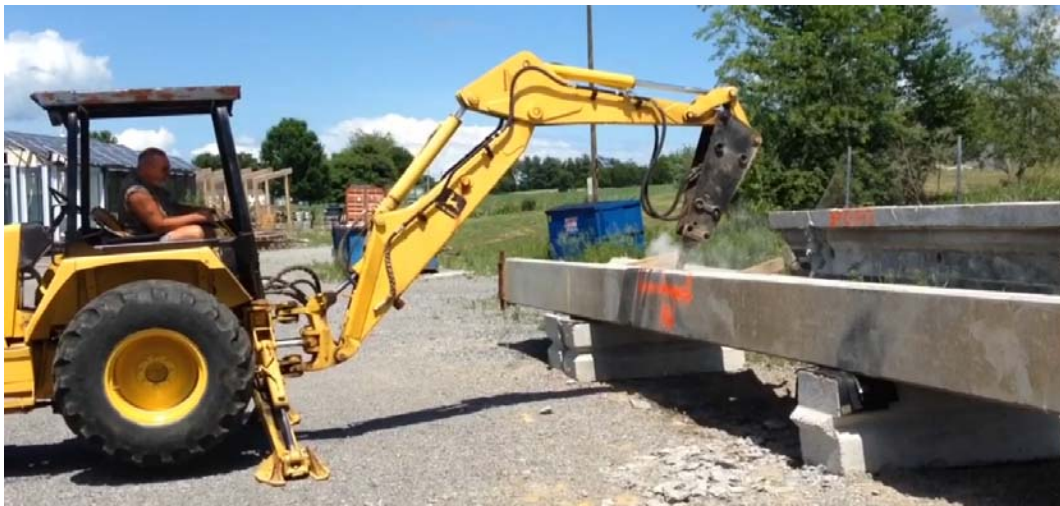
Figure 4-3 – Hydraulic Breaker Damaging Strands

In order to simulate impact damage from over-height vehicles, four (4) prestressing strands were damaged using a hydraulic breaker at Virginia Tech’s Laboratory Facilities (Figure 4-3).

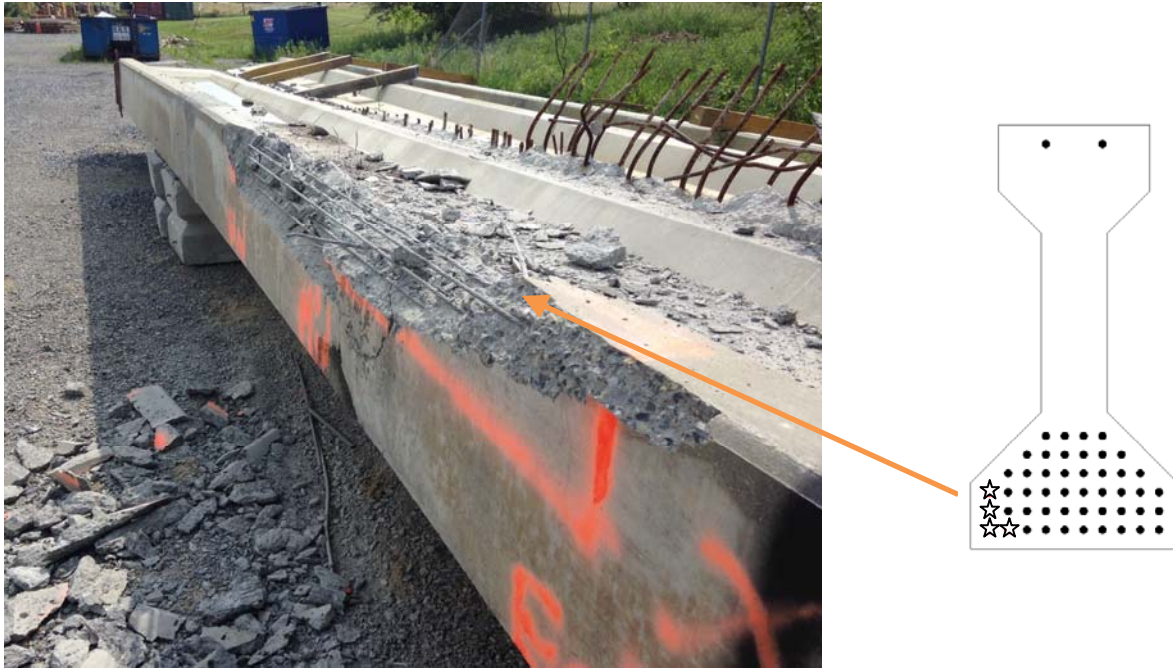
Figure 4-4 – Damaged Prestressing Strands

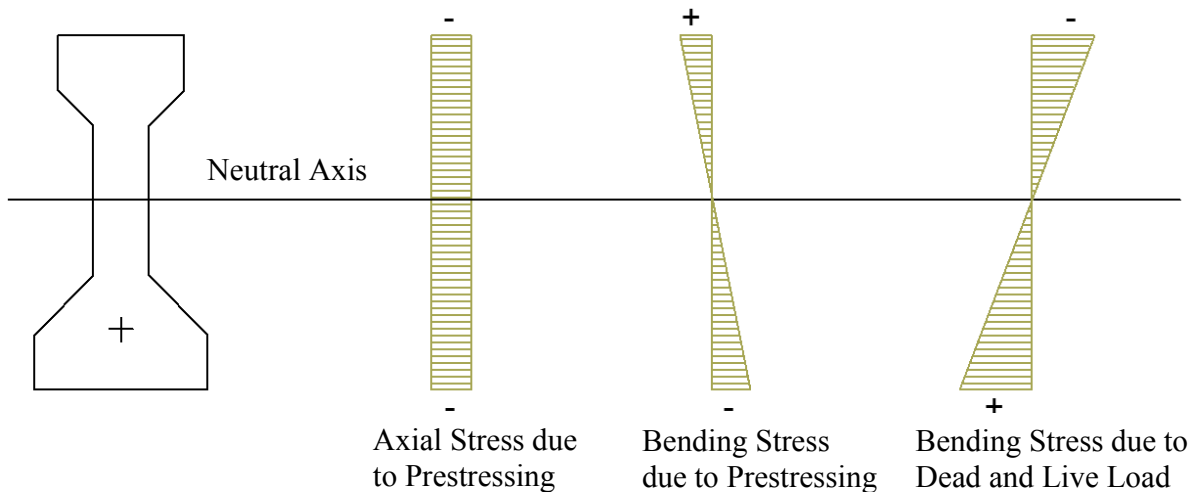
Figure 4-6 – Stresses Applied to Girder Cross Section (Un-Damaged Girder)

The forces applied to the concrete section are represented in Figure 4-6 showing the axial, bending, dead, and live load force effects acting on the girder cross section.

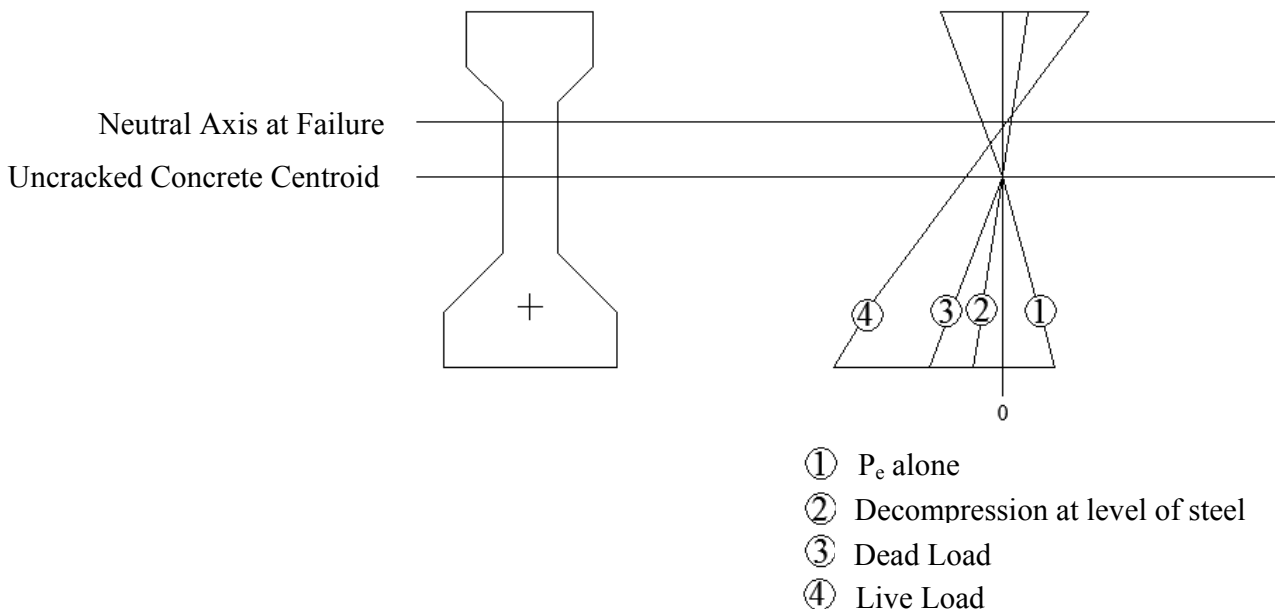
Figure 4-7 – Force Equilibrium for Ultimate Flexural Strength

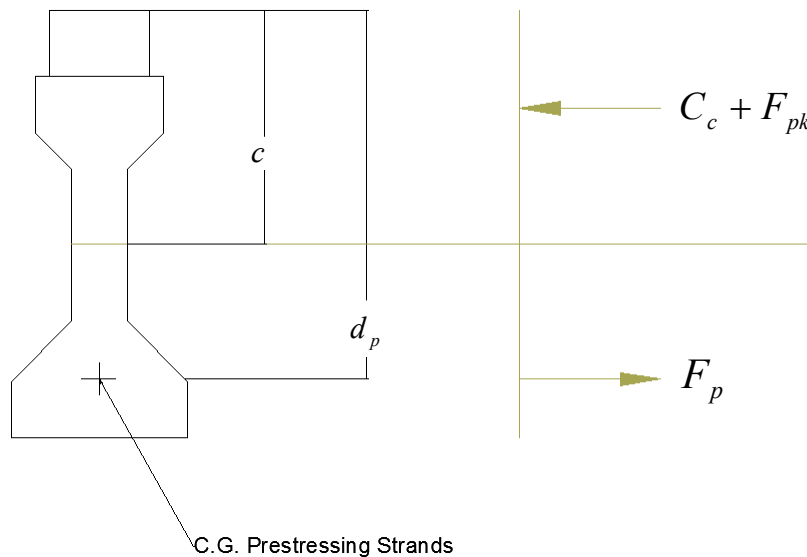
Figure 4-8 – Force Equilibrium for Nominal Flexural Strength (Un-damaged Girder)

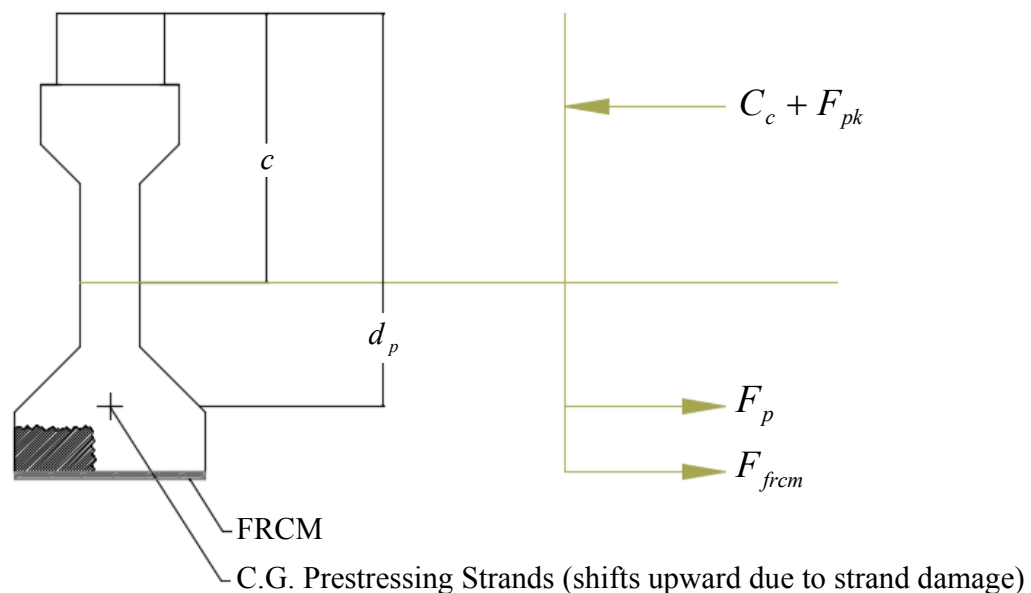
Figure 4-12 – Force Equilibrium for Nominal Strength with FRCM Strengthening

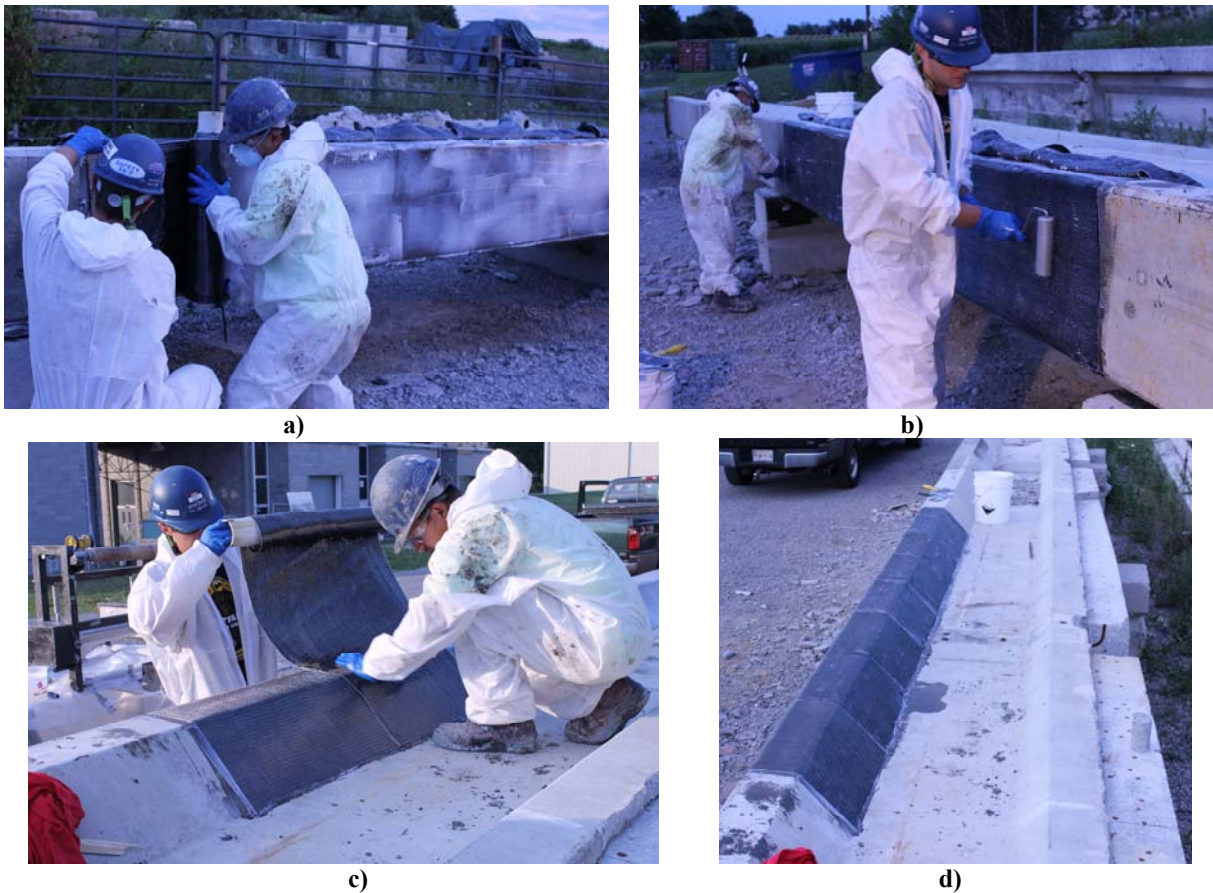
Figure 4-22 – FRP Sequence of Application a) Steps 1 b) Step2 c) Step 3 d) Completed Repair

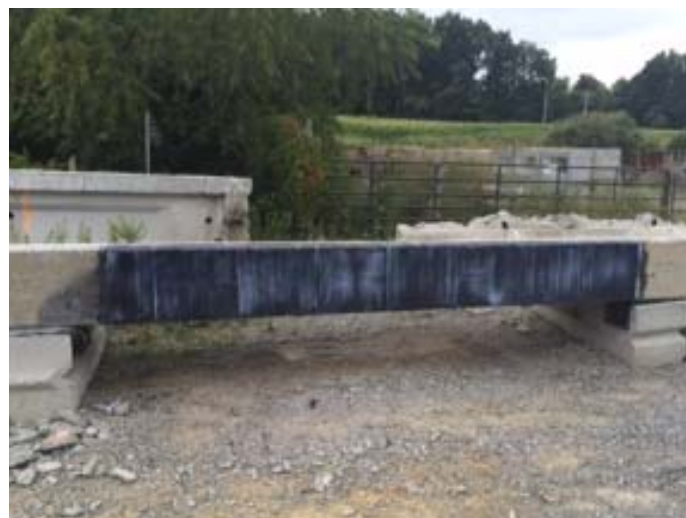
Figure 4-23 – FRP Strengthened Girder

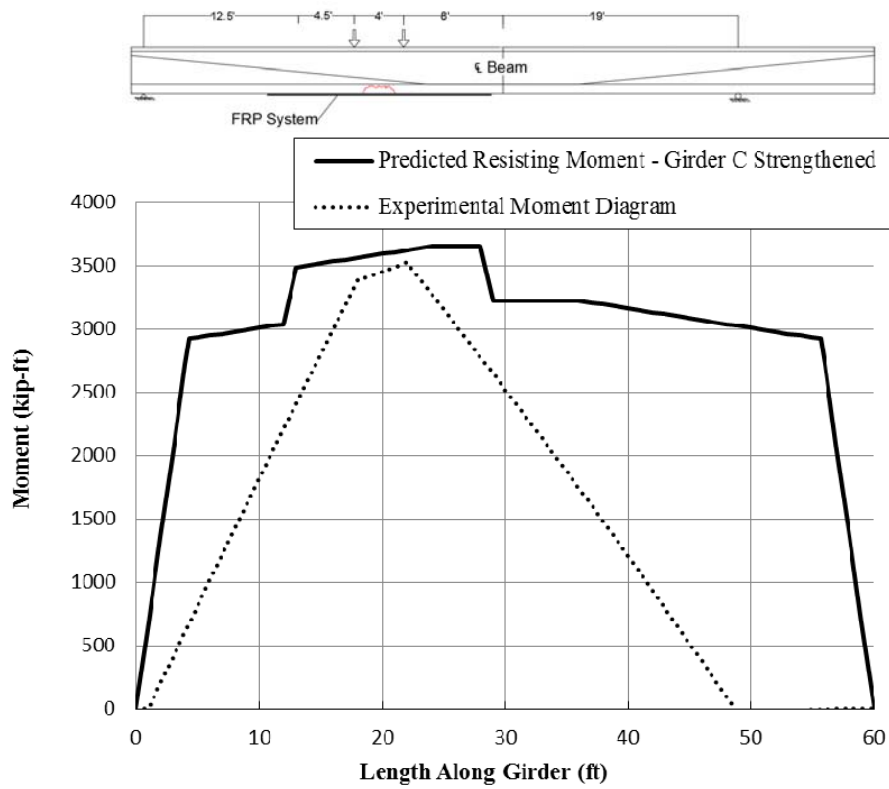
Figure 4-30 – Moment Diagrams for Test 3 – 48 ft Configuration

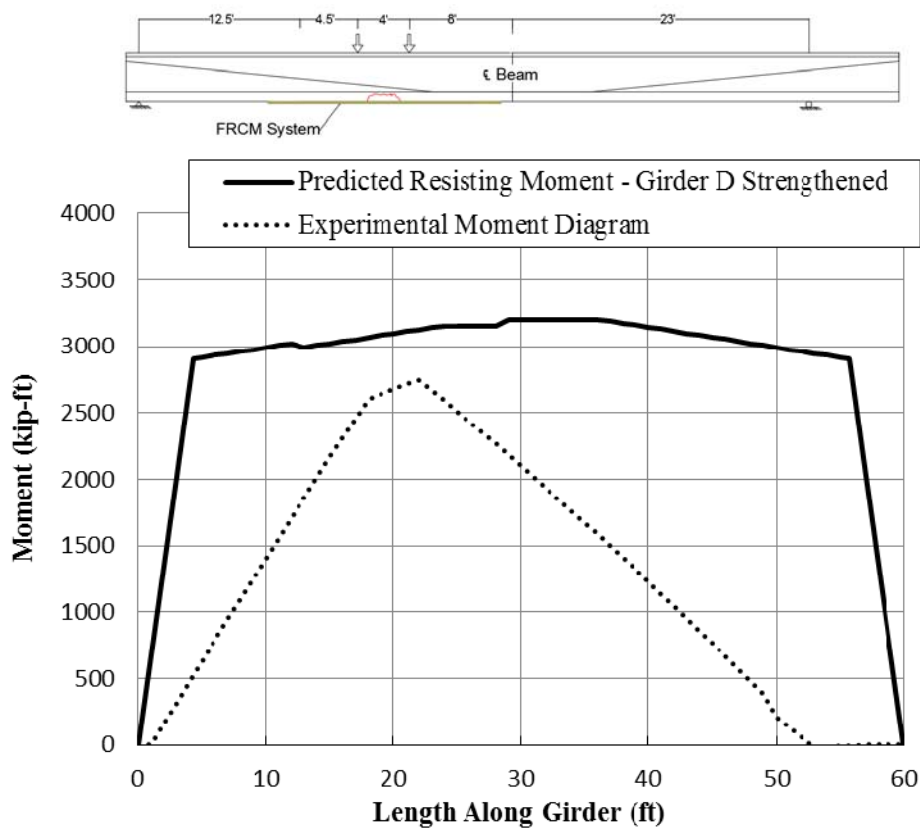
Figure 4-34 – Moment Diagrams for Test 5

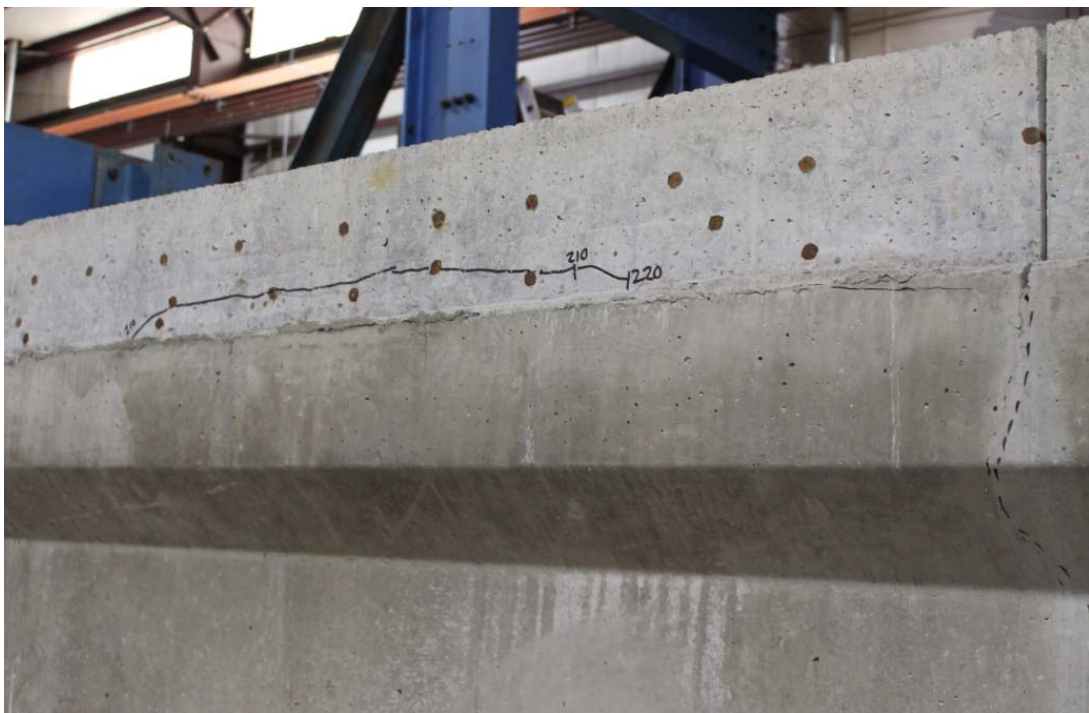
Figure 4-36 – Test 5 – Horizontal Shear Cracking and Crack Propagation at Gap

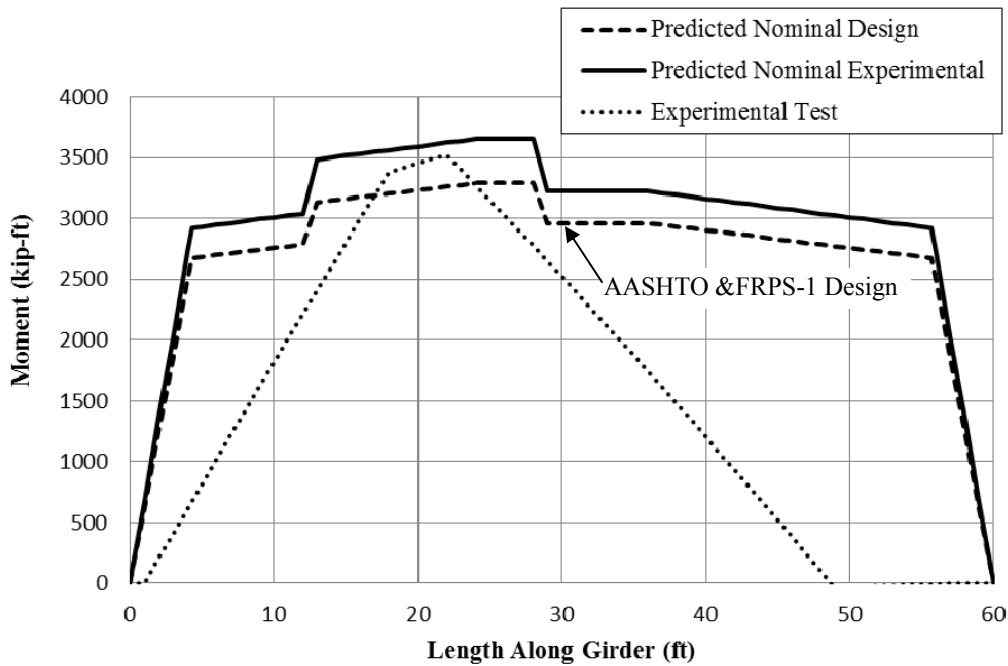
Figure 5-4 – Girder C Moment Diagrams

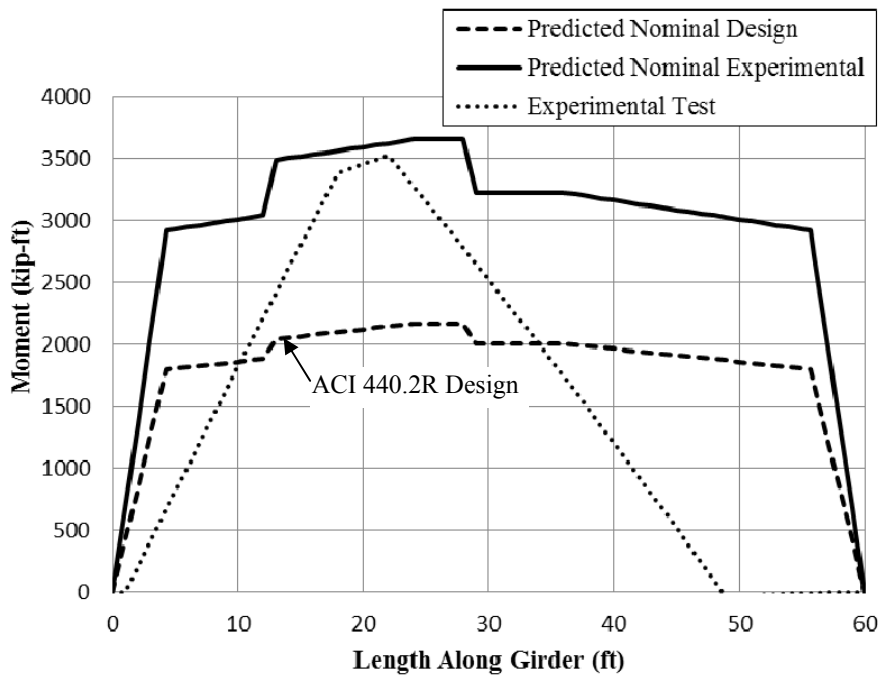
Figure 5-7 – Girder C Moment Diagrams
