# FINAL PROJECT REPORT #00042134-04-103B Volume II

## FRP Reinforcement for Concrete: Performance Assessment and New Construction

### Volume II: Two Bridges in Missouri

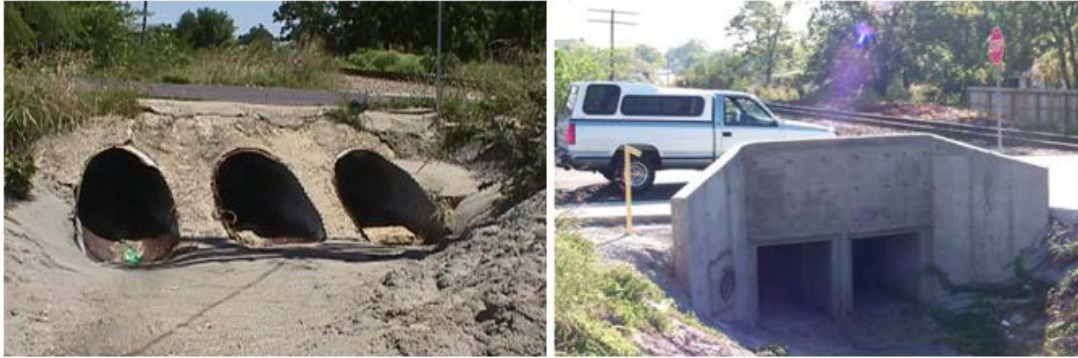
**Figure 1: Old (left) and new (right) Walker Bridge**

The Walker box-culvert bridge was constructed in 1999 on Walker Avenue in the City of Rolla, Missouri to replace the original bridge that was made of three concrete-encased corrugated steel pipes and became unsafe to operate due to excessive corrosion of the steel pipes. GFRP bars were implemented in the new bridge as an alternative for steel rebar in order to extend the service life beyond that of conventional steel-RC construction. The new bridge is 10.97 m (36 ft.) wide, consisting of eighteen 1.5 by 1.5 m (4.92 by 4.92 ft.) box culverts with a thickness of 150 mm (5.9 in.). The old and new bridges are shown in Figure 1. The RC boxes were entirely reinforced with No.2 GFRP bars (nominal diameter of 6.3 mm) pre-bent and cut to size by the manufacturer. The 25.4 mm (1 in.) concrete cover was maintained using plastic wheel spacers. Figure 2 shows a completed GFRP cage before concrete casting. Conventional concrete made of Portland cement, fly ash, tap water, and Missouri river aggregate with a maximum aggregate size of 9.5 mm (3/8 in.) were used to produce the units. The measured concrete compressive strength was 42.7 MPa (6.2 ksi) [4].

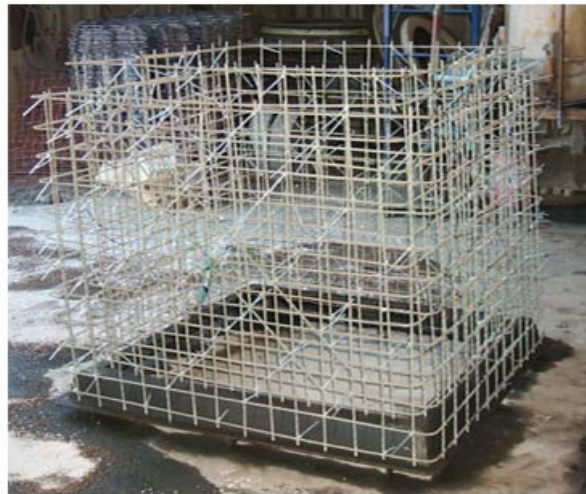
**Figure 2: A Complete GFRP cage before concrete casting**

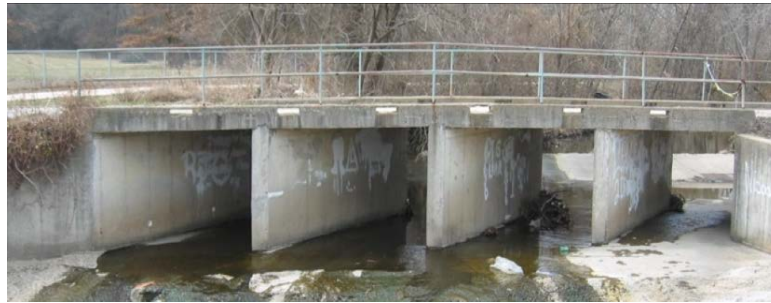
Figure 3: A View of the Former Southview Bridge

Southview Bridge initially included four-cell steel reinforced concrete (RC) box-culverts (Figure 3). The 250 mm (10 in.) thick RC bridge slab went through an expansion in 2004 which included the construction of an additional lane and a sidewalk [5]. The new deck was built on three conventional RC walls as for the existing structure. The concrete deck of the complementary part implemented Nos. 3, 4 and 6 GFRP bars (Figure 4) and No. 3 prestressed CFRP tendons [6].

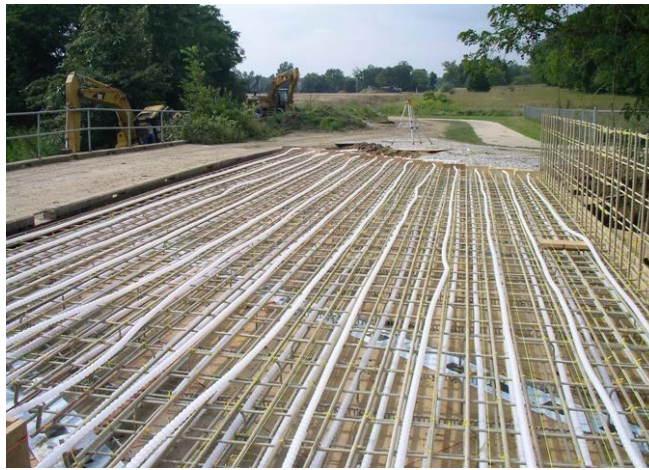
Figure 4: Southview Bridge Deck Top-GFRP Layer and CFRP Tendons

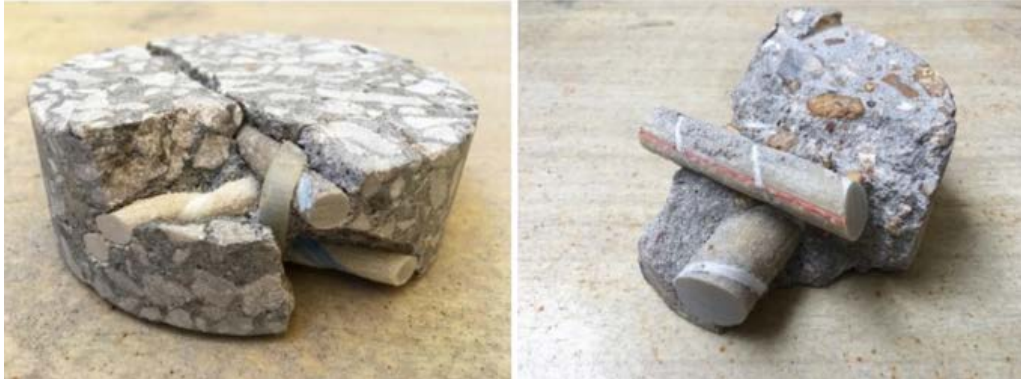
Figure 5: GFRP coupons extracted from the concrete cores of Walker (left) and Southview (left) Bridge

Technically-competent personnel performed the extraction of concrete cores from both bridges in 2016. Four 102 mm (4 in.) diameter concrete cores were extracted from the bottom of two culverts of Walker Bridge and two cores with similar size were extracted from the deck of the Southview Bridge. GFRP coupons were extracted from the cores (Figure 5) and were sliced to an approximate width of 10 mm (0.4 in.) using a diamond saw for microscopic examination.

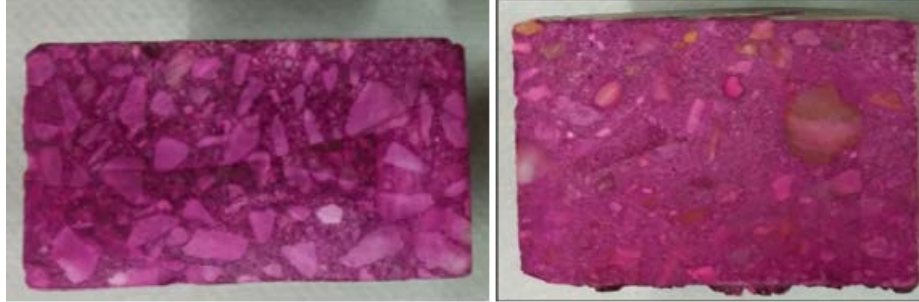
**Figure 6: Carbonation depth measurement of concrete samples extracted from Walker (left) and Southview (right) Bridge**

A carbonation depth equal to the concrete cover may be responsible for steel corrosion initiation. The carbonation depth was measured by spraying the 1% solution of phenolphthalein in 70% ethyl alcohol on freshly fractured concrete surfaces [8]. The colorless solution turned to pink/purple when the pH was higher than 9 and stayed colorless otherwise. No indication of concrete carbonation was observed using this method in samples from both bridges (Figure 6). While no carbonation of concrete can be considered beneficial to steel rebars because the pH remains at high values, the opposite is true for GFRP reinforcement that is more sensitive to high alkalinity. Thus, the GFRP bars extracted from these cores were subject to an aggressive alkaline environment over the 17 and 11 years of service for Walker and Southview bridge respectively.

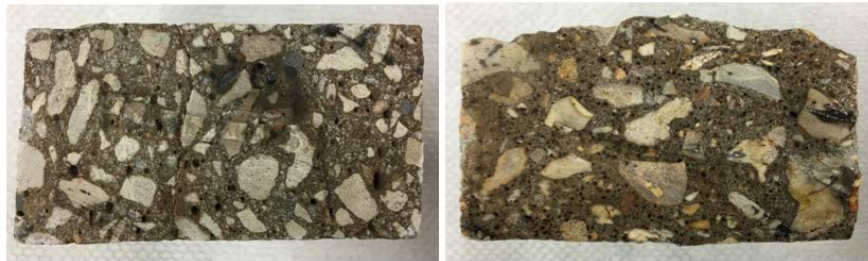
**Figure 7: Chloride diffusion measurement of concrete samples extracted from Walker (left) and Southview (right) Bridge**

An adaptation of the rapid migration test (RMT) using silver nitrate solution was employed to determine the chloride diffusion in the concrete samples. Two concrete samples were cut in order to provide fresh split surfaces. A 0.1 mol/L silver nitrate solution was poured on the entire cut surface [9]. In presence of chloride, a clearly visible white/silver precipitation takes place on the surface while in the absence of chlorides, the solution reacts with the hydroxides present in the concrete, changing the surface color to brown. No clear evidence of chloride diffusion was observed in all the tested specimens of both bridges using this method. It was noticed that the surface became darker, to a color similar to brown, while there was no visible gray area (Figure 7).

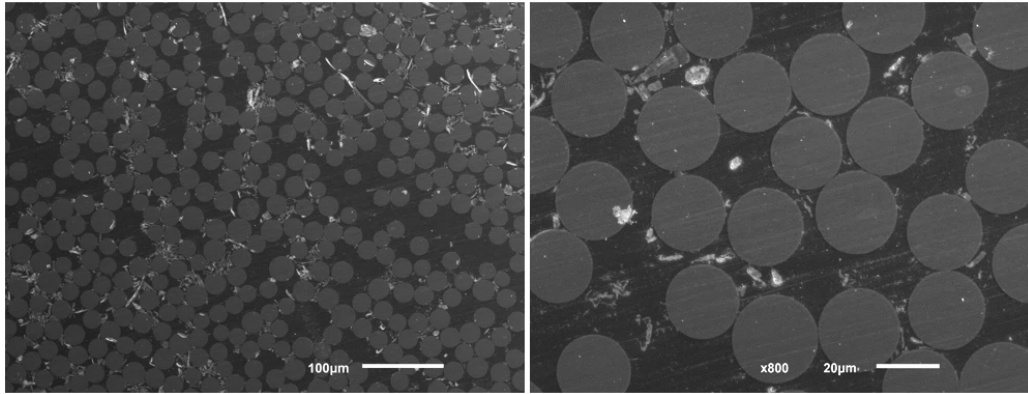
**Figure 8: SEM images of GFRP bar after 16 years of service in Walker Bridge in magnification levels of 200x (left) and 800x (right)**

The GFRP microstructure was investigated since it is a critical parameter in performance and durability of GFRP bars [10]. The full cross-section of prepared GFRP coupons were scanned using SEM at different levels of magnification and images were taken at random locations. Attention was paid to the areas in the vicinity of the bar edges since possible degradation due to chemical attack starts at GFRP-concrete interface. Representative images are shown in Figure 8 and Figure 9. SEM analysis suggests that there was no apparent sign of deterioration in the GFRP coupons. No damage was observed in the matrix and at the matrix-fiber interface. Glass fibers appeared to be intact without no loss of cross-sectional area.

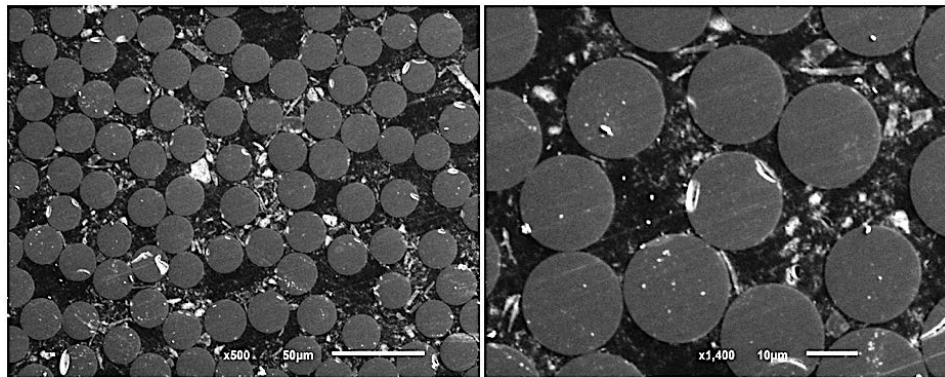
**Figure 9: SEM images of GFRP bar after 11 years of service in Southview Bridge in magnification levels of 500x (left) and 1400x (right)**

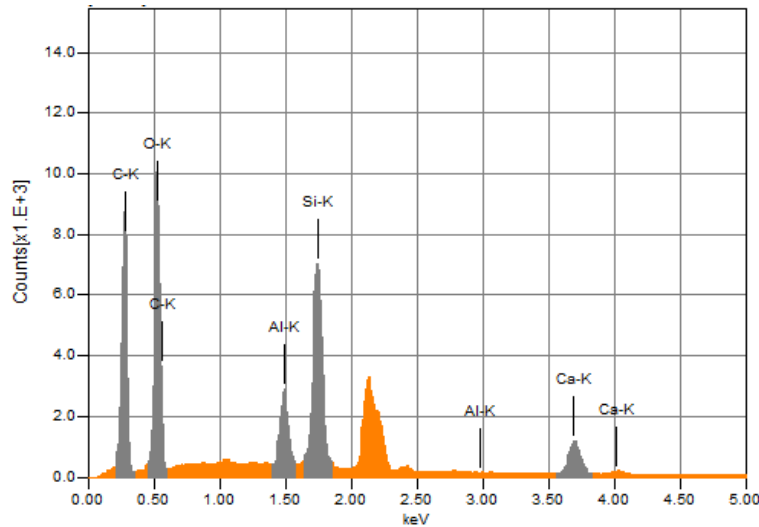
Figure 10: Result of the EDS analysis performed on GFRP samples extracted from Walker Bridge

EDS was performed at several locations of each GFRP slices with a focus on the edge of the bar to identify existing chemical elements. Results are shown in Figure 10 and Figure 11 where the vertical axis corresponds to the counts (number of X-rays received and processed by the detector) and the horizontal axis presents the energy level of those counts. Si, Al, Ca (from glass fibers) and C (from the matrix) were the predominant chemical elements in the extracted samples. No apparent sign of any chemical attack was observed in the bars.

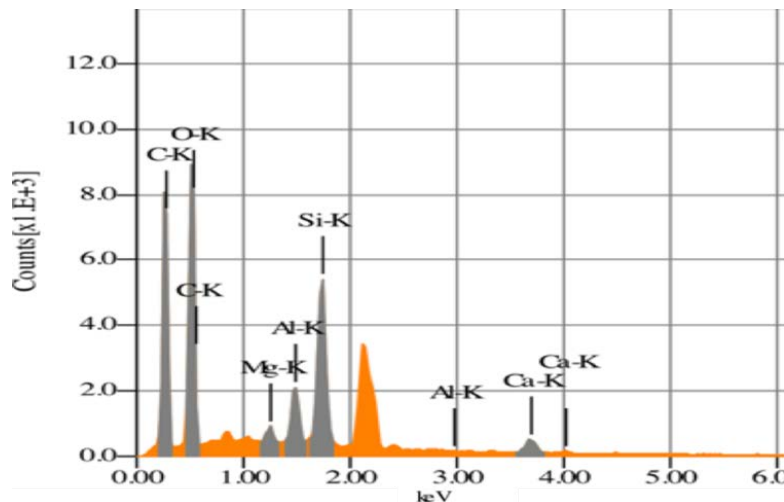
Figure 11: Result of the EDS analysis performed on GFRP samples extracted from Southview Bridge

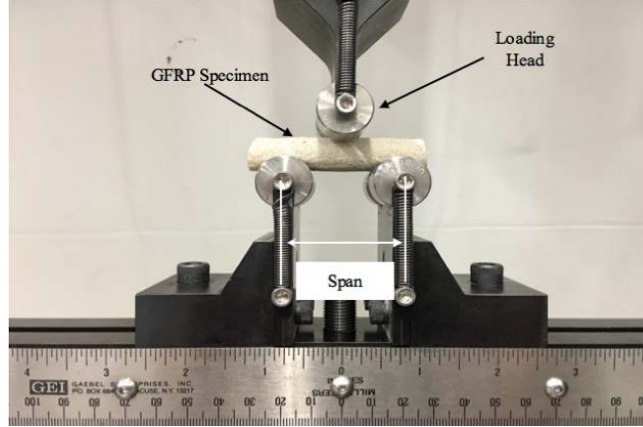
Figure 12: Horizontal shear test performed on GFRP bars extracted from Southview Bridge

The horizontal shear strength of the extracted GFRP coupons was determined following ASTM D4475 [11] as a useful parameter for durability evaluation. The test was performed on three GFRP coupons extracted from Southview Bridge: i) one No. 4 GFRP bar with the total length of (58 mm) 2.3 in, and ii) two No. 6 GFRP bars with the total length of 76 mm (3 in.) and (74 mm) 2.9 in. No horizontal shear test was performed on samples extracted from Walker Bridge due to their small diameter. Since no historic data was available at the time of construction, the results were compared to the test performed on pristine bars produced by the same manufacturer in 2015 as a benchmark. Specimens were tested with the span-to-diameter ratio equal to three, according to standard and compared with pristine samples. The test was performed in displacement control with the rate of 1.27 mm/min (0.05 in/min) of the cross head (Figure 12).
