# FINAL PROJECT REPORT # 00042134-05-3A

## Volume IV: Performance of Fiber-Reinforced Self-Consolidating Concrete for Repair of Bridge Sub-Structures and Fiber Reinforced Super Workable Concrete for Infrastructure Construction

Participating Consortium Member:  
University of Oklahoma, Norman, Oklahoma

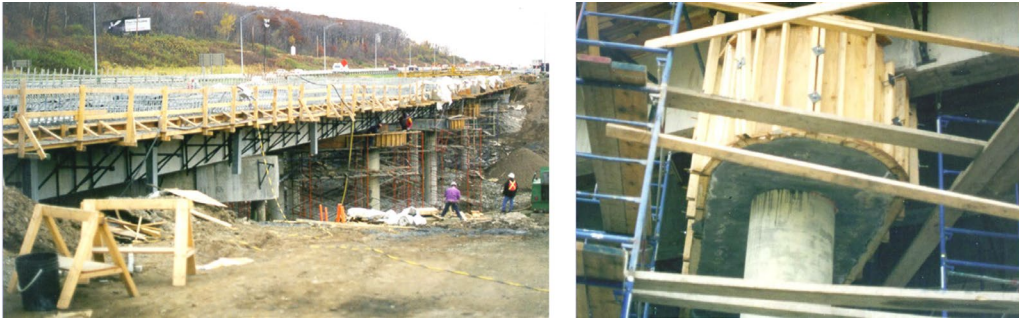
**Figure 1.1: SCC Used in the Repair of Bridge Pier Caps (Khayat et al., 2010)**

Successful experience with the performance of SCC as a superior repair material has attracted the attention of construction firms and departments of transportation. Examples of the repair of damaged bridge substructures are shown in Figures 1.1 thru 1.3.

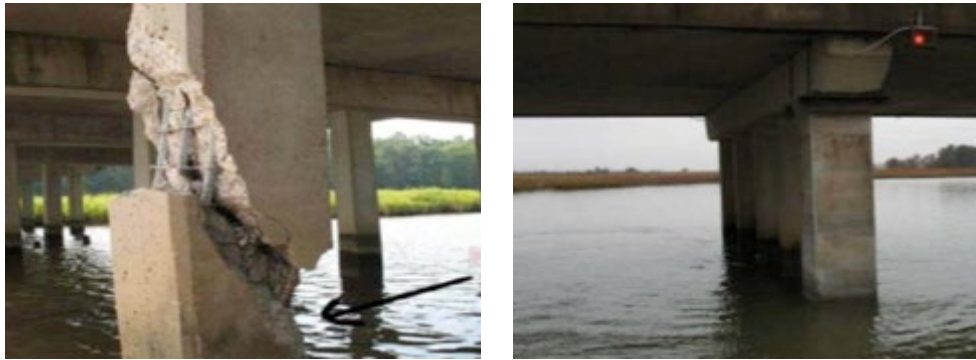
**Figure 1.2: SCC Used in the Repair of Bridge Piles (Ozyildirim, 2013)**

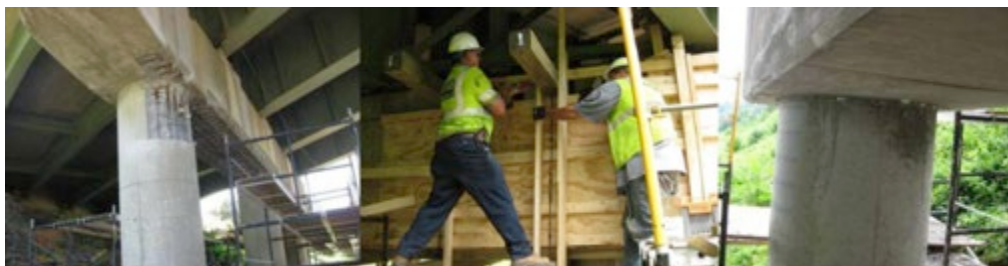
**Figure 1.3: SCC Used in the Repair of Bridge Columns and Pier Caps (Ozyildirim, 2013)**

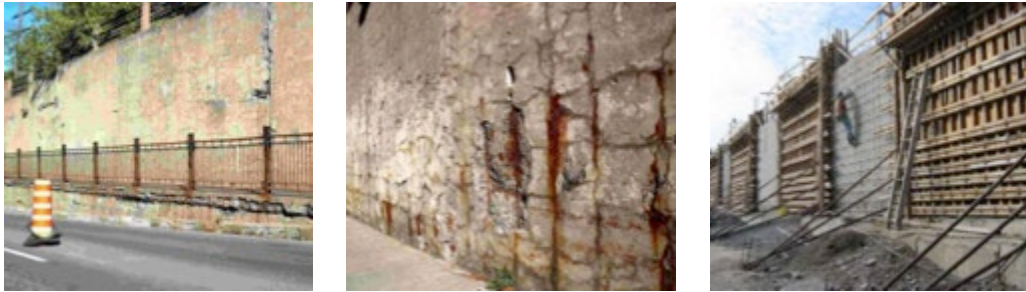
**Figure 1.4: FR-SCC Used in the Repair of the Jarry/Querbes Underpass (Khayat et al., 2005)**

had undergone severe degradation due to aggressive exposure to frost action. The project was successfully repaired with the use of FR-SCC. The use of synthetic structural fibers was beneficial in obtaining only small and finely distributed surface cracking. This project is shown in Figure 1.4.

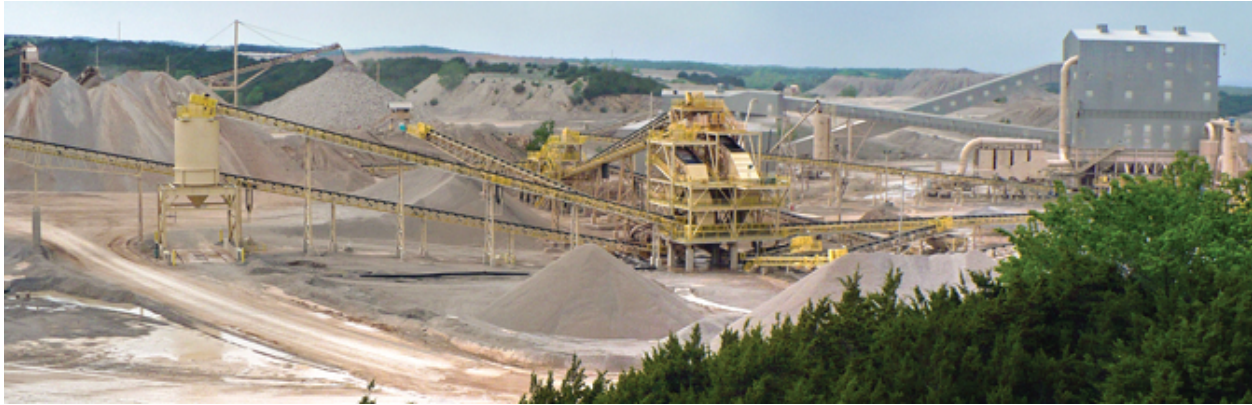
**Figure 2.1: Dolese Bros. Co. Davis Quarry**

Aggregates for the research study consisted of natural river sand and limestone donated by Dolese Bros. Co. from their Davis Quarry, Figure 2.1, and river gravel donated by Metro Materials, Norman, Oklahoma. The fine aggregate consisted of natural river sand while the coarse aggregates consisted of a No. 57 limestone gradation and a No. 7 river gravel gradation, shown in Figure 2.2. The aggregate gradations and ODOT gradation limits are provided in Tables 2.2, 2.3, and 2.4 for the sand, No. 57 limestone, and No. 7 river gravel, respectively, all of which met the requirements. The specific gravity, dry rodded unit weight (DRUW), absorption, and LA abrasion values for

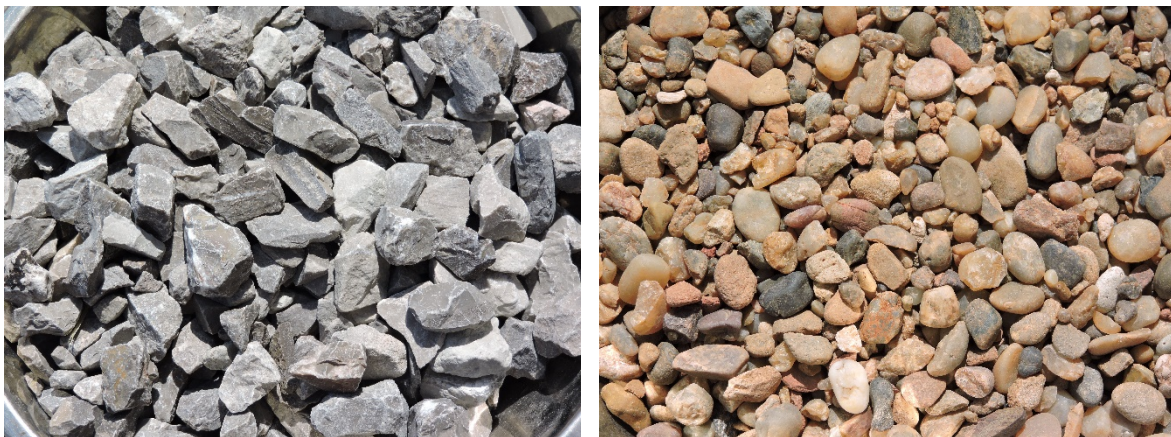
**Figure 2.2: #57 Limestone (l) and #7 River Gravel (r) Coarse Aggregates**

each aggregate type are provided in Table 2.5. The No. 57 limestone and No. 7 river gravel coarse aggregates met the minimum abrasion resistance requirements of the ODOT specifications.

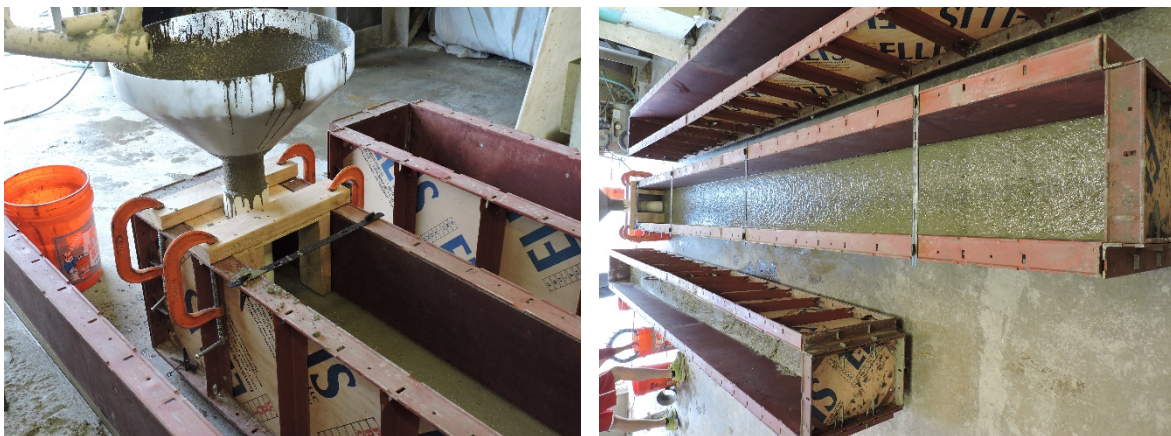
**Figure 3.2: Full-Scale Flow Test of FR-SCC Mix Design, 15% Type K Expansive Agent**

The research team continued to refine the FR-SCC mix design with the 0.5% synthetic fibers and citric acid retarder and developed a full-scale flow test to mimic the repair application. The setup for the full-scale flow test is shown in Figure 3.2 and uses the same formwork, access pipe, and funnel as that which will be used to construct the full-scale repaired beams. The FR-SCC successfully flowed the full 14-foot length of the formwork, with a depth of concrete at the placement point of 7 inches, and a depth of concrete at the far end of the formwork of 6-3/4 inches. The final FR-SCC mix designs are shown in Table 3.6 for both 10% Type K expansive agent and 15% Type K expansive agent. ODOT requested an evaluation of both Type K replacement percentages in order to provide more flexibility in future specifications.

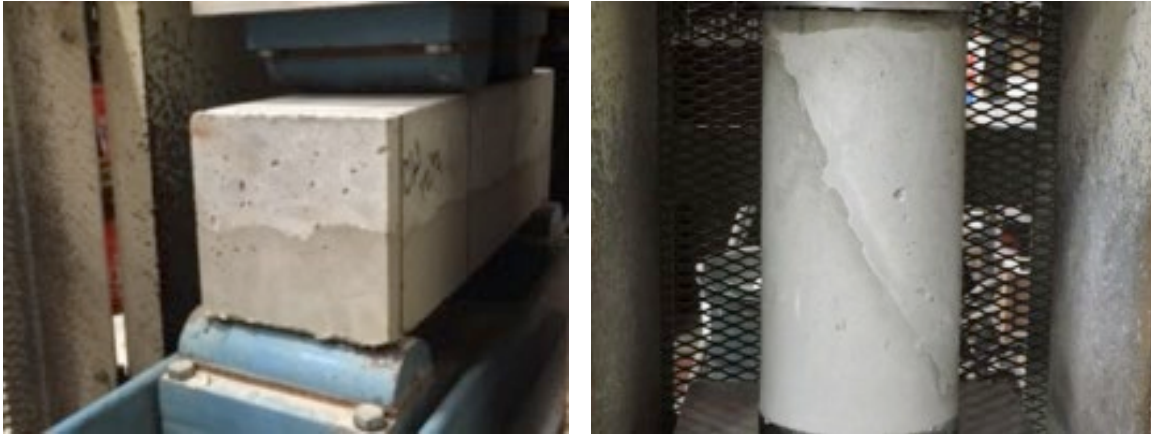
**Figure 4.1: Composite Prism Test Specimen (l) and Slant Shear Test Specimen (r)**

The composite prism and slant shear tests used standard modulus of rupture and compressive strength specimens, respectively, with a combination of substrate concrete and repair material. The composite prism test is based on a standard modulus of rupture prism with the top 3 inches consisting of the Class AA mix and the bottom 3 inches consisting of the FR-SCC mixes. The slant shear test is based on a standard 6x12 compressive strength cylinder with the substrate cast first

with the molds placed at a 30° angle to the horizontal and then the FR-SCC cast with the cylinder in a vertical orientation. The result is a joint between the two concretes at an angle of 30° to the vertical. The substrate concrete for both specimens is cast first and allowed to cure for 28 days prior to placement of the FR-SCC repair materials. Representative test specimen types are shown in Figure 4.1, where the darker concrete indicates the FR-SCC repair materials.

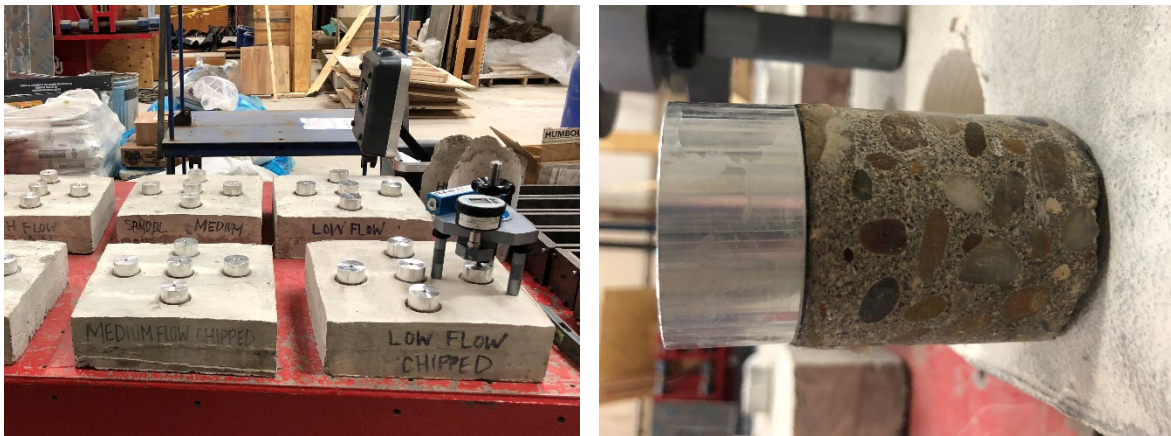
**Figure 4.2: Pull-off Test Setup (l) and Pull-off Test Specimen (r)**

The direct pull-off test uses a 12 inch by 12 inch substrate base to which an overlay is placed of the material to be tested. Both layers are 2 inches thick, with the substrate placed and allowed to cure a minimum of 28 days prior to placing the overlay material. After sufficient curing of the overlay material, the overlay is cored to a depth of approximately 1/2-inch into the substrate, aluminum plugs are glued to the overlay, and the pull-off tester is attached to the plugs. Three pull-off tension tests are performed for each specimen, with the average pull-off strength characterizing the bond of the overlay with the substrate. It is preferable that the specimen fail within the substrate for maximum bond with the overlay. The pull-off test setup and a representative specimen are shown in Figure 4.2.

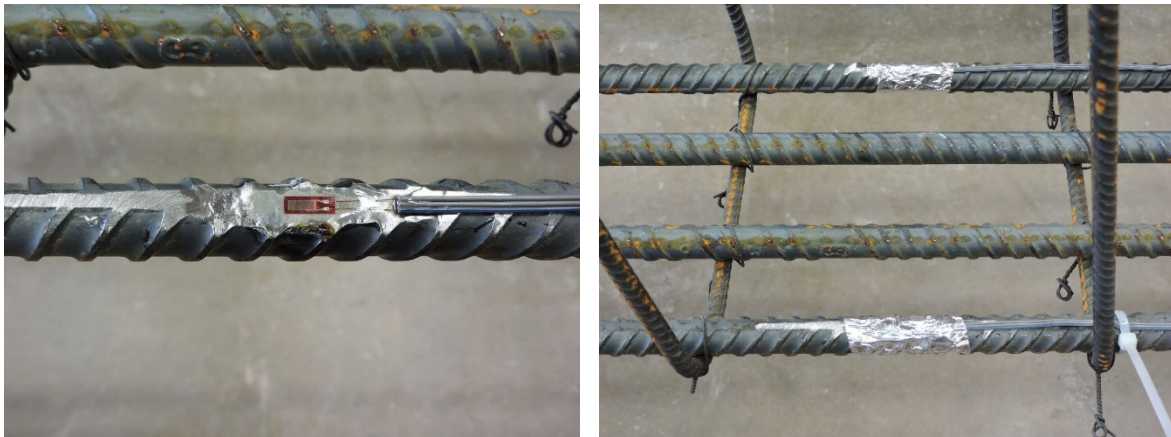
**Figure 5.3: Strain Gages Installed Near Midspan of Longitudinal Reinforcing Steel**

Once the reinforcing cage construction was complete, strain gages were installed on two of the longitudinal reinforcing bars near midspan, as shown in Figure 5.3. The strain gages were installed to verify that a flexural failure occurred. After grinding and cleaning of the reinforcing steel, each gage was attached using cyanoacrylate adhesive and then wrapped in a butyl rubber tape and aluminum foil for protection during the concrete placement. The lead wires for the strain gages were fed to the top of each cage and secured to the reinforcing steel with plastic zip ties. A data acquisition system monitored the strains in the reinforcing steel during the load test.

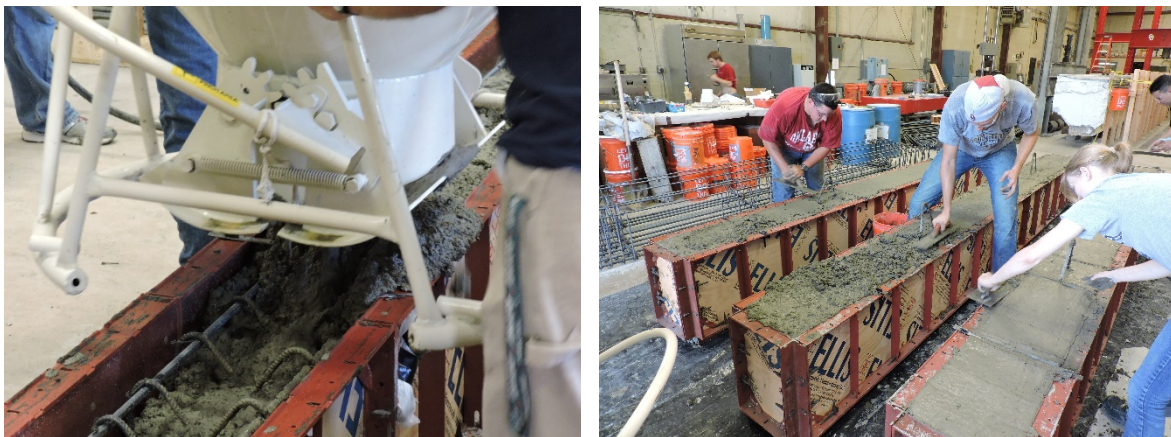
**Figure 5.4: Full-Scale Control Beam Specimen Concrete Placement (l) and Finishing (r)**

The Class AA mix was delivered by Dolese Bros. and placed into the beam forms using a concrete bucket, as shown in Figure 5.4. The beams were filled in two layers. After the first layer was poured, the concrete was vibrated to reduce air pockets and ensure proper consolidation. Once the last layer was poured and vibrated, the top was screeded and smoothed with finishing trowels, as shown in Figure 5.4. During the finishing process, premade steel hooks were vibrated into the top of the beams for transporting the specimens. The beams and companion small scale specimens were moist cured for 7 days.

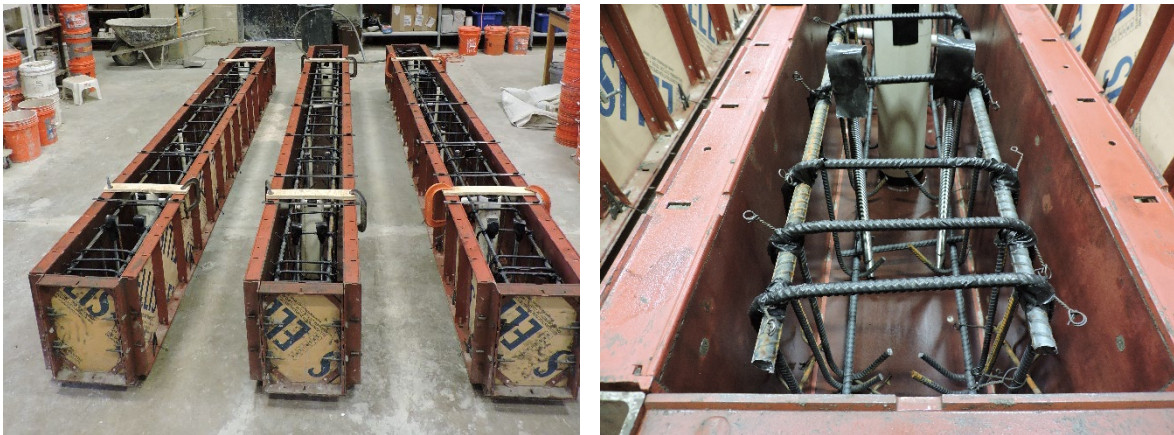
**Figure 5.8: Upside Down Placement of Cages (l) and Protection of Exposed Portion of Stirrups (r)**

Placement of the Class AA substrate portion for the FR-SCC repaired beam specimens involved first placing the reinforcing cages upside down within the formwork and securing the inserts, as shown in Figure 5.8(l). In addition, the portion of the stirrups within the subsequent repair zone were wrapped with black electrical tape in order to keep them clean and free from any contamination from the Class AA placement, as shown in Figure 5.6(r).

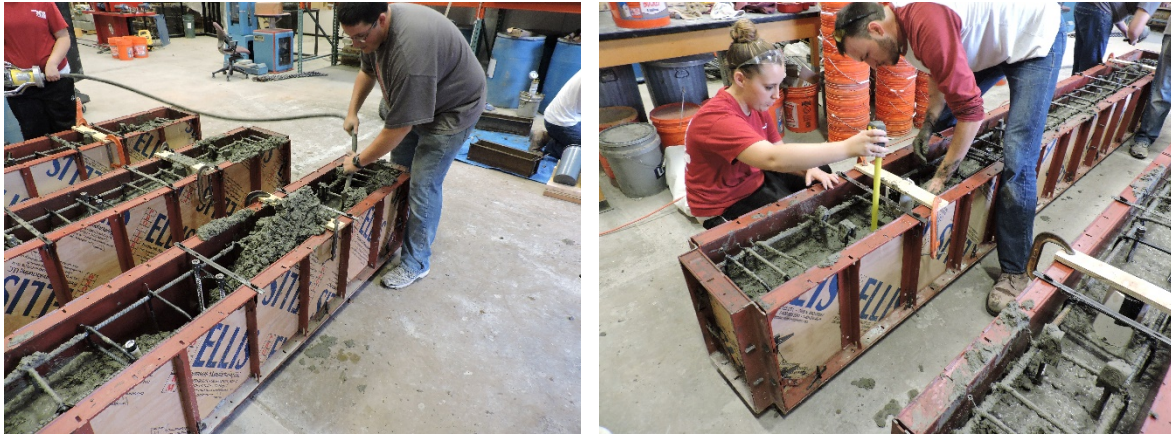
**Figure 5.9: Placement of Class AA Substrate for Full-Scale FR-SCC Repaired Beam Specimens**

The Class AA mix was delivered by Dolese Bros. and placed into the beam forms using a concrete bucket. The beams were filled in two layers. After the first layer was poured, the concrete was vibrated to reduce air pockets and ensure proper consolidation, as shown in Figure 5.9(l). The second layer was carefully placed and consolidated in order to leave the 6-inch-thick nominal FR-SCC repair zone along the top of the specimen. The concrete was carefully sloped to provide the subsequent FR-SCC repair a depth of 5 inches at one end and 7 inches at the other, as shown in Figure 5.9(r). Once the concrete started to initially stiffen, the edge of a trowel was used to roughen the surface to mimic the concrete removal process that would be used in the field for a repair of this type. The beams and companion small scale specimens were moist cured for 7 days.

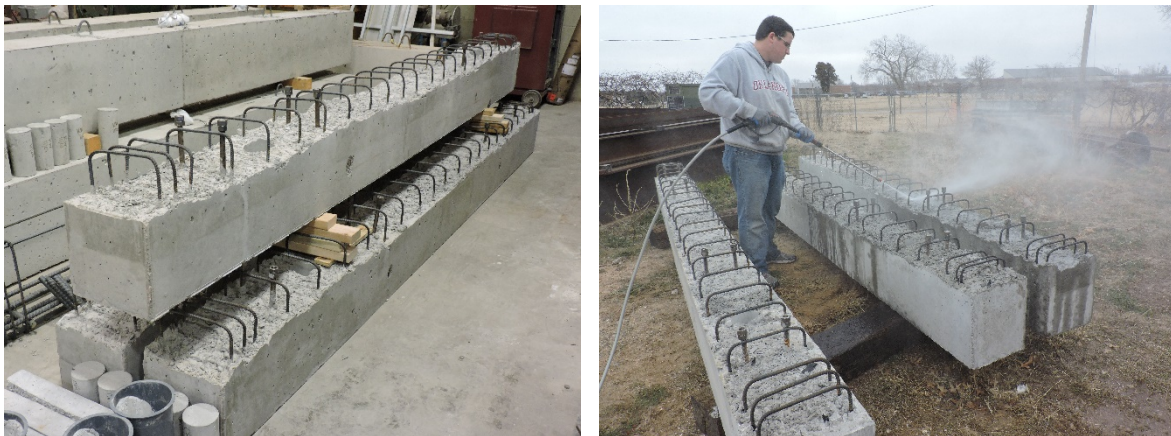
**Figure 5.10: Preparation of Class AA Substrate for Full-Scale FR-SCC Repaired Beam Specimens**

After 7 days of moist curing, the beams were removed from the forms and allowed to cure for the remaining 28 days within the Fears Structural Engineering Lab, as shown in Figure 5.10(l). The black electrical tape was removed from the exposed portions of the stirrups, and the PVC inserts for the access ports, vent holes, and pick points were also removed. The specimens then underwent hydro-demolition to remove the surface paste and any loose material in preparation for the repair material placement, as shown in Figure 5.10(r).

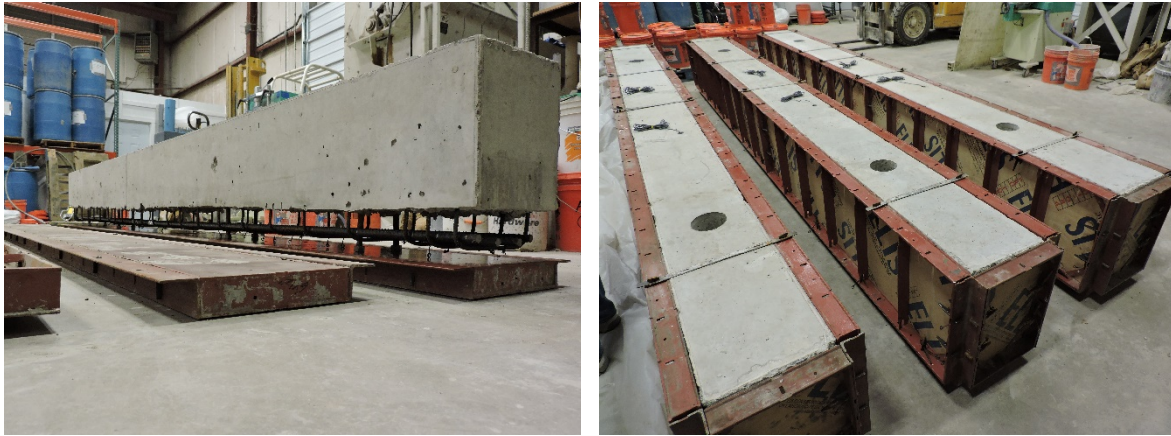
**Figure 5.11: Preparation for FR-SCC Repair Material Placement**

Preparation and placement of the FR-SCC repair material involved first rotating the Class AA portions of the beams right-side up and then installing the flexural reinforcement. The strain gage wires were fed through the vent holes, and the specimens were then placed into the formwork, as shown in Figure 5.11. The FR-SCC repair material was mixed within the 1-cubic-yard mixer housed within the Fears Structural Engineering Lab and placed with a concrete bucket and funnel through the 4-inch-diameter access port at one end of each specimen, as shown in Figure 5.12(l).

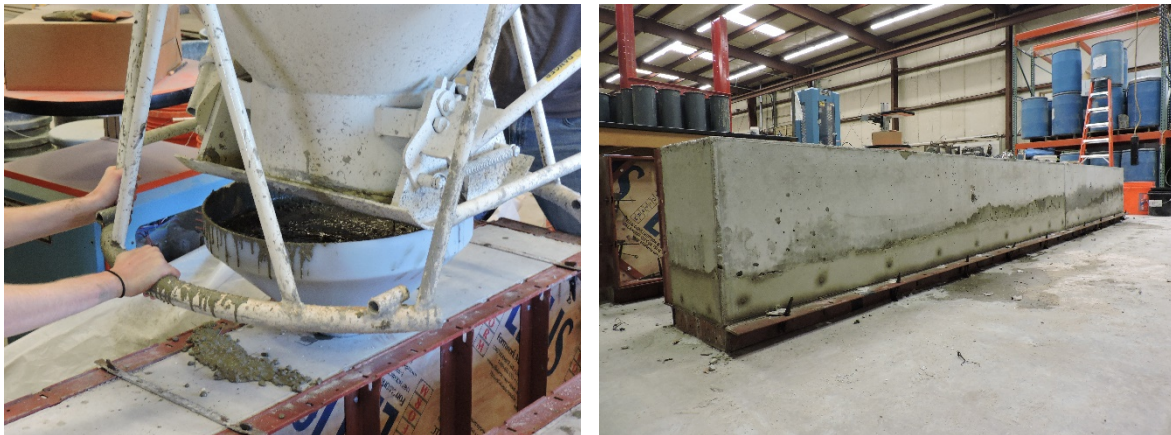
**Figure 5.12: Placement of FR-SCC Repair Material (l) and Completed Specimen (r)**

The specimens were then moist cured for 7 days, removed from the forms, and visually and acoustically inspected to insure complete coverage of the FR-SCC repair. A completed specimen is shown in Figure 5.12(r).

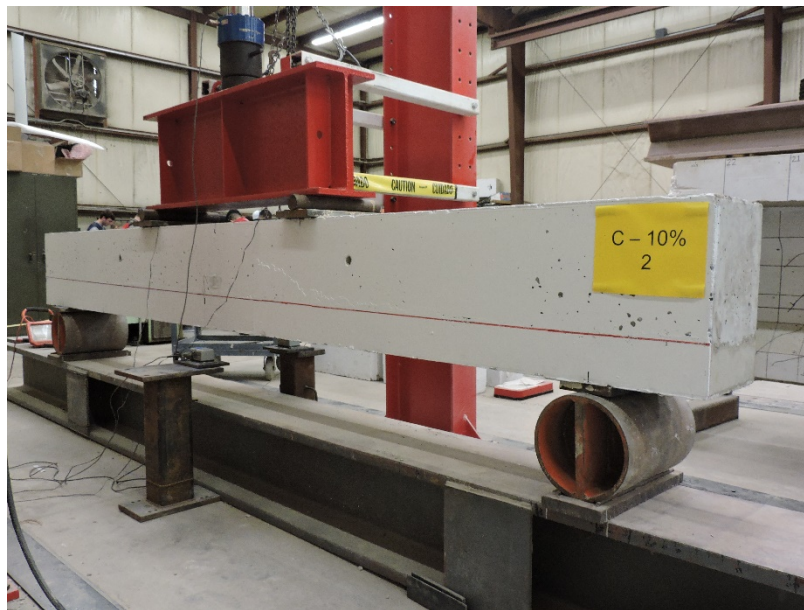
**Figure 5.14: Photograph of Full-Scale Beam Specimen Test Setup**

A schematic of the test setup is shown in Figure 5.13. This third point loading arrangement results in a constant moment region within the center third of the specimen. A photograph of a test specimen within the test fixture is shown in Figure 5.14. A 100-kip load cell was placed on top of the spreader beam to monitor the load being applied during the testing process. String pots were attached to metal angles adhered near midspan to monitor the beam's deflection. The load cell, two string pots, and two internal strain gages were connected to a data acquisition system to monitor the test during loading.

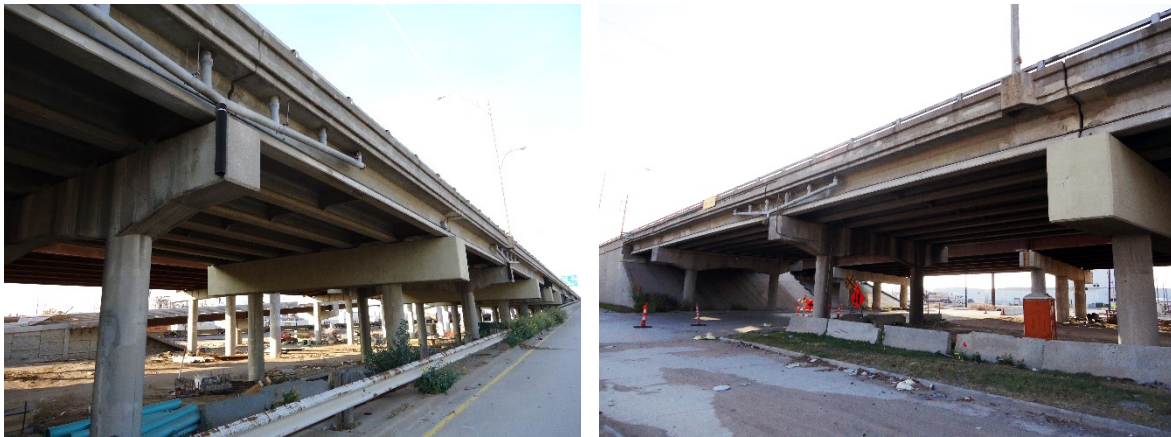
**Figure 6.1: Overall Views of the I-244 Bridge Over the Arkansas River**

The I-244 Bridge over the Arkansas River was constructed in 1967 with a total length of almost 3,000 feet, and recent ODOT evaluations had classified the bridge structure as functionally obsolete, with an operating rating of 57.9 tons and an inventory rating of 35.0 tons. This bridge was particularly beneficial for two reasons. First, the bridge had undergone concrete repairs in the past that had performed poorly. Successful application of the FR-SCC would help convince ODOT of the value of this material for repairs to infrastructure throughout the State of Oklahoma. Second, the bridge was scheduled to be replaced. As such, the research team had the opportunity to repair an AASHTO Type II prestressed girder in service, after which it was removed and transported to the Fears Structural Engineering Lab at OU for testing. As a comparison, the research team also identified one identical girder for testing that had experienced minimal deterioration. This second girder served as a control to compare with the performance of the repaired girder. Photographs of the existing bridge are shown in Figures 6.1 and 6.2. Figure 6.2 highlights the previous concrete repairs.

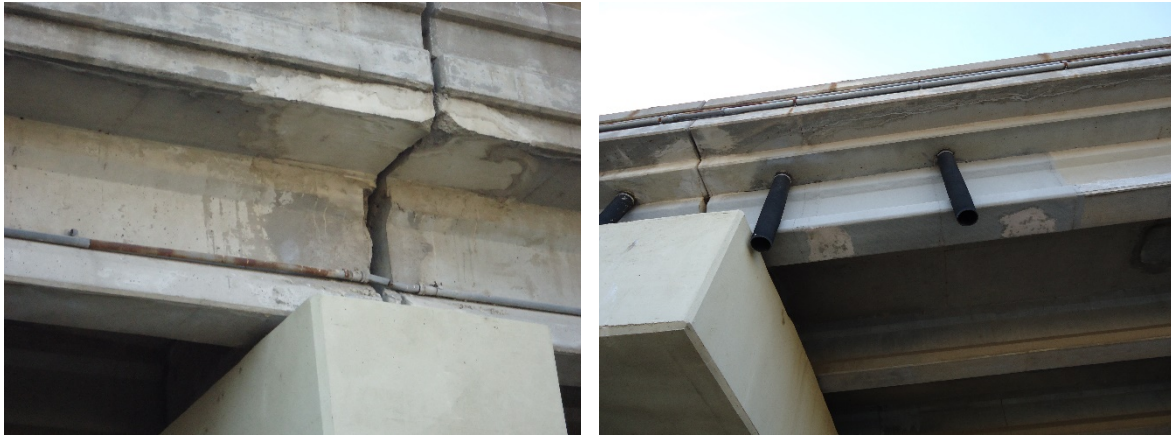
**Figure 6.2: Previous Concrete Repairs to the I-244 Bridge Over the Arkansas River**

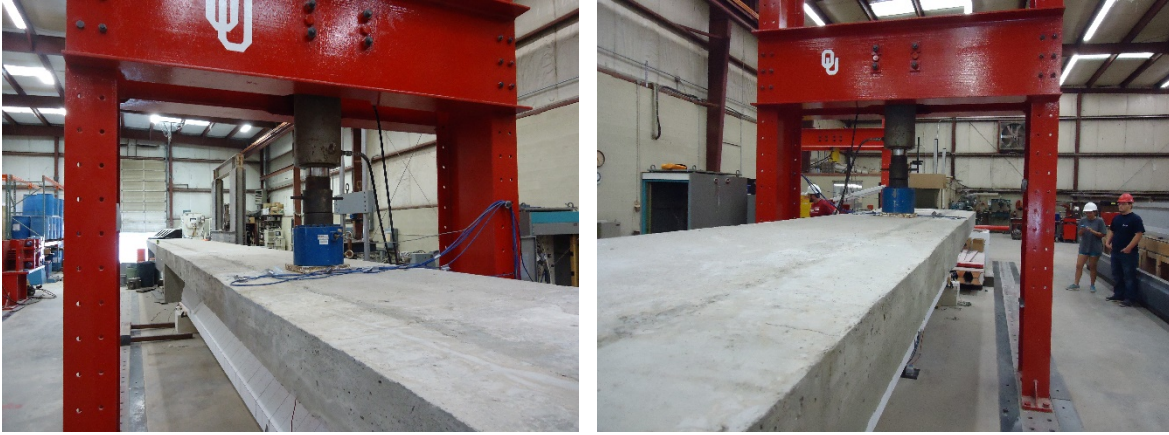
**Figure 6.7: AASHTO Girder C1 Test Setup**

problem with prestressed concrete bridges due to leaking deck joints located at the supporting piers. The support and loading arrangements for the AASHTO girder tests are shown in Figures 6.5 and 6.6. Photographs of the test setup and instrumentation are shown in Figures 6.7 and 6.8, respectively.

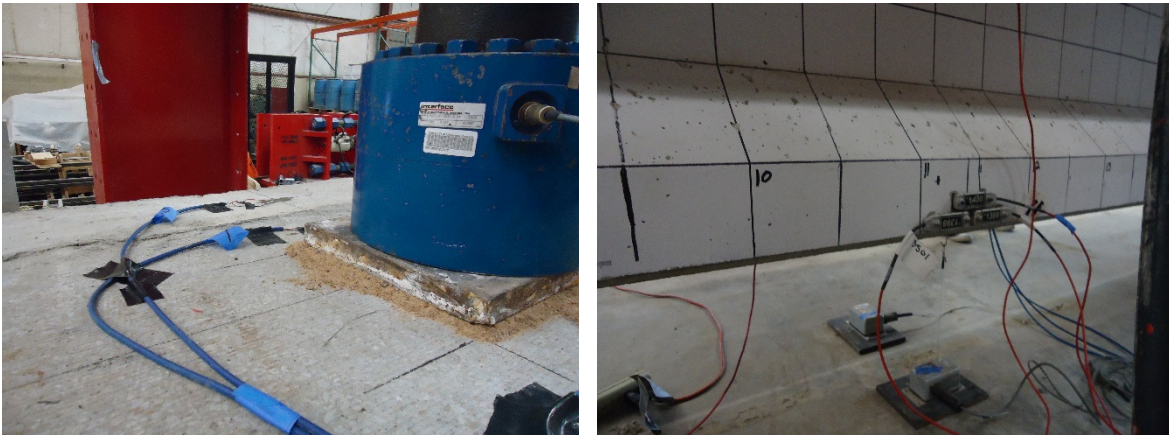
**Figure 6.8: AASHTO Girder Instrumentation, Load Cell (l) and Wire Pots (r)**

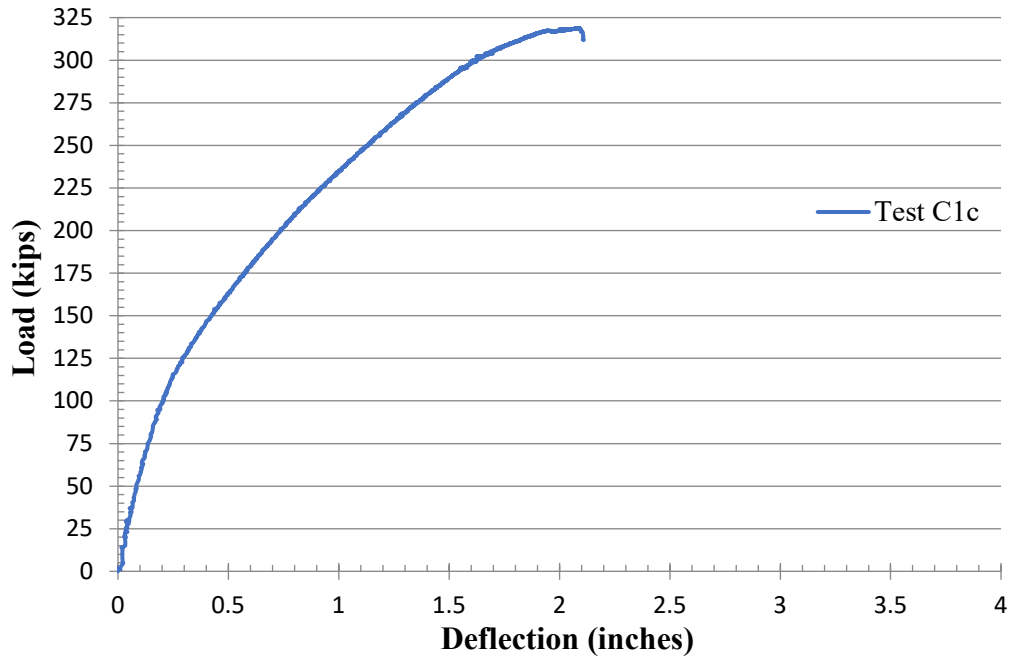
Figure 6.9: Control Girder C1 Support Condition Test (South End)

Testing of the AASHTO Type II control girder was completed for both the C1 and C2 support conditions. The load-deflection plots are shown in Figures 6.9 and 6.10, respectively. The failure mechanism for the C1 support condition test was identified as bond-shear failure, which is characterized by shear cracks migrating downward toward the strand, followed by splitting along the strand and finally slippage of the strand. Visible corrosion of the strands near the end of the girder likely contributed to the splitting-bond failure of the prestressing strands. The failure mechanism for the C2 support condition was identified as compression-shear failure, which is characterized by several shear cracks migrating upward toward the top of the girder, followed by a compression failure of the girder compression zone.

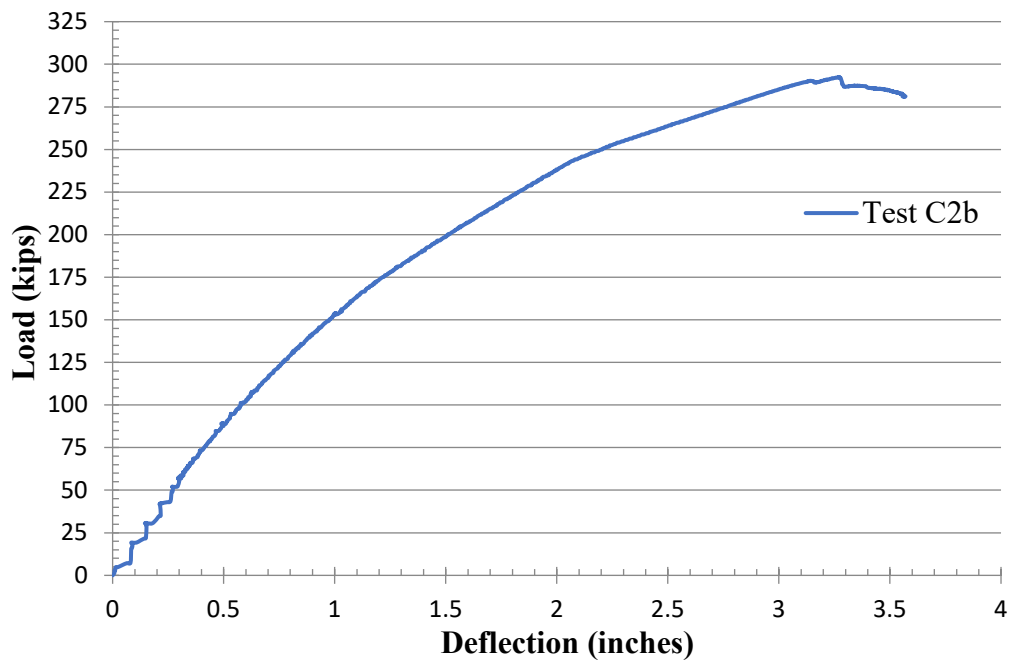
Figure 6.10: Control Girder C2 Support Condition Test (North End)

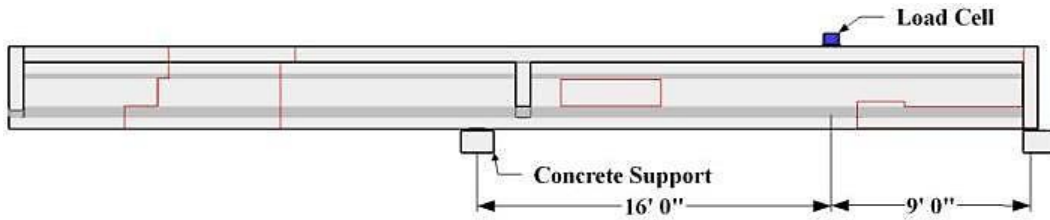
**Figure 6.11: Test C1 Support Conditions (West Elevation)**

As mentioned previously, the FR-SCC repaired AASHTO Type II girder had extensive deterioration near the ends of the span, primarily as a result of leaking deck joints above the pier supports. The support conditions for the AASHTO Type II repaired girder were identical to the control girder and are shown in Figures 6.11 and 6.12. The red outlined portions represent the FR-SCC repaired areas of the girder, which are shown in photographs for the two end regions in Figures 6.13 and 6.14.

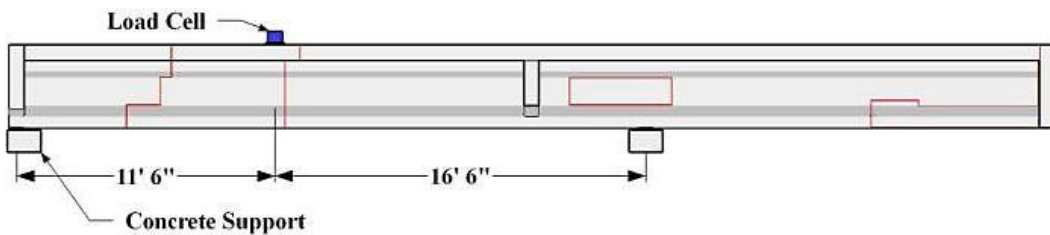
**Figure 6.12: Test C2 Support Conditions (West Elevation)**

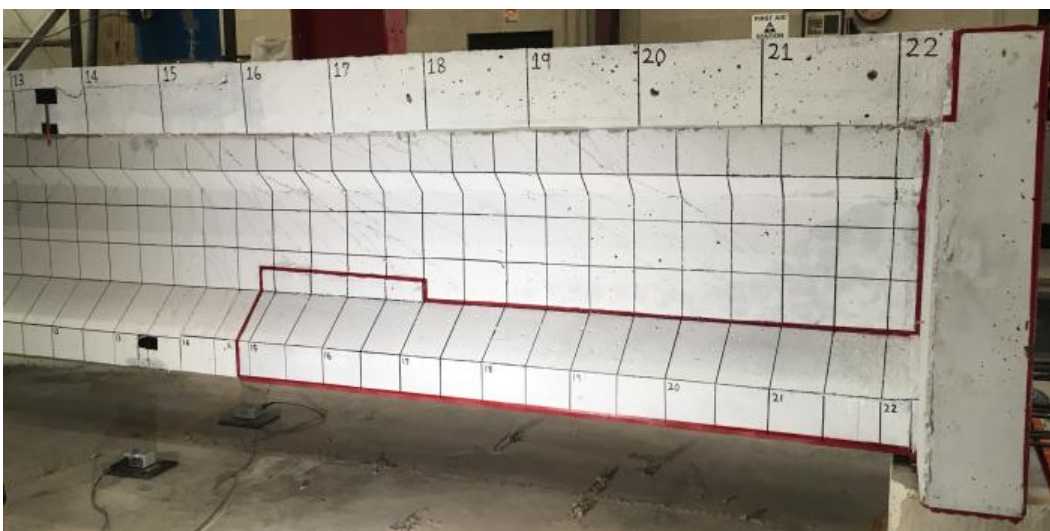
**Figure 6.13: Photograph of Girder South End FR-SCC Repaired Region**

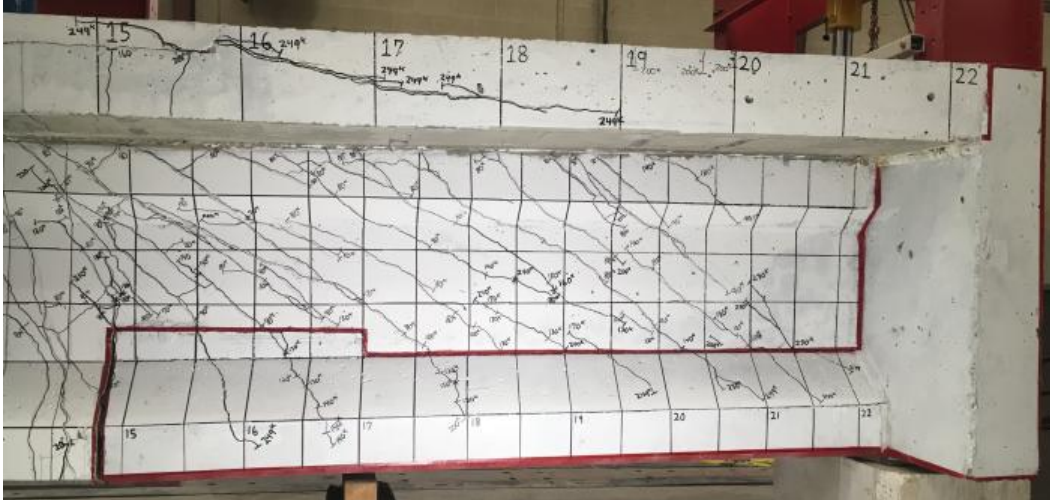
**Figure 6.17: South End Region Repair at End of C1 Support Condition Testing**

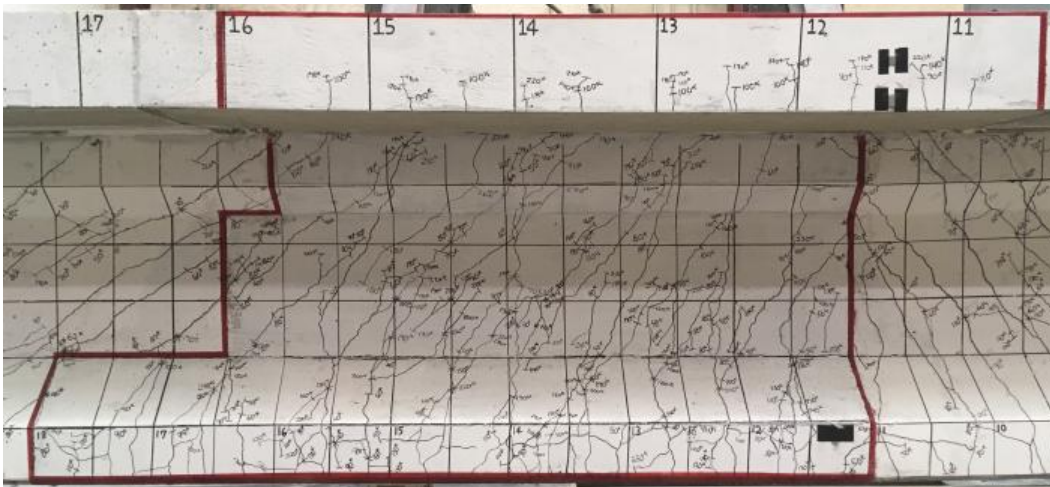
**Figure 6.18: North End Region Repair at End of C2 Support Condition Testing**

The failure mechanism for the C2 support condition was identified as bond-shear failure, which is characterized by shear cracks migrating downward toward the strand, followed by splitting along the strand and finally slippage of the strand. As shown in Figure 6.18, the repair underwent extensive shear cracking, and the shear cracks extended continuously from the original concrete through the FR-SCC repaired region, indicating that the repair performed very well and also bonded well and acted monolithically with the original concrete.
