**FINAL PROJECT  
REPORT #00042134-04-103  
Volume III**

**FRP Reinforcement for  
Concrete: Performance  
Assessment and New  
Construction**

**Volume III: Construction and  
Monitoring of the Innovation Bridge**

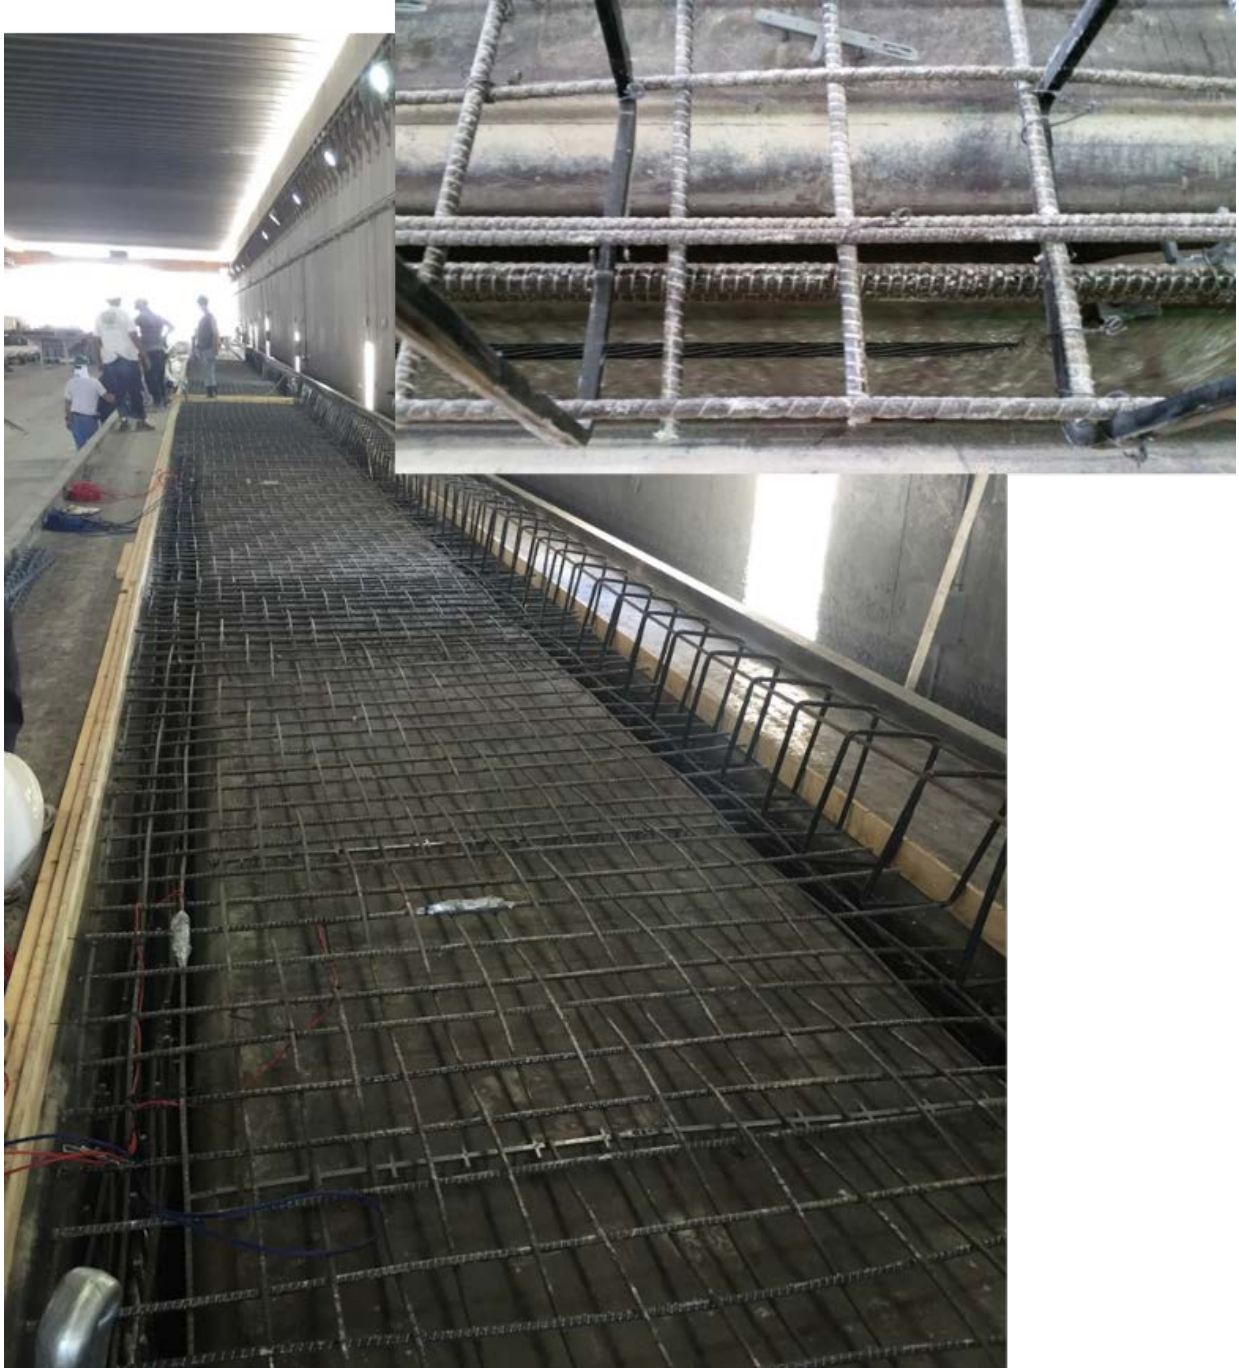
**Figure 2: Double-tees casting bed and detail of BFRP reinforcement at casting**

The reinforcement grids for both stems and flange were made of pre-assembled interwoven BFRP bars (#3 and #4 at spacing 6 in. o.c., respectively). Figure 2 shows the casting bed for the two in-line DTs after the CFRP tendons were prestressed and all BFRP reinforcement was in place. Visible in the photograph are the continuous close stirrups to reinforce the curbs to be cast-in-place at the site. Also visible are two VWGs encapsulated in a protection shield and installed on the BFRP bars over the stem (longitudinal direction) and across the mid flange (transverse direction). The top insert is a close up view of the reinforcement over the stem while the self-consolidating concrete is being poured. Visible are: the top 7-wire CFRP strand; the supplemental top #7 BFRP bar over the stem; the BFRP top mat; and, the continuous close stirrup.

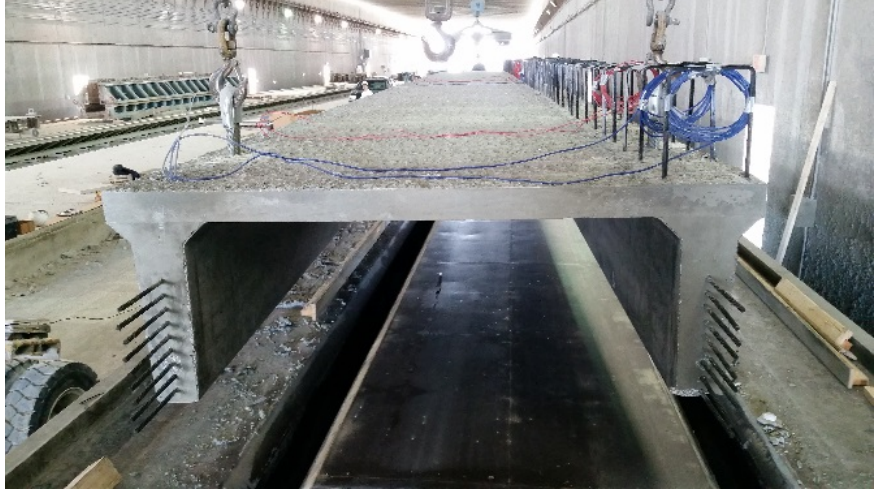
**Figure 3: Double-tee being lifted from the casting bed**

Figure 3 shows one of the DTs being lifted from the bed a day after casting. Visible are the nine plus nine CFRP tendon terminations and the continuous close stirrups for curb reinforcement. The red and blue cables connect the VWGs installed on tendons, reinforcing bars and concrete. The VWGs in the tendons helped confirming the degree of prestressing at tensioning and following stages.

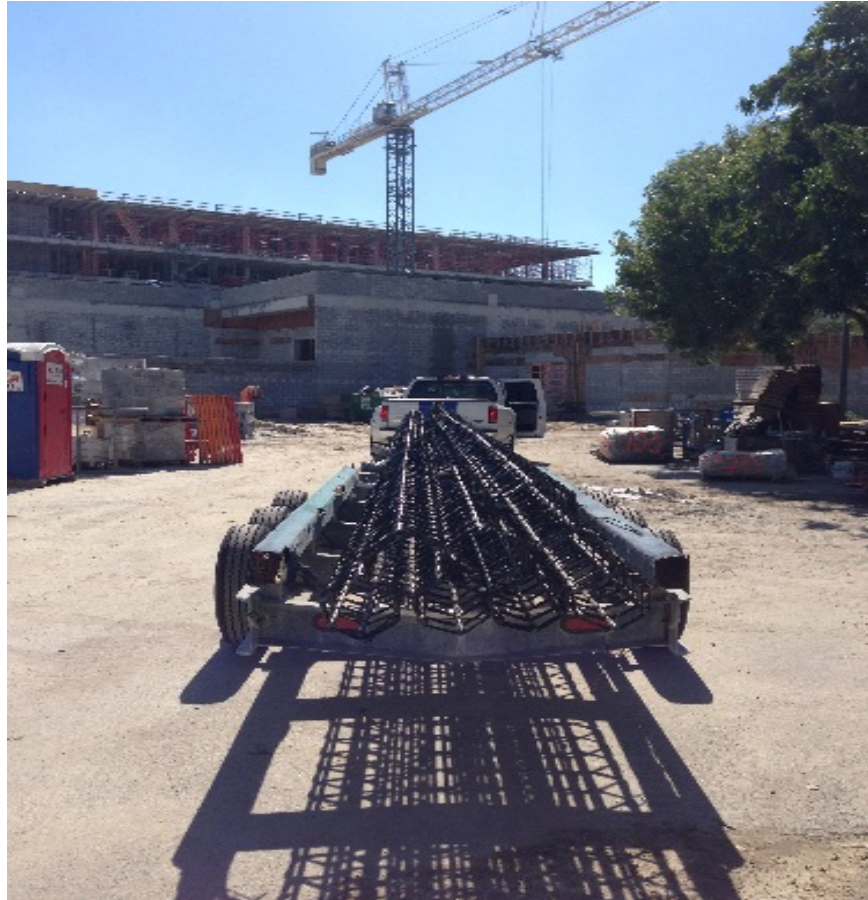
**Figure 5: Delivery of BFRP pile cages at the site**

The eight, 16-in. diameter, 40 foot-long auger-cast piles were reinforced with a prefabricated cage of six #6 BFRP bars and #3-equivalent BFRP spirals. The cages (in the shape of hexagons) were prefabricated at the composites manufacturer's plant and delivered to the site, ready for installation as shown in Figure 5. The factory prefabrication ensured high product precision and speed of on-site installation. Each cage was light enough to be picked up by two workers and moved without the use of any equipment. This application is a world "first" and takes advantage of precision manufacturing.

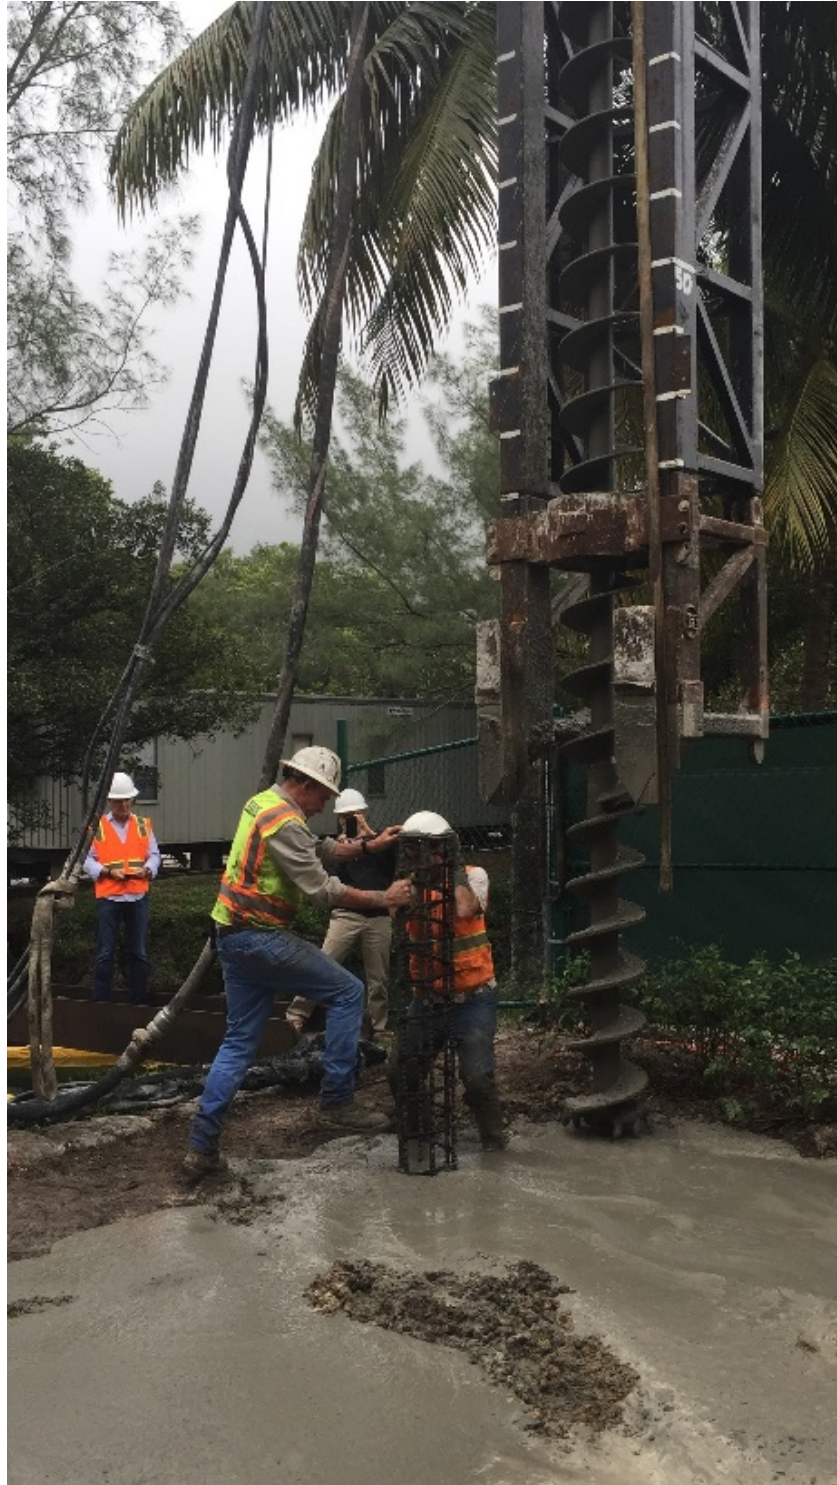
**Figure 6: Construction of auger-cast pile**

The final phase of construction of one of the piles is shown in the photograph of Figure 6 where workers are seen pushing down into the grout-filled hole the last 5 feet of the reinforcement cage. Since the FRP weight is approximately one fourth that of steel, the cage did not spontaneously sink in and workers had applied some direct force. This could have easily been done by using the scoop of the backhoe or by climbing onto the spiral as shown in the photograph. The latter was possible given the excellent chemical adhesion of the spiral to the longitudinal bars.

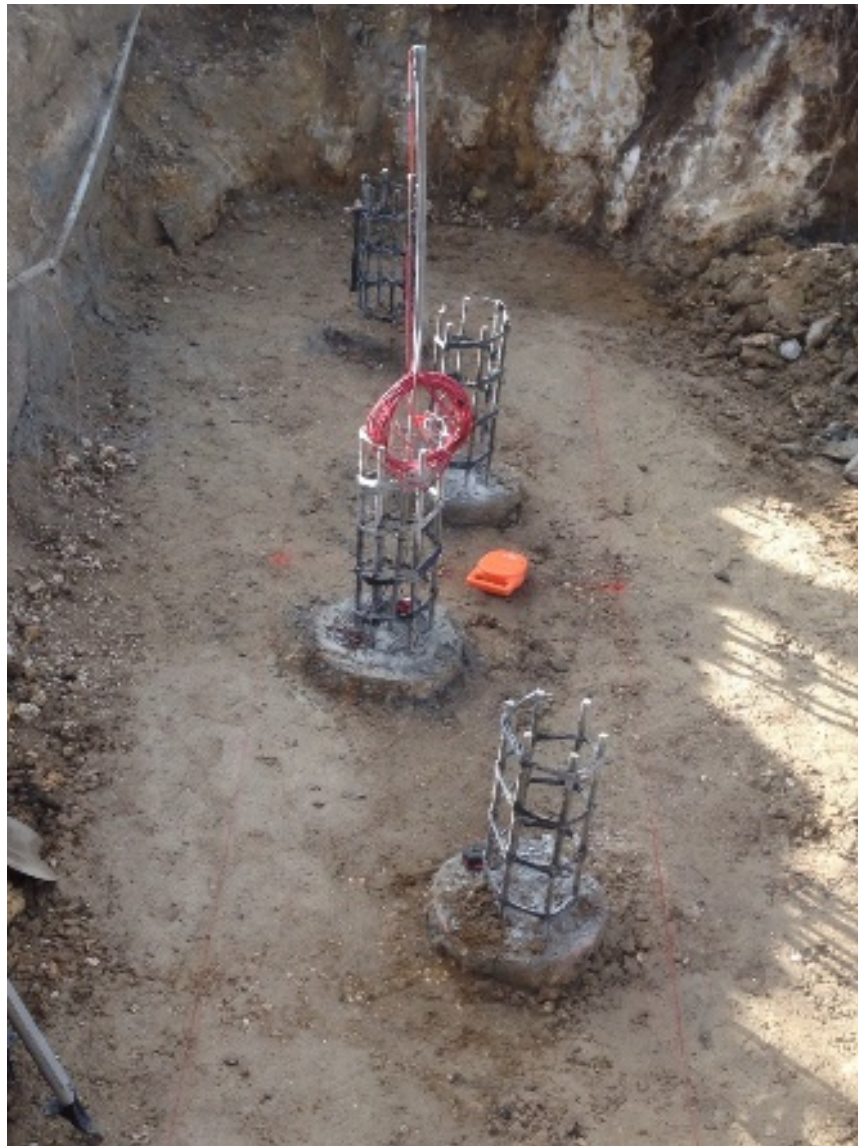
**Figure 7: Exposed reinforcement in piles**

Figure 7 shows the termination of the four piles at one abutment with exposed reinforcement after grout removal. This operation was simple and did not cause any damage to the BFRP cage. Exposing the pile reinforcement was not a design requirement since conventional bridge practice for pinned pile connection to the cap simply requires the pile to be cut flush and extend one foot

into the cap. Exposing the reinforcement was selected to demonstrate the feasibility of the grout demolition process and the resilience of the FRP reinforcement. The red cable coming out of the second pile in the photograph connects to two VWGs installed on the pile longitudinal bars.

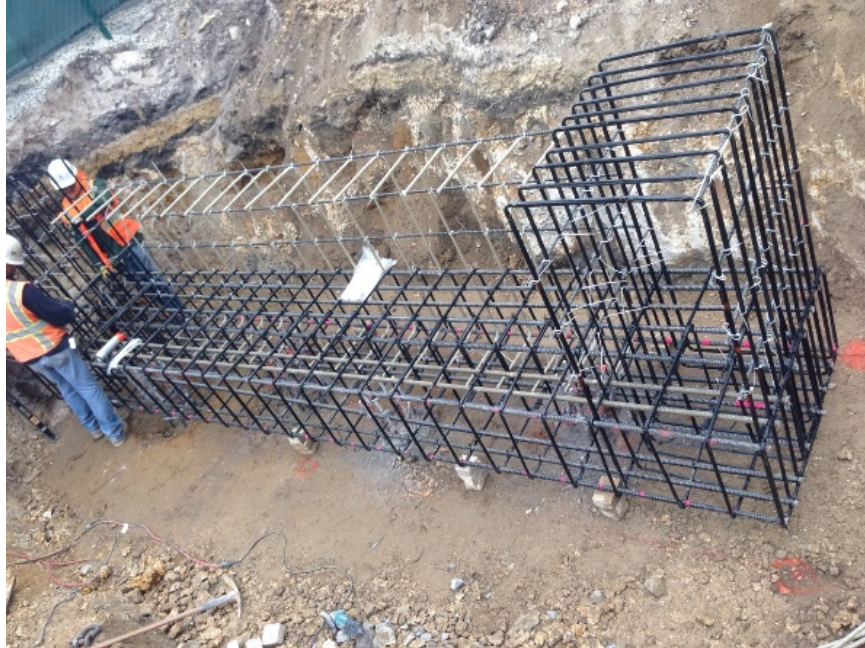
**Figure 8: Reinforcement cage for pile cap, side blocks and back-wall**

The pile caps, side blocks (to support the lampposts) and back-walls are made of concrete reinforced with straight BFRP bars, bent GFRP bars and continuous close BFRP stirrups. The application of continuous close BFRP stirrups is a U.S. “first” which takes advantage of performance efficiency of the composite reinforcement when continuity of the fibers is assured. Because of their geometry, close stirrups do not require surface deformation to provide a mechanical bond to concrete. Additionally, the radius of curvature of the bend can be tighter as fibers need not slide over each other as required when bending a straight pultruded bar before the resin polymerizes. Figure 8 shows the completed assembly of the reinforcement cage for pile cap, side blocks and back-wall. The “U-shaped” deformed GFRP bars were used as the reinforcement for the back wall and were spliced into the deck reinforcement.

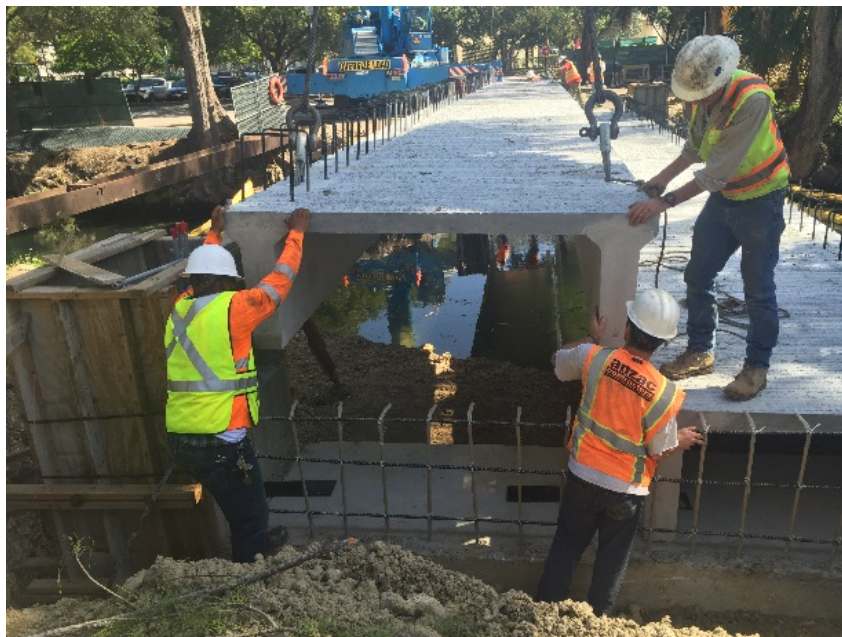
**Figure 9: Installation of girder**

The installation of the second bridge girder is depicted in the photograph of Figure 9. Visible are the two neoprene rubber pads over the cap to provide contact with the stainless steel bearing plates mounted in each stem. Also visible is the back-wall reinforcement.

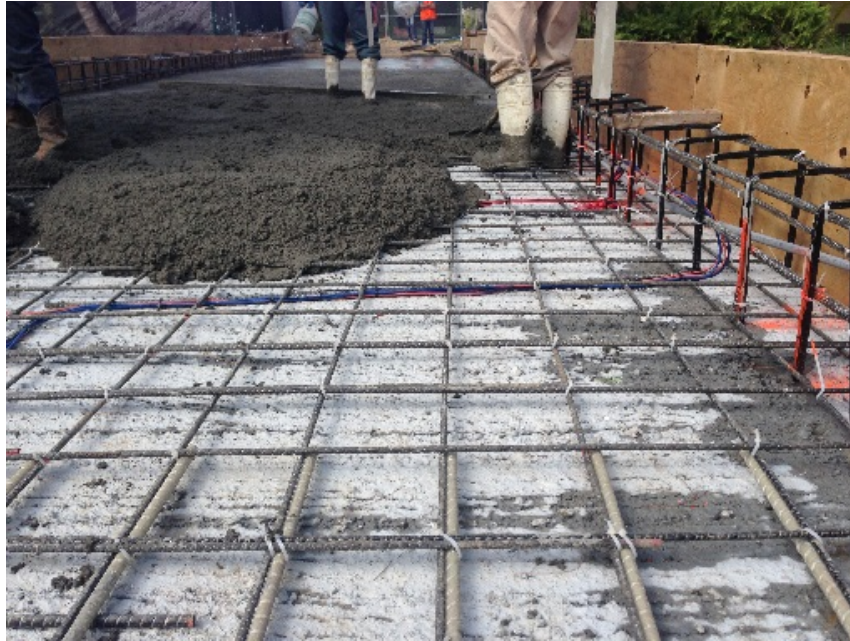
**Figure 10: Casting of the deck topping**

topping over the BFRP mat. Visible to the right are the stirrups for the curb reinforcement. In the foreground are the GFRP bars used to splice the back-wall U-shaped GFRP deformed reinforcement.

The blue and red cables connect the VWGs installed on the BFRP mat.

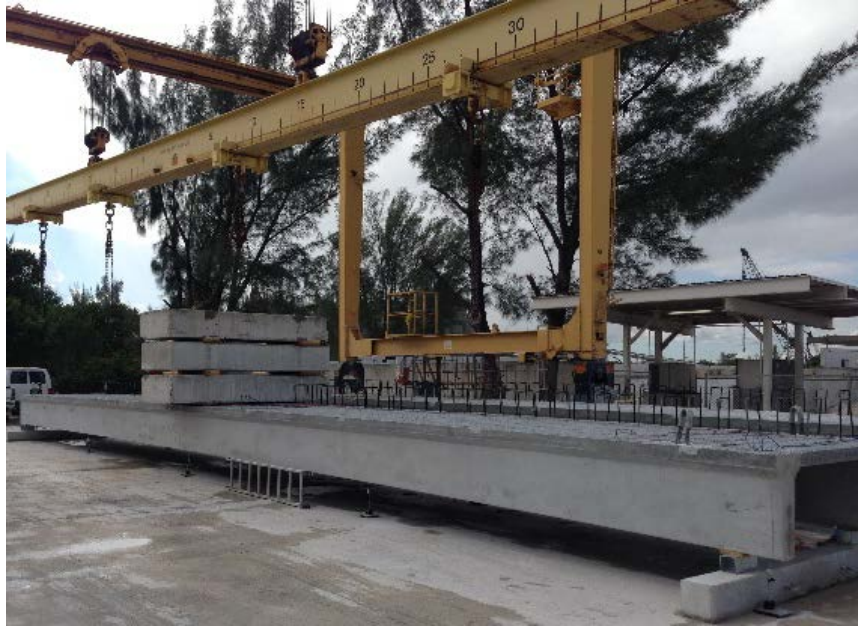
**Figure 11: Double-tee static load test at precast yard**

The simply supported girder was loaded with three concrete blocks at its mid-span for a total load of 27 kip plus self-weight. The total dead and live load corresponded to a maximum mid-span moment of 785 ft.-kip, which corresponded to 85% of the first-crack moment computed as 922 ft.-kip.

The results of the load test in terms of strains in the reinforcement and concrete and quarter-span/mid-span deflections measured with linear variable differential transformers (LVDTs) matched the analytical prediction. Appendix 2 provides detailed load test results.

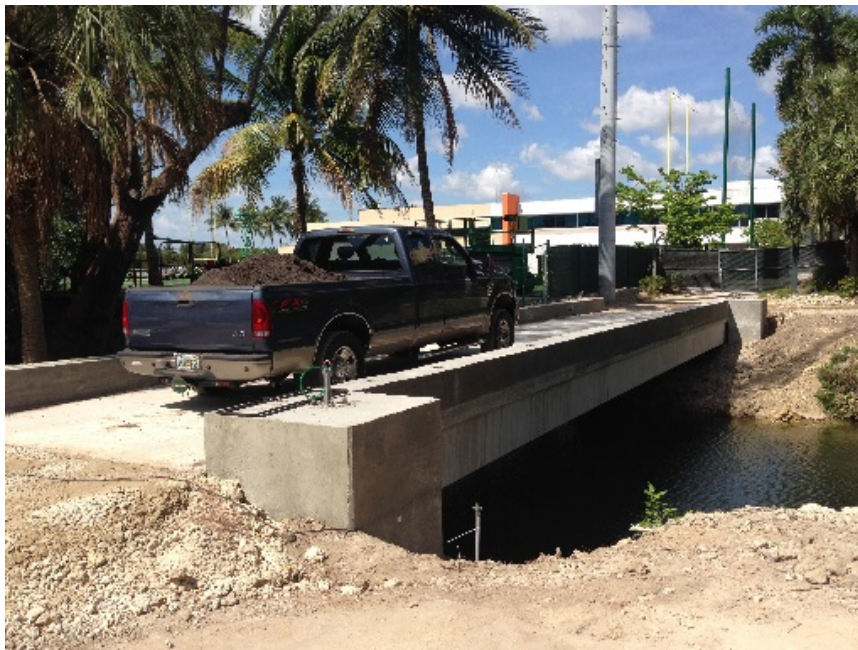
**Figure 12: Load test at completion of superstructure construction**

Figure 12 shows the fully loaded pick-up truck used for the first field load tests. The total weight of the vehicle was 12,080 lb. with the heavier axle weighing 7,720 lb. The mid-span moment generated by the vehicle for load position one (maximum moment) including self-weight (i.e., two girders, decks and curbs) was equal to 1,402 ft.-kip, while the shear at the support for load position two (maximum shear) including self-weight was 84.8 kip. The bridge is designed for a distributed live load of 100 psf. Exceptional transit of a service vehicle is limited to 1,000 lb. wheel load.

Strains and deflections measured during the test were consistent with the analytical predictions. The strain in structural elements was recorded using VWGs attached to reinforcement. The strain in concrete and BFRP rebars were negligible while 30 micro-strain was recorded in one of the instrumented CFRP tendons. Additionally, no crack was observed in the bridge after the load test. Deflections are measured with a total station theodolite directed to permanently mounted targets on one of the exposed stem sides. Similar tests are planned at intervals of one year to monitor the bridge performance over time. Appendix 3 features a detailed report on deflection measurements at different stages of the research program.

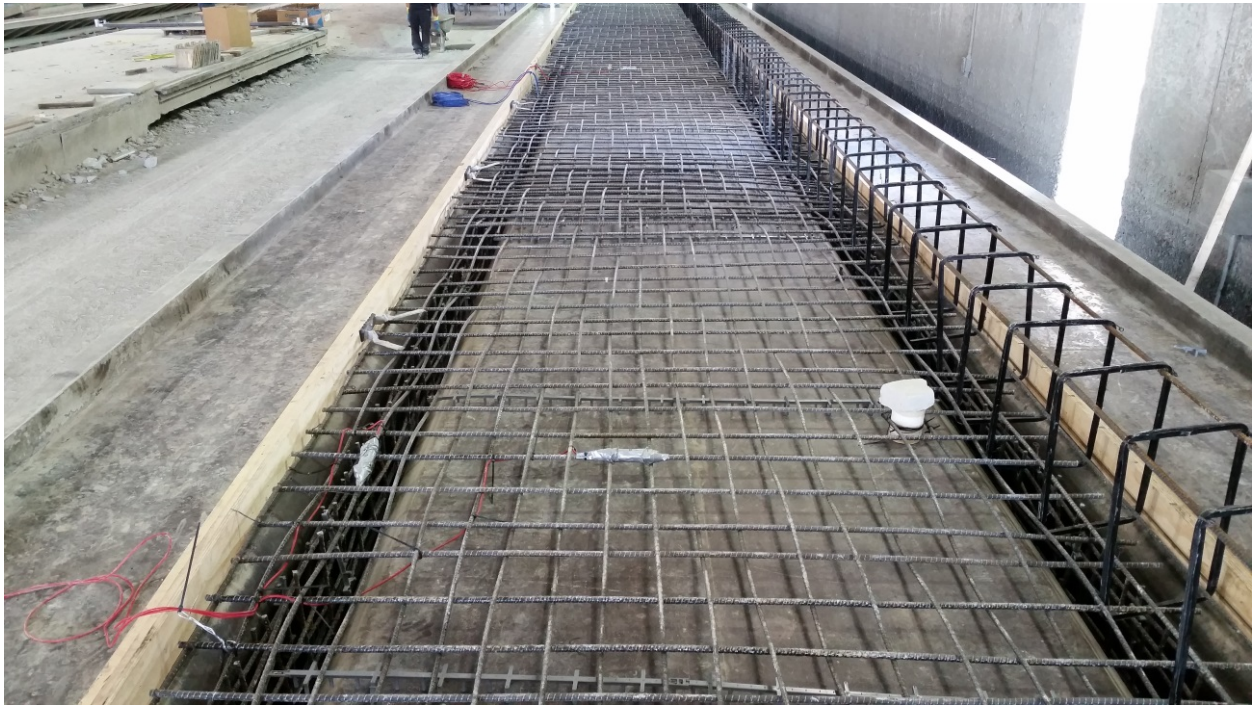
**Figure 3: BFRP reinforcement and CFRP tendons arranged in the Coreslab prestressing bed**

Two DT precast girders were constructed and instrumented at the Coreslab plant of Miami, adopting a pre-stressing bed and equipment available for conventional DT girders. CFRP strands and the BFRP reinforcement were arranged and positioned before the CFRP tensioning phases took place (Figure 3).

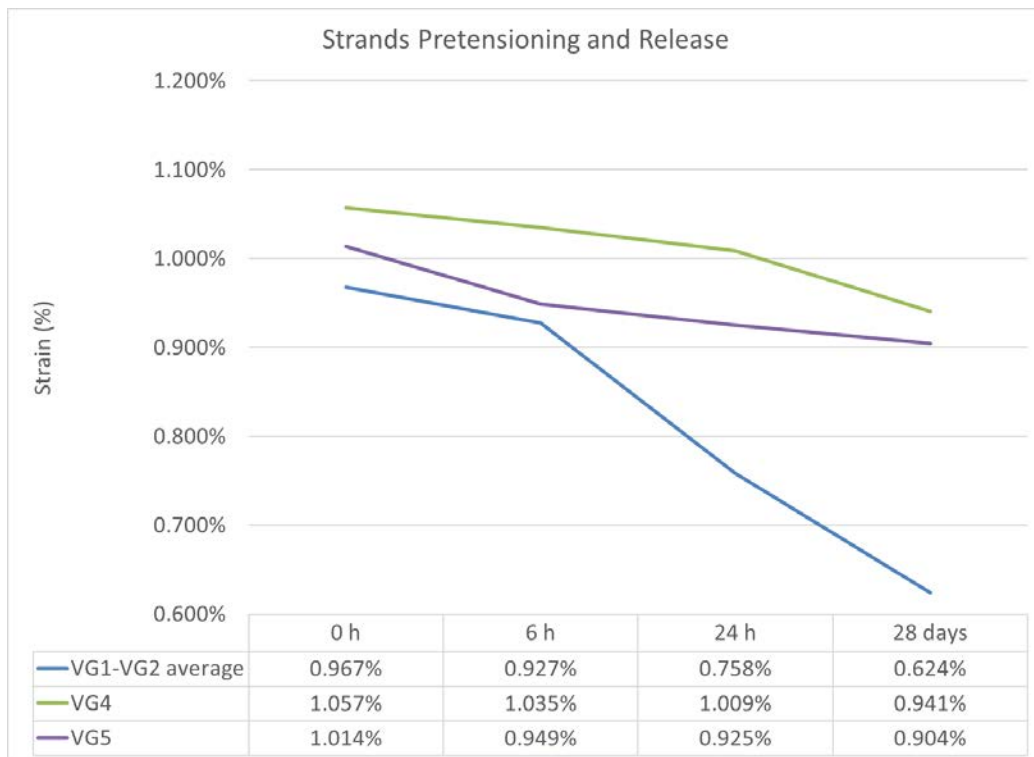
**Figure 7: Strains in tendons after tensioning, casting, releasing and curing phases**

Figure 7 shows the strain measurements performed on the top and bottom tendons: a) after the tensioning phases (0 hours); b) after the concrete pouring (6 hours); c) after the release of prestressing forces (24 hours); and, d) after the demolding and complete curing of the PC girders (28 days). The first strain loss (b-a) deals with the pretensioning apparatus settlement (i.e., CFRP and steel cables anchorage systems). The second loss (c-b) is due to the elastic shortening of concrete at the time of the release. The third loss is caused by concrete creep/CFRP relaxation during the 28 days of curing.

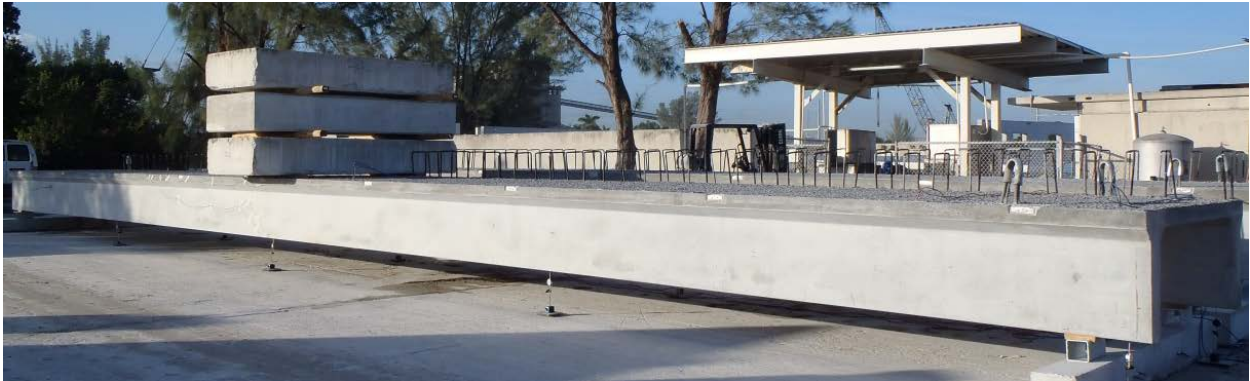
**Figure 8: DT girder loaded under a three-point-load setup**

In order to analyze the flexural response near service conditions, a load test was carried out on the instrumented DT girder before its installation on-site. The girder was loaded under a three-point-load setup, over the 66 ft effective span of the bridge model (Figure 8). Four rectangular hollow steel tubes placed over prismatic concrete elements were used as supports. A soft wood interface was provided between the supports and the girder bearing plates to help the levelling procedure and prevent stress concentration during the test. Three rectangular concrete blocks, each of them weighting 9 kip, were used to apply the intended load by mean of a crane (Figure 9).

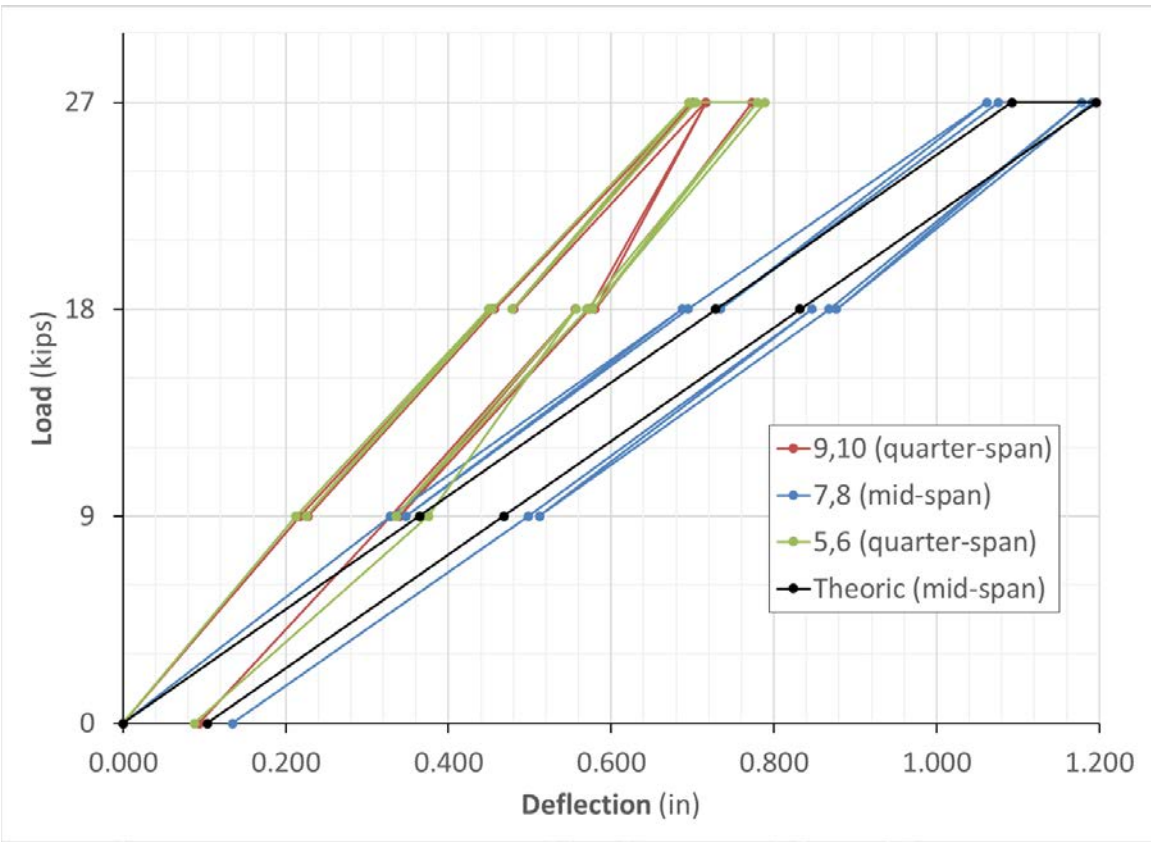
**Figure 12: Load-deflection diagrams**

The girder exhibited the elastic performance expected at the serviceability limit state, with no cracks being visually detected. Due to the 24 hours sustained 27-kip load, it was possible to observe

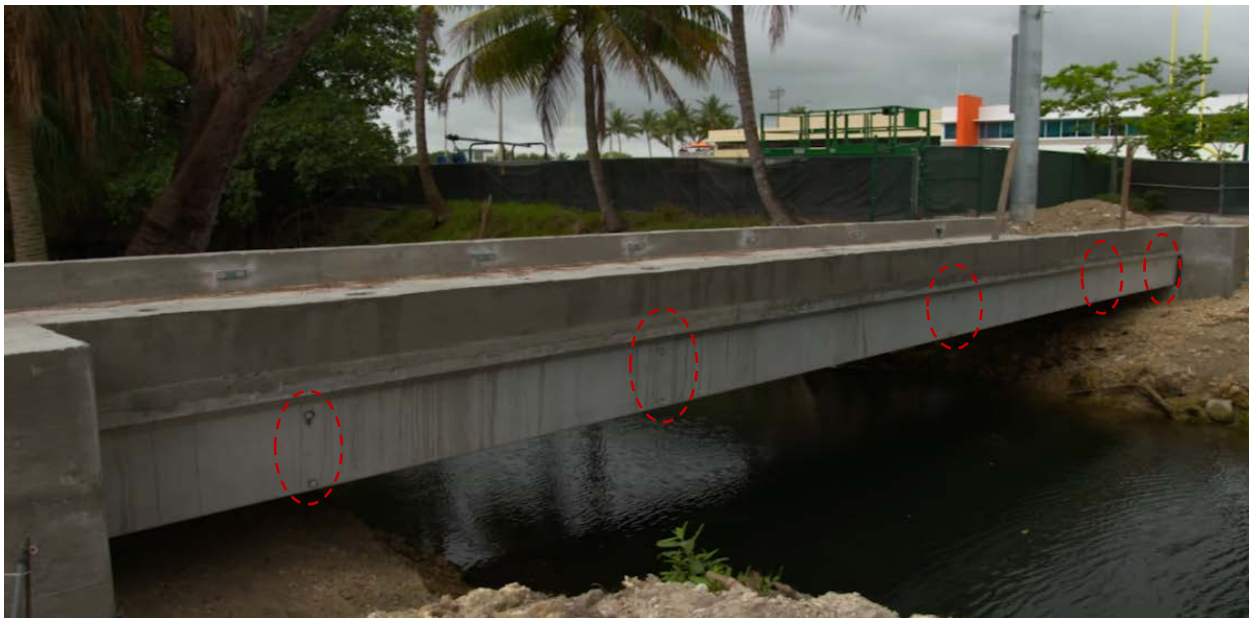
Figure 5: Targets view from Point A

Figure 5 shows a photograph of the girder stem with targets visible from the survey Point A.

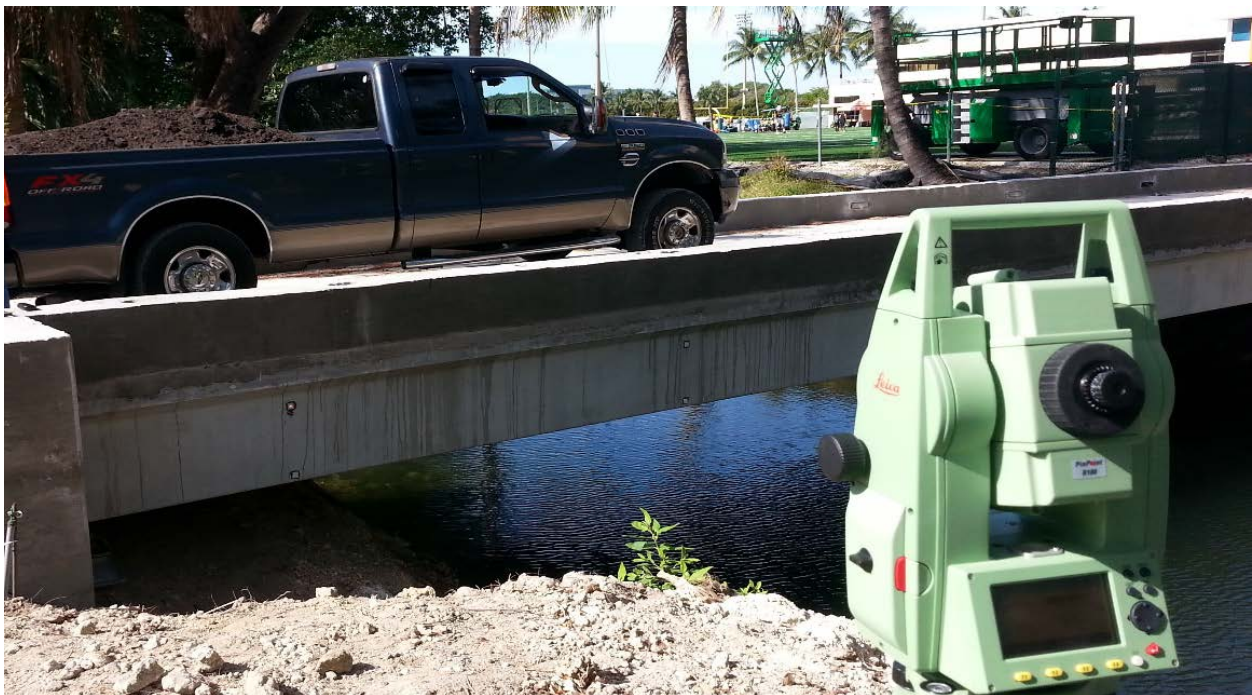
Figure 7: On-site load test

The load test was conducted in two parts: as a maximum moment test and a maximum shear test. For the first one, the truck was longitudinally centered facing the parking lot in order to measure strains and deflections. In this way, the front axle of the truck was positioned at a distance of 117 in. (3 m) from the left end (parking lot), while the rear axle was positioned at a distance of 275 in. (7 m) again from the left end. The total weight of the vehicle and its cargo was 12.08 kip (54 kN), with the heavier axle weighing 7.72 kip (34 kN). The mid-span moment generated by the vehicle for load position one (maximum moment) and including self-weight (two girders, decks, and curbs) was equal to 1,418 kip·ft (1922 kN·m), while the shear at the support for load position two (maximum shear) including self-weight was 85 kip (380 kN). The bridge is designed for a distributed live load of 100 psf (4.8 kN/m<sup>2</sup>), which will result in a service maximum moment of 1,894 kip·ft (2,568 kN·m) and a maximum shear of 115 kip (511 kN). Figure 7 shows the truck moving over the bridge.

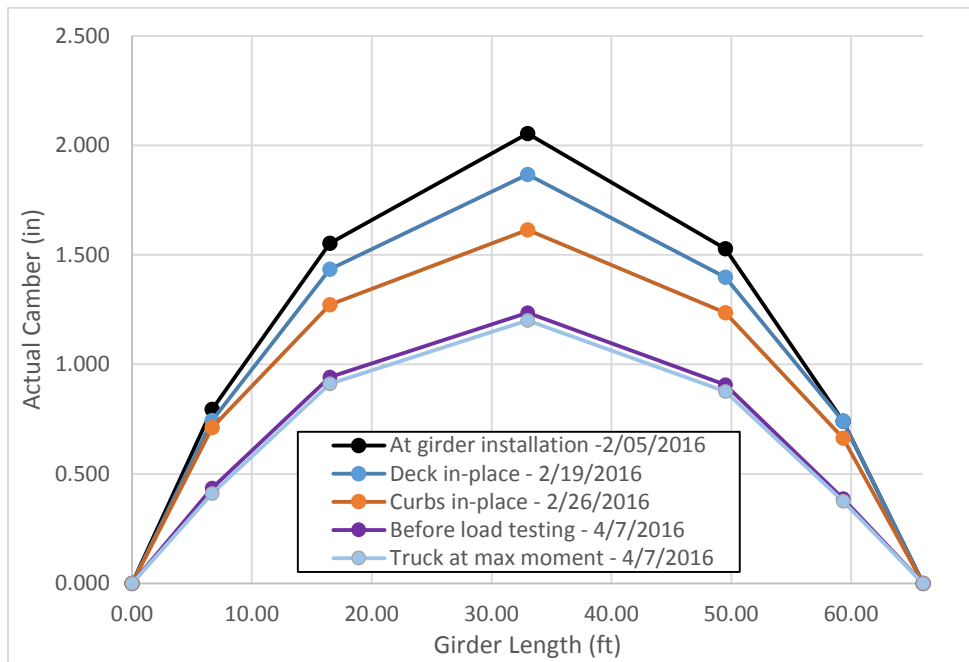
**Figure 9: Camber values measured at centroid-height targets**

- Girder camber. In Figure 9, five curves are shown starting from the one recorded at the time of girder installation through the one during the load test with truck positioned to generate the maximum moment. Plotting the net camber data over the girder length, a consistent symmetric shape can be clearly identified as well as a consistent deflection increment (i.e., reduction in camber) at increasing load.

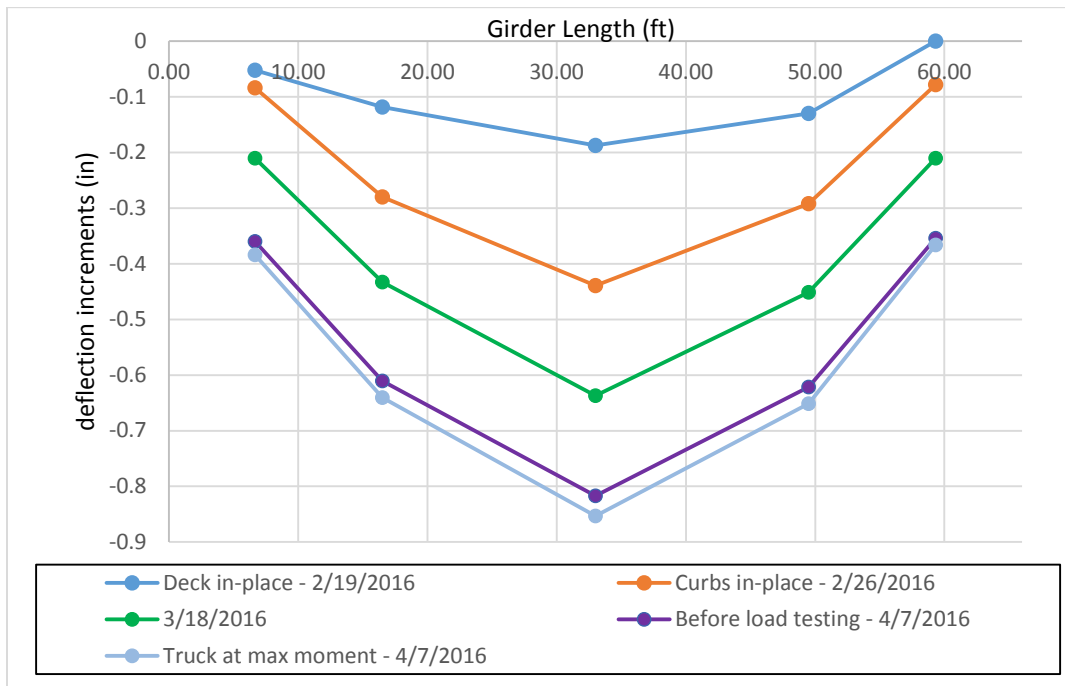
Figure 11: Deflection from initial on-site camber - increments – refined

Figure 11 shows the deflection increments as a result of loading rather than the reduction in camber. The reference line (zero line) is the deflection at the time of girder installation. An almost perfectly symmetric shape of the deflections increments is apparent.

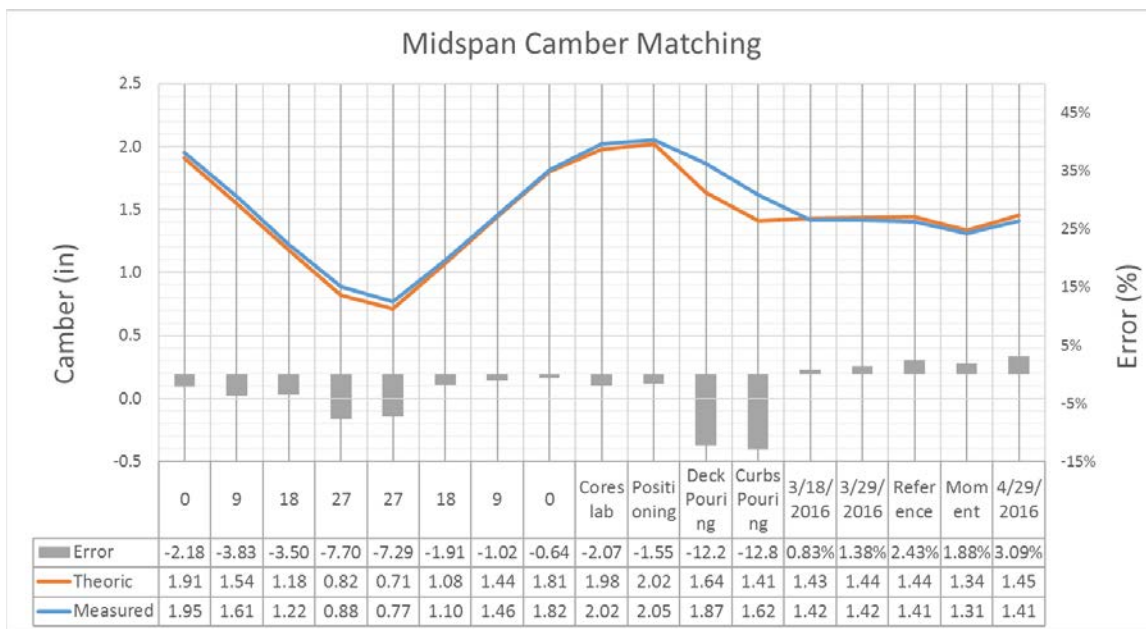
Figure 12: Camber values over the girder load history

Figure 12 shows the theoretical/experimental camber values over the girder load and construction history up to the end of April 2016.
