**FINAL PROJECT
REPORT #00042134-04-103A
Volume I**

**FRP Reinforcement for
Concrete: Performance
Assessment and New
Construction**

**Volume I: Sierrita De La Cruz Creek
Bridge**

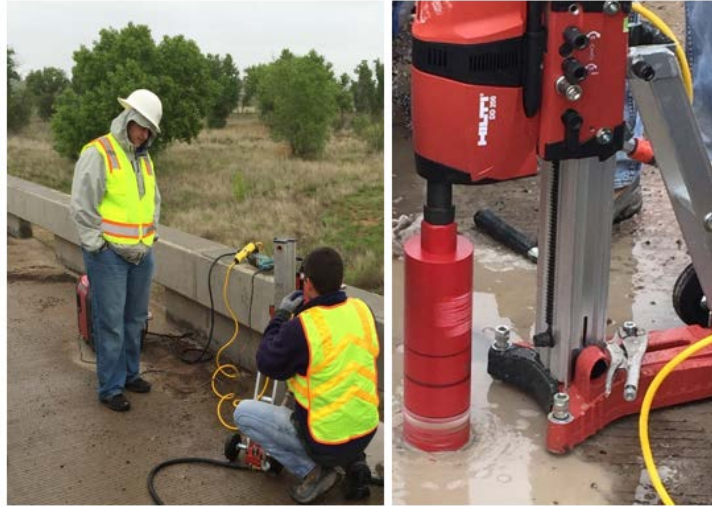
Technical personnel performed the extraction of concrete cores in May 2015 (Figure 4). A total of nine 4 in (101.6 mm) diameter concrete cores were extracted from various locations on the bridge deck to include GFRP (5 cores), ECS (3 cores) and black steel rebars (1 core). The holes from sample extraction were repaired using a fast-curing cementitious grout.

Figure 4: Concrete core extraction from the bridge deck

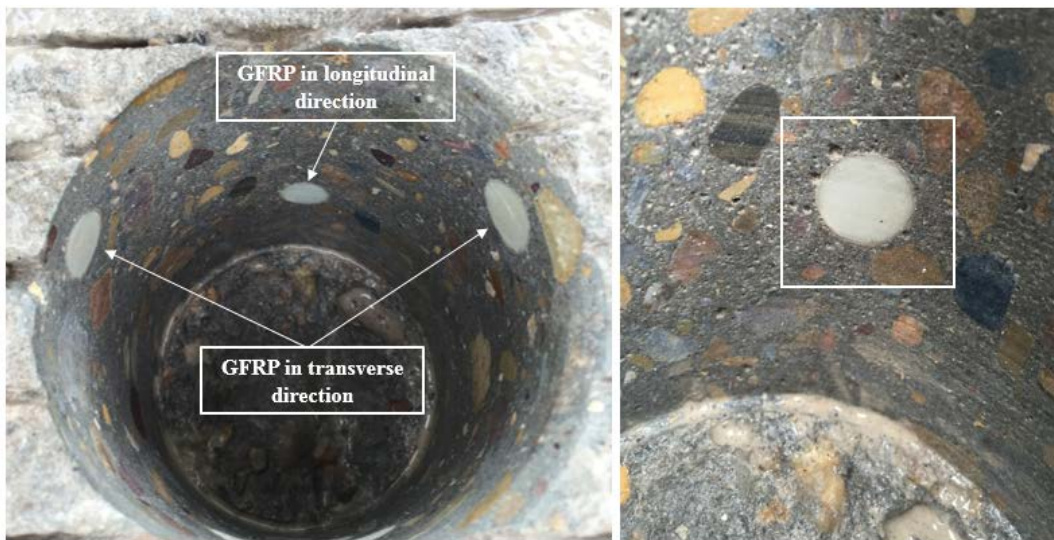
Figure 5: GFRP bars viewed from a cored section (left) and a close-up view of the GFRP bar implemented in transverse direction (right)

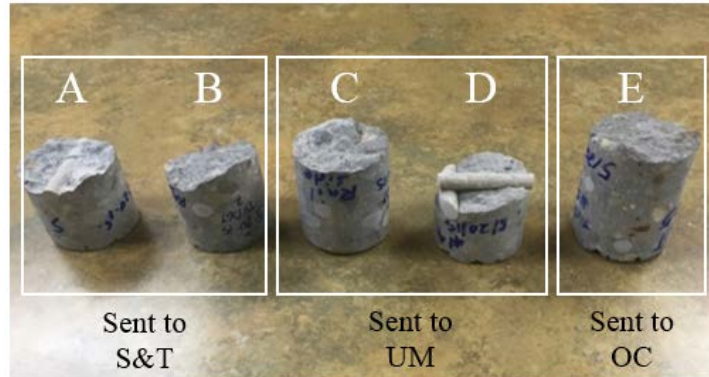
Figure 6: Five extracted concrete cores with the GFRP bars

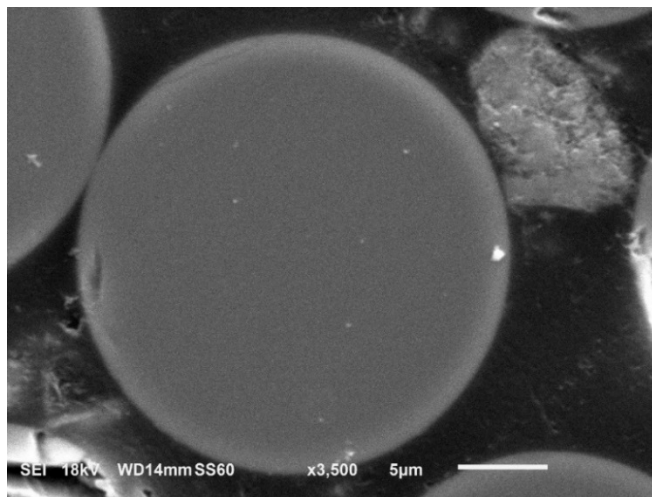
Figure 13: SEM image of a single glass fiber at magnification of 3500x

SEM analysis confirmed that there was no sign of deterioration in the GFRP coupons. Glass fibers were intact without loss of any cross-sectional areas. Fibers were surrounded by the resin matrix and no gap nor sign indicating the loss of bond between resin and fibers, was observed.

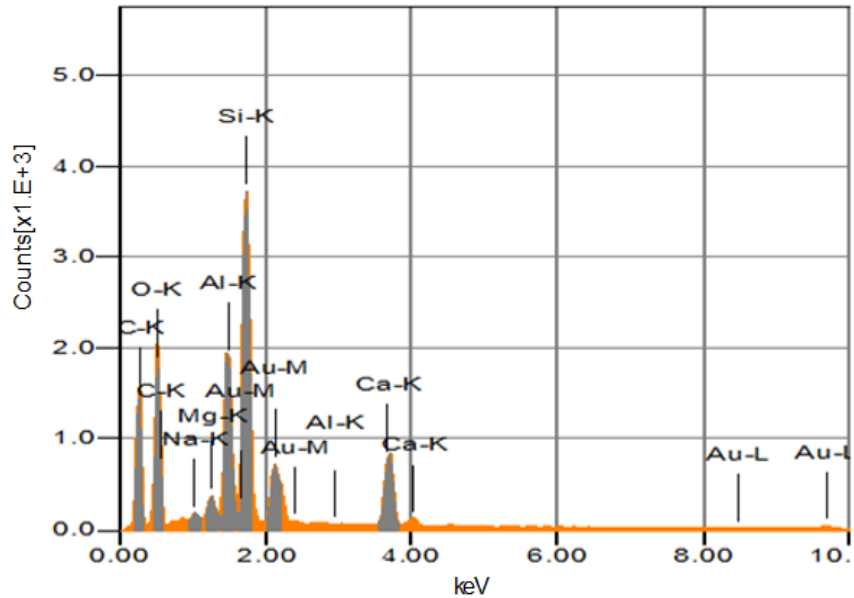
Figure 16: Result of the EDS analysis performed on control GFRP samples

Si, Al, Ca (from glass fibers) and C (from the matrix) were the predominant chemical elements in the extracted samples which were also identical to the control samples. Although, there is a variation in fiber/resin constituents for GFRP bars produced in 2015 compared to the ones manufactured in 2000 (as provided in Table 1), the only difference in detected elements was the presence of Mg in control samples which was not found in extracted ones. Additionally, the presence of Na in the extracted samples was not a sign of degradation or alkaline attack since Na was observed in both control and extracted samples. It may be due to contamination during sample preparation.

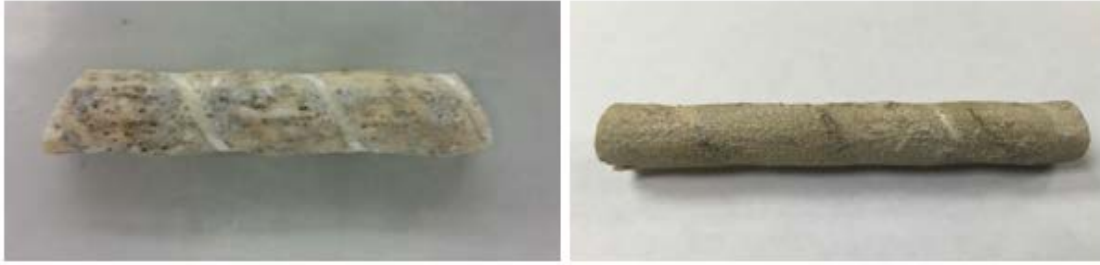
Figure 19: No. 6 (left) and No. 5 (right) GFRP bars tested for horizontal shear strength

An increase of 4% in the inter-laminar shear strength of No. 5 GFRP bar was observed. Since the interlaminar shear is dominated by the resin, the increase may be a result of resin crosslinking over time. On the other hand, the inter-laminar shear strength of No. 6 GFRP bar decreased by 23% compared to average results of control samples. In both instances, since only one coupon was available for the in-service condition, additional testing is required to comment on the change or no change of interlaminar shear property.

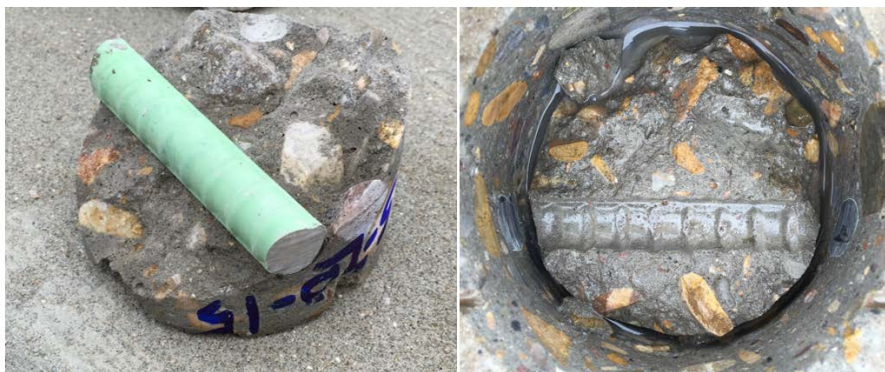
Extracted epoxy-coated steel rebar sent to OC (left) and its footprint (right)

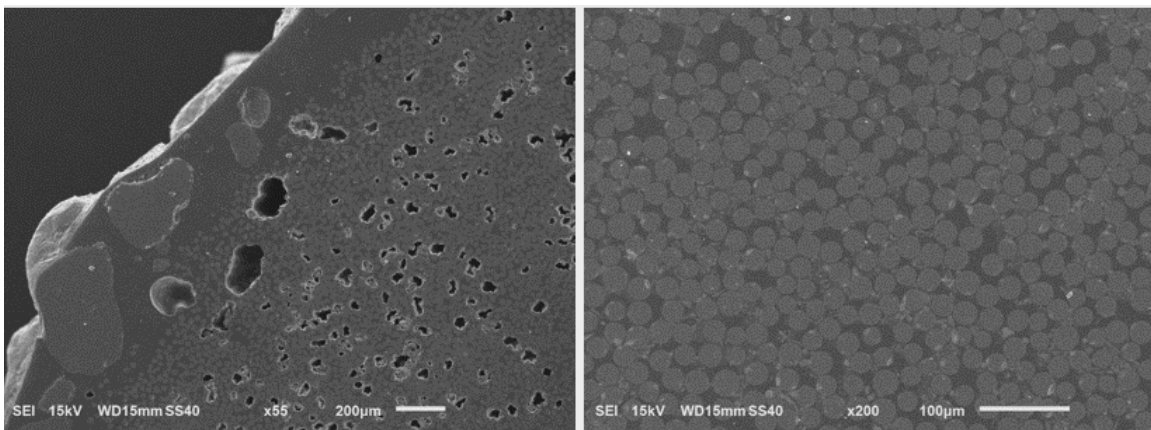
SEM images of GFRP bar at the edge at magnification level of 55x (left) and at the center at magnification level of 200x (right)

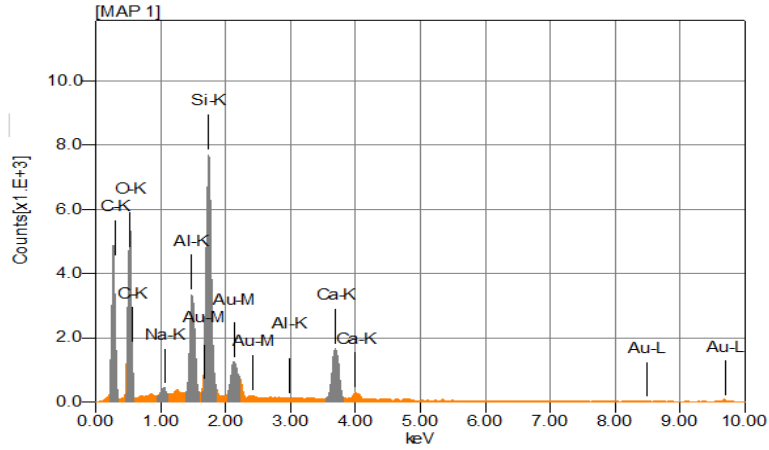
Result of the EDS analysis performed on GFRP coupons after 15 years of service

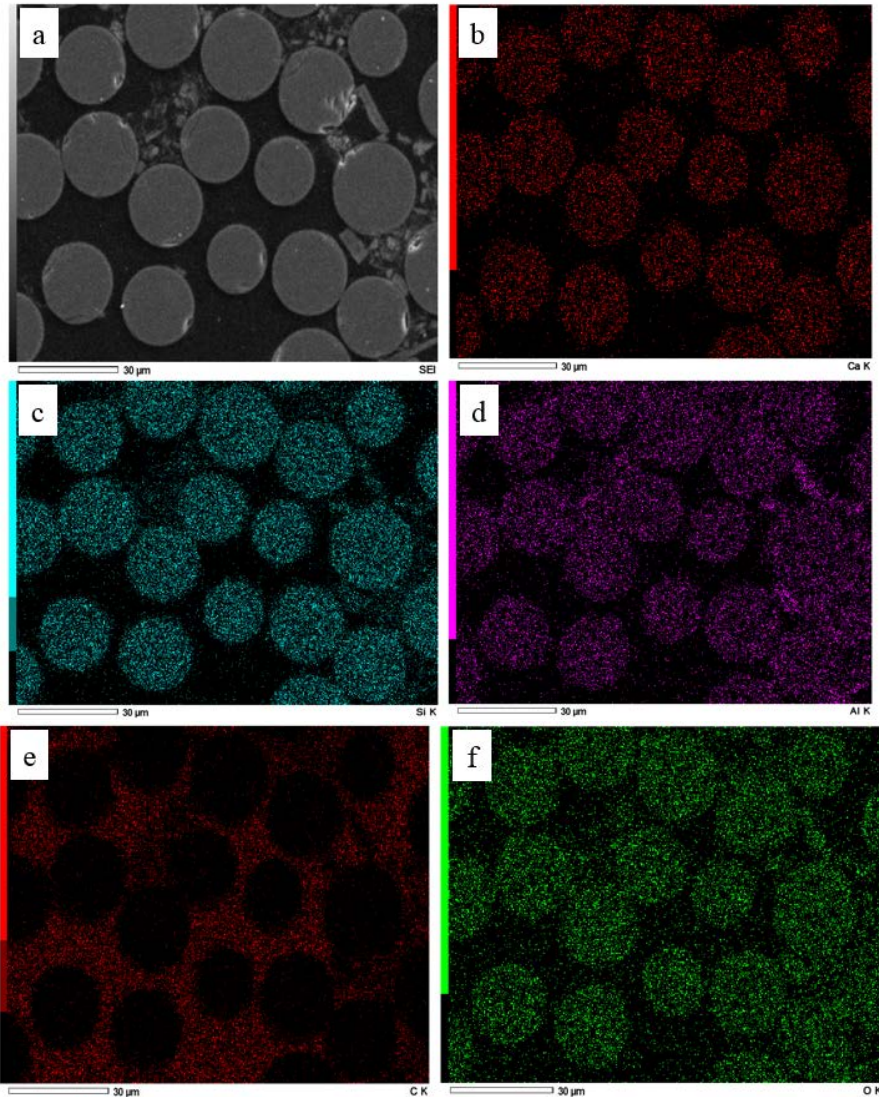
Elemental scatter in GFRP bars after 15 years of service in magnification level of 1000x: SEM image of GFRP (a), and elemental distributions of Ca (b), Si (c), Al (d), C (e), and O (f)
