FINAL PROJECT REPORT #00059416

Durability of GFRP Bar Reinforcement Extracted from In-service Concrete Structures

Participating Consortium Member:
Missouri University of Science and Technology

RE-CAST:
REsearch on Concrete Applications for
Sustainable Transportation
Tier 1 University Transportation Center

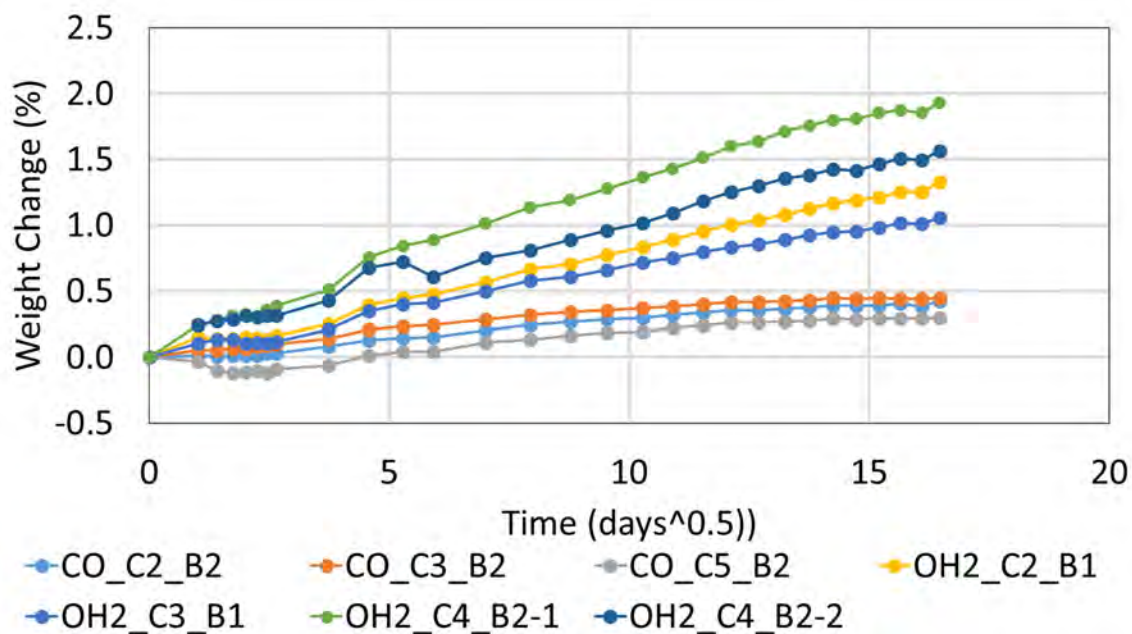
For Cuyahoga and O’Fallon Park bridges, long-term data of moisture uptake and weight gain at equilibrium were analyzed. Percent weight changes for the O’Fallon and Cuyahoga bars up to Dec. 15, 2018 (271 days) are shown on a log time scale in *Fig. 46*. By 259 days, all bars had met the ASTM D570 equilibrium condition of less than 5 mg (1.1×10^{-5} lb) average weight gain per two-week period over the last three bi-weekly measurement intervals. Table 10 lists the weight gains at equilibrium and at the last measurement (271 days). The average weight gain for the O’Fallon bars at saturation is 0.30%, which is much less than the 1% qualification limit established in ASTM D7957 for the same test conditions.

Fig. 46–Graph of Cuyahoga and O’Fallon moisture uptake versus square root of time for exposure to 122°F (50°C) distilled water

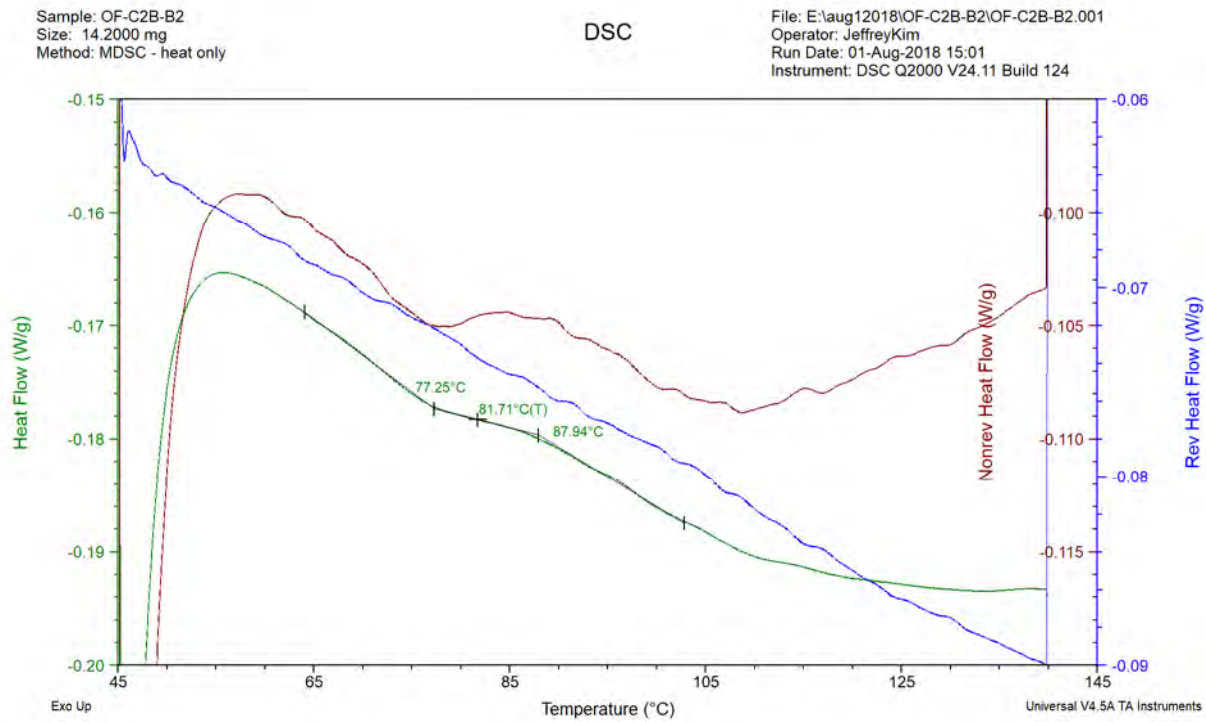
The lowest T_g was 176°F (80°C) for O'Fallon Park Bridge and the highest was 239°F (115°C) for Sierrita de la Cruz Creek. It should be kept in mind that bars from Sierrita de la Cruz Creek were analyzed using DMA rather than DSC. According to the ASTM D7957 GFRP bar specification, the T_g is required to be equal to or greater than 212°F (100°C) as a critical parameter in load transfer capability of the resin.

Fig. 48—Example differential scanning calorimetry curve for determining T_g on a bar from the O’Fallon bridge

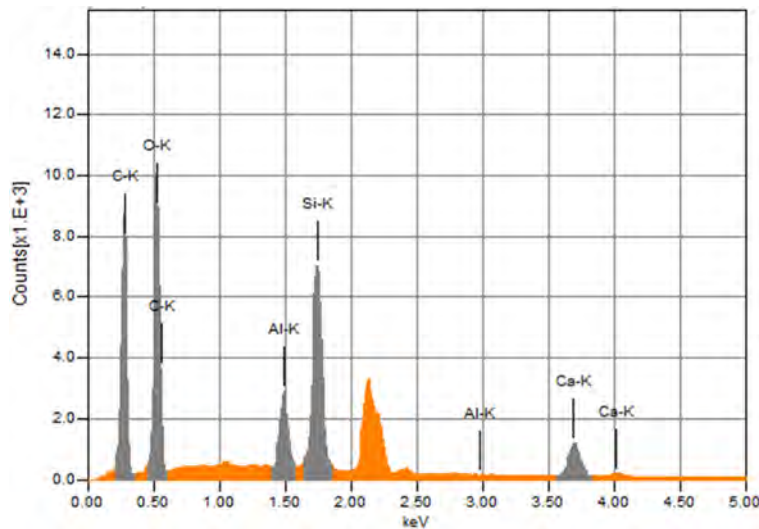
The results of EDS analysis showed the predominance of Si, Al, Ca (from glass fibers) and C (from the matrix) chemical elements in the extracted samples. No change in elemental distribution was found between central fibers and non-intact fibers. *Fig. 51* shows the result of EDS in samples from Walker Box Culvert Bridge.

Fig. 51–Result of the EDS analysis performed on GFRP samples extracted from Walker Box Culvert Bridge

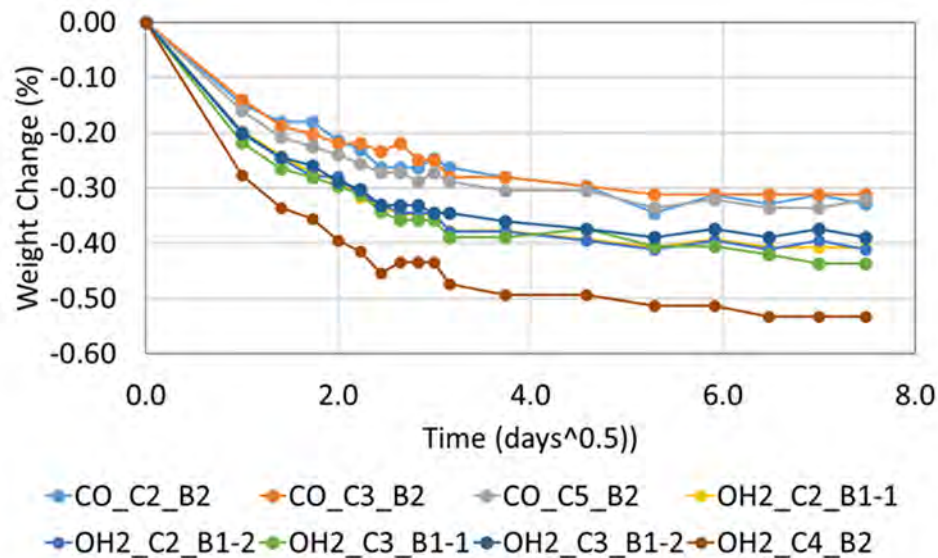
Moisture content measurement was performed in five of the 11 bridges: Gills Creek, Salem Ave., Bettendorf, O'Fallon Park and Cuyahoga. Of the ones completed to-date (Cuyahoga and O'Fallon), all dry-out specimens reached equilibrium after 56 days at 176°F (80°C). A plot of percent weight loss versus the square root of time (in days) is shown in *Fig. 52*. It can be seen that the weight loss is not monotonic. It is suspected that the deviations from monotonic weight loss are due to abnormal humidity conditions in the laboratory, while affecting the weigh measurement, although this possibility cannot be verified.

Fig. 52—Weight change versus the square root of drying time, in 176 °F (80°C) circulating oven air for Cuyahoga and O'Fallon bridges

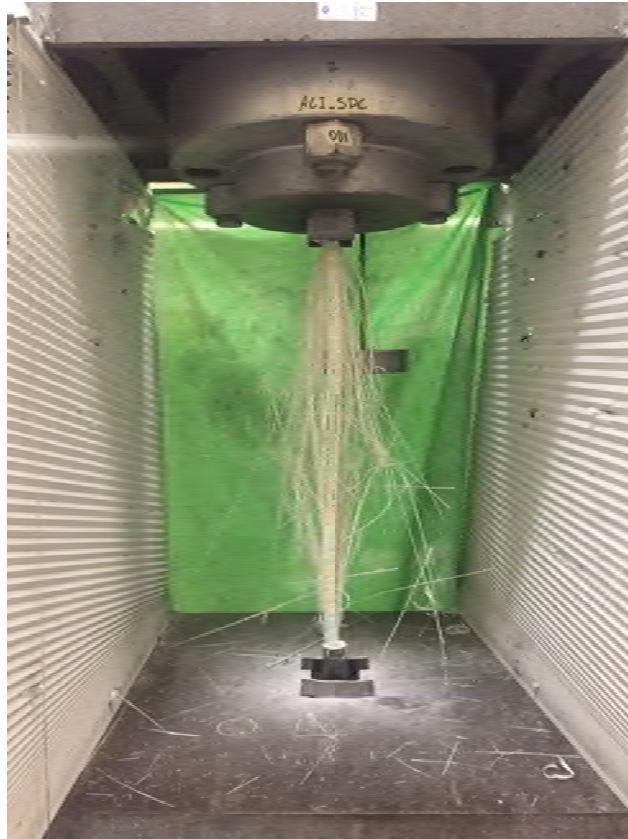
Ten #5 pristine bars were tested for tension capacity at the University of Miami as described in Section 4.1.8.2. The test set up is shown in Fig. 53 and the results of the test is shown in Table 19. The average peak load was 36,989 lbs. (164,535 N), which is similar the manufacture's specification dated 2002. The results of the tension test for each bar is shown in Appendix VI. All bars failed as shown in Fig. 54.

Fig. 54—Pristine GFRP tension failure

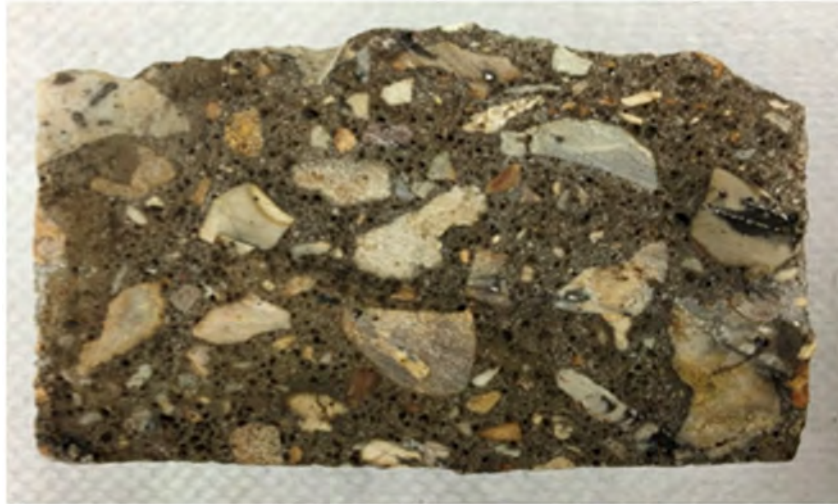
Fig. 55 shows the worst case scenario, where the chloride penetration was approximately 2.5 in. (64 mm) and *Fig. 56* shows the best-case scenario, where no visual chloride penetration was observed. The test results of the individual bridges are reported in Appendix IV.

Fig. 56–Southview Bridge sample with no visual chloride penetration

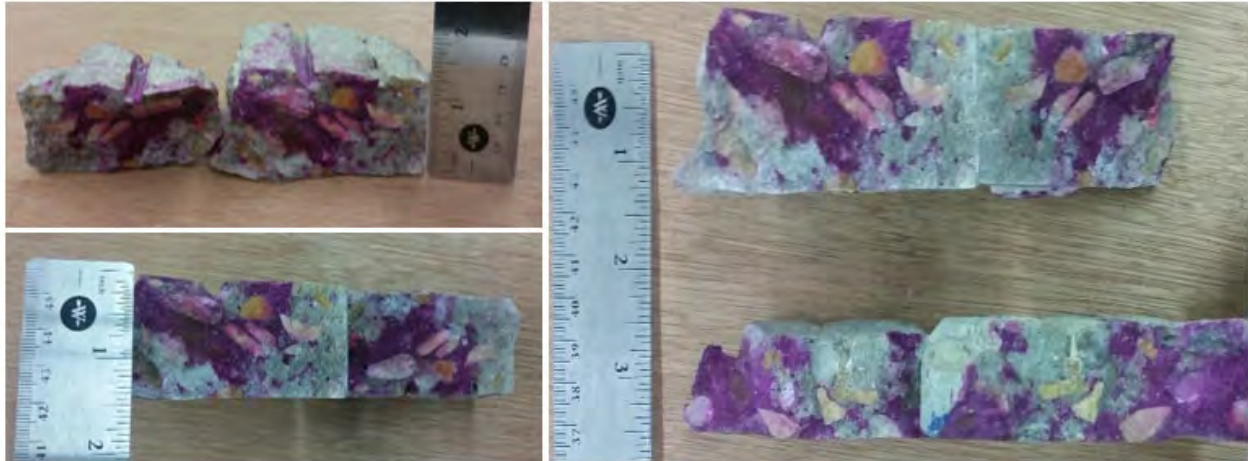
All 11 bridges were tested for carbonation depth. The purple zone indicated no carbonation and the white zone indicates the carbonation depth. Most samples presented some carbonation near the surface, but others presented no carbonation at all. Sierrita de la Cruz Creek Bridge, however, presented significant depth of carbonation reaching near the core of the sample. The samples from Sierrita de la Cruz Creek Bridge tested for carbonation are shown in Fig. 57. Fig. 58 shows an example where carbonation happened near the surface for the case of Cuyahoga Bridge.

Fig. 57–Sierrita de la Cruz Creek Bridge carbonation depth

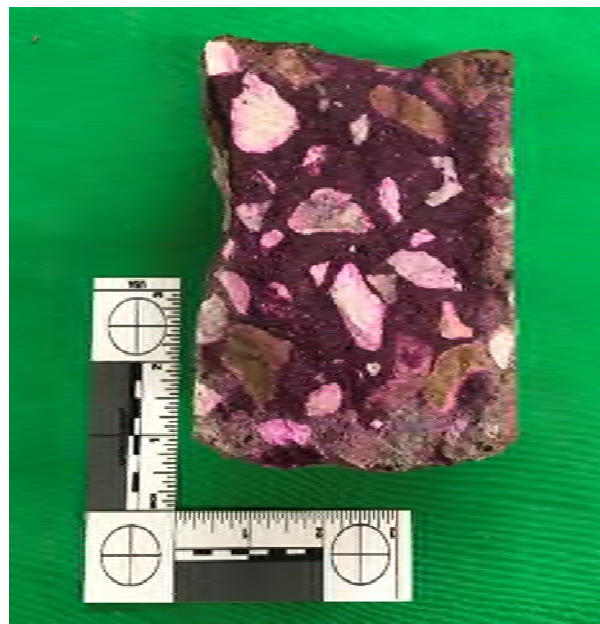
Fig. 58–Cuyahoga Bridge carbonation depth near the surface (deck)

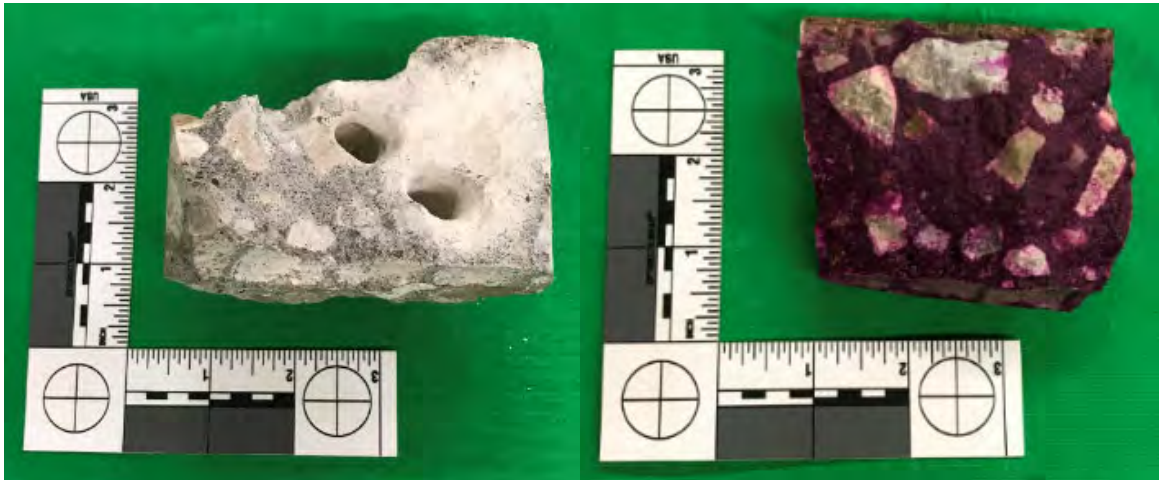
The pH of the samples varied between 9 and 13. The lowest average pH for was 10 for Roger's Creek and McKinleyville Bridge, while the highest average pH was 12.2 for Cuyahoga and Gills Creek Bridge. The average results for each bridge can be observed in Table 23. *Fig. 59* shows a sample tested with phenolphthalein indicator solution for Cuyahoga Bridge and *Fig. 60* its corresponding pH based on color range.

Fig. 59–Cuyahoga Core 4 pH test with phenolphthalein

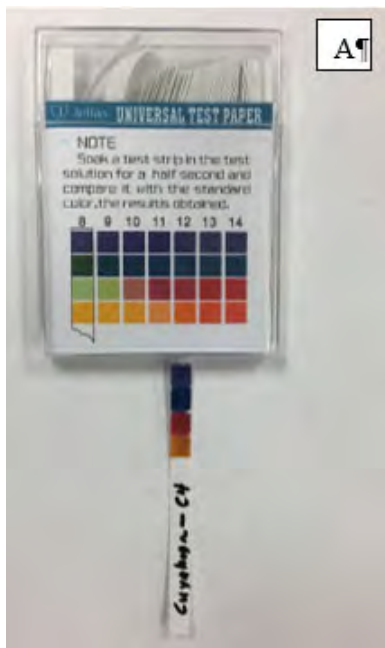
Fig. 60—pH color range for Cuyahoga core 4

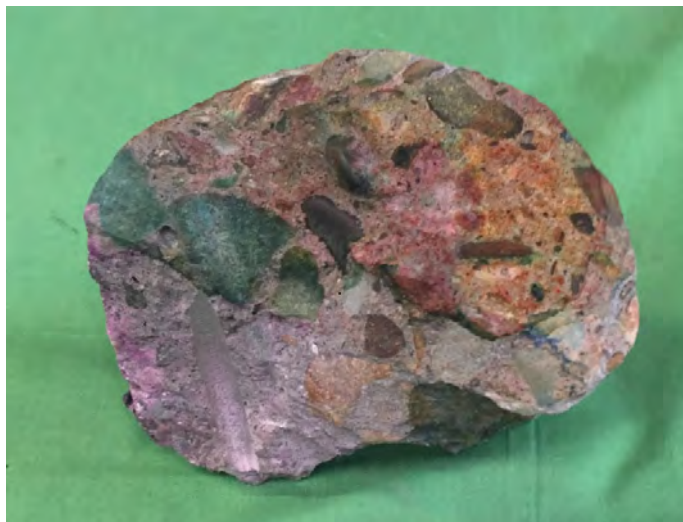
Fig. 61—McKinleyville pH range using the rainbow indicator

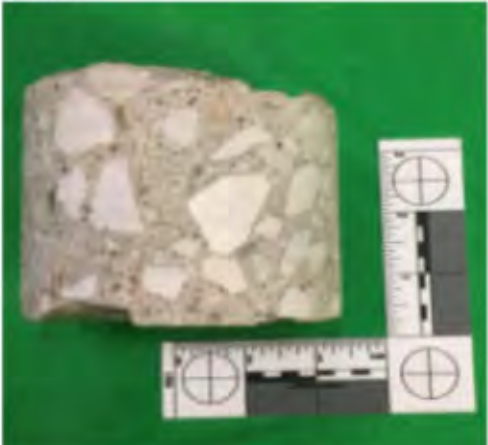
Core	Height (in)	Diameter (in)	Clear cover (in)	Notes	Picture
BE_C1	2.75	3.75		Missing steel -- rebar

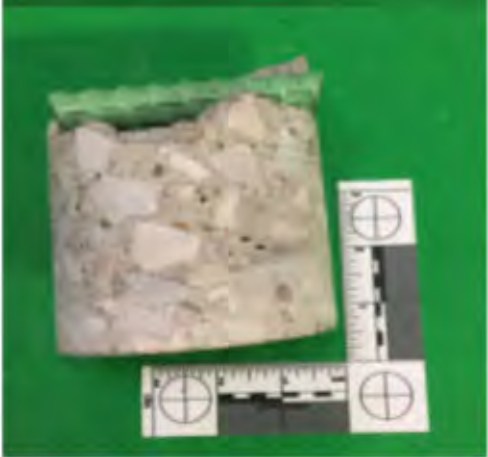
BE_C2	2	3.75		Steel rebar, core has hole in -- center

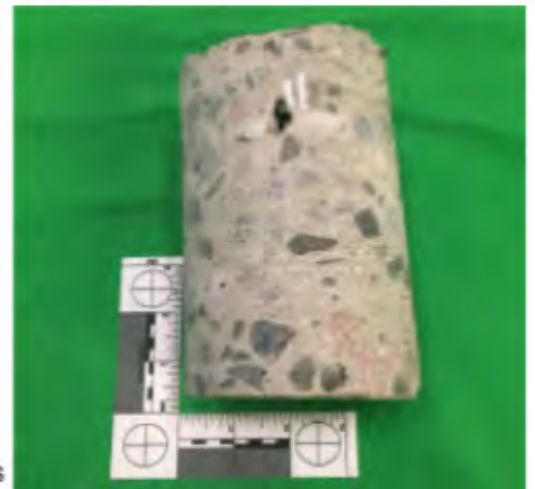
OF_CC	6	3.75	4.5	(2) Steel rebars	
-------	---	------	-----	------------------	--

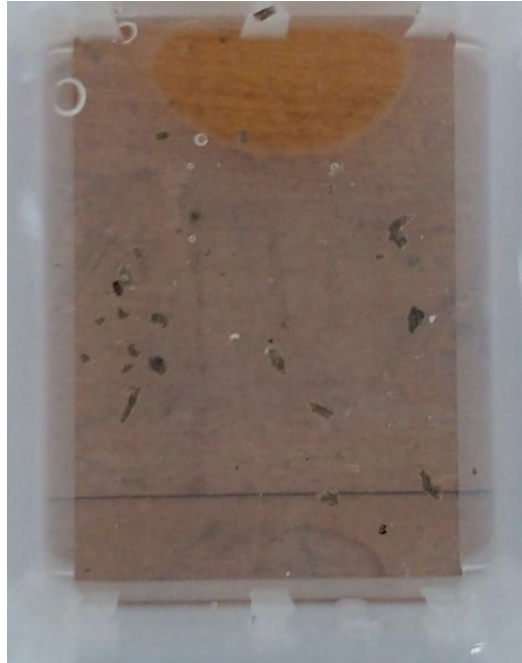
During uptake testing, one specimen lost weight between some of the measurements. Fig. 6 displays the causes for the loss in weight. CO_C5_B2 lost many small sand particles over the first two weeks.

Fig. 6. Sand particles at the bottom of the immersion chamber of CO_C5_B2

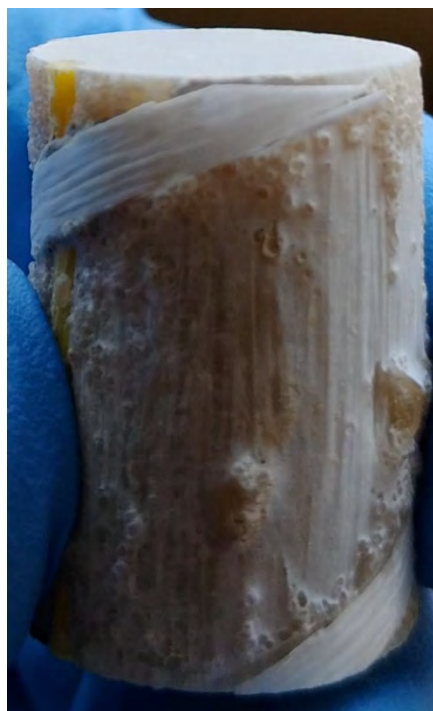
During moisture absorption testing, OH2_C4_B2(2) lost weight between some of the measurements. Between 28 and 35 days into uptake testing, lost a large piece of helical wrap. Fig. 8 displays the cause for this loss in weight.

Fig. 8. Part of the helical wrap fell off of OH2_C4_B2-2

Weight losses as a result of pre-conditioning at 104 °F (40°C) for 48 h in non-circulating oven air are shown in Table 23. The two OH2_C4_B2 specimens had consistently higher pre-conditioning weight loss than any other bar. Such a faster change in percent weight can be expected for the OH2_C4_B2 bar because of its smaller diameter versus the other bars.

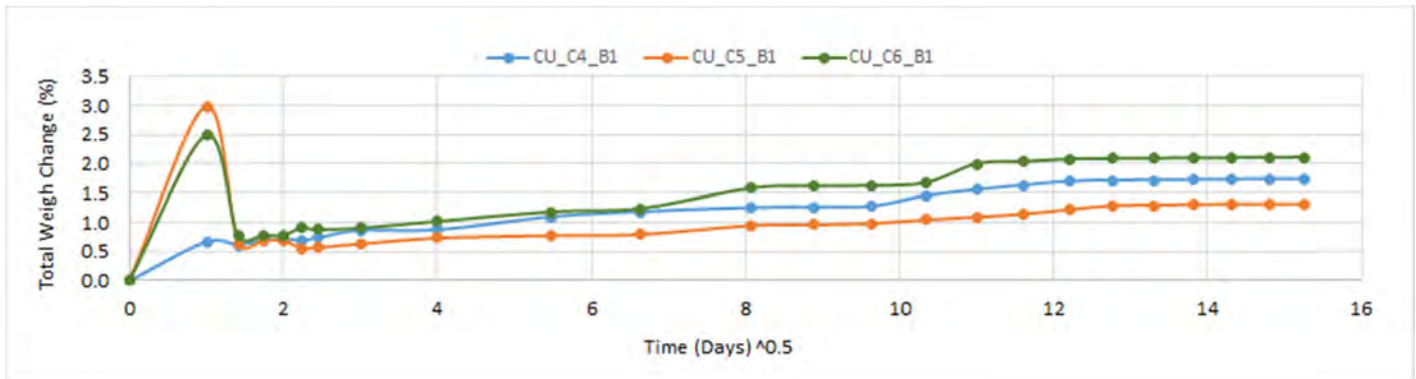
According to ASTM D570, any observation as to warping, cracking or change in appearance of the specimens should be reported. Between 30 and 44 days into uptake testing, CU_C4_B1 and CU_C6_B1, lost a little piece of helical wrap around 7 mg and 5 mg respectively. In addition to

losing a piece of helical wrap, some residue was noticed in all of the specimens' containers after 6 weeks of testing.

Fig 9. Cuyahoga moisture uptake vs. square root of time – MST

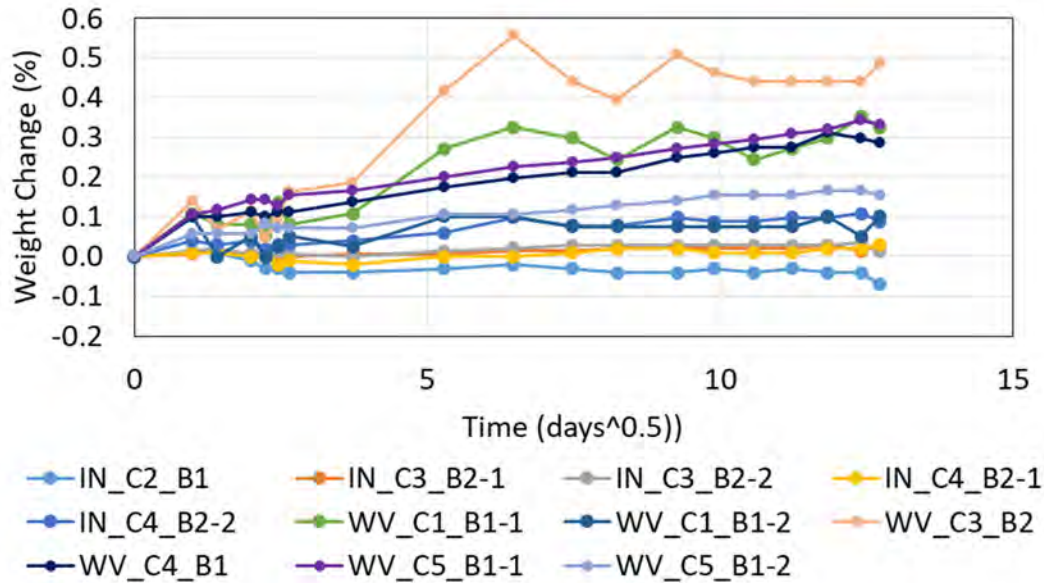
Water absorption tests for the *McKinleyville Bridge* were performed at the Penn State University, according to the procedure depicted in Section 4.1.2. Drying and measurement procedures are described in Appendix II. Percent weight changes for the *McKinleyville* and *Thayer* bars up to Mar. 9, 2019 (162 days) are shown on a square root of time scale in Fig. 10.

Table 26 lists the weight gains of the WV bars at 24 hours, at equilibrium, and at the last measurement (162 days). Equilibrium was reached in 56 days for the WV bars.

Fig. 10. Moisture uptake vs. square root of time for McKinleyville and Thayer bars – PSU

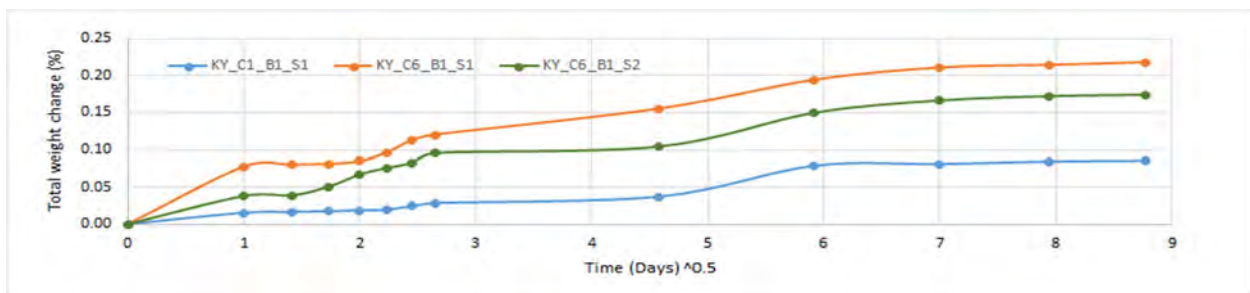
Three bars from Roger's Creek (KY) were tested for Moisture Absorption following the ASTM D570. The bars are: KY_C1_B1_S1, KY_C6_B1_S1, and KY_C6_B1_S2. They reached moisture equilibrium at 77 days with a total change in weight of 0.16%, as seen in Fig. 11 and Table 28. There were no signs of delamination of wrapping or shedding some parts of the bar.

Fig. 11. Roger's Creek moisture uptake vs. square root of time – MST

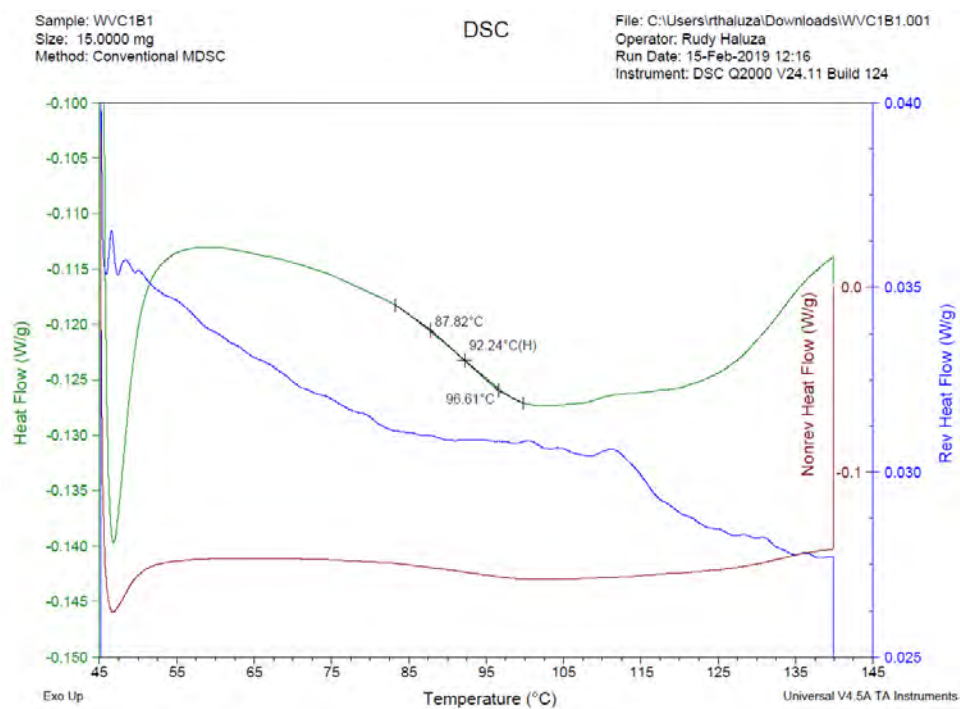
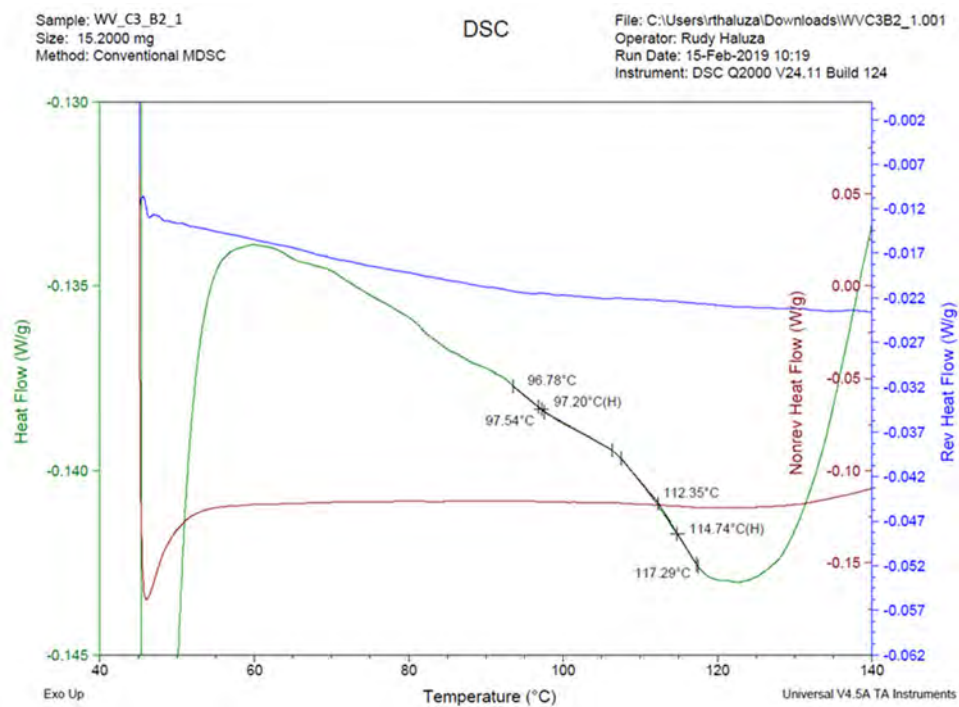
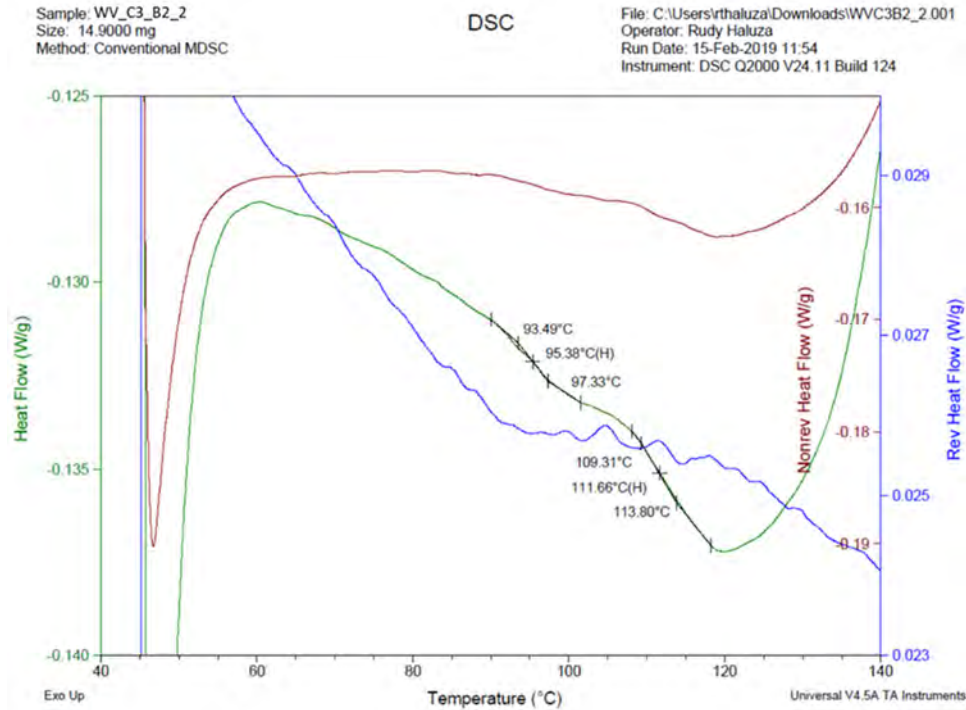
MDSC analysis of bars from the *McKinleyville Bridge* was performed at Penn State University using the procedure described in Section 4.1.4. The results are summarized in Table 50 and the graphical results for each bar are shown in Fig. 44 through Fig. 46. The *McKinleyville* bars displayed no discernable inflection point in the reversible heat flow curves, although nearly all of the total heat flow curves for these bars had two separate T_g values. The lower and upper T_g values are both reported for the bars in Table 50. Only the lower T_g average is reported in the main body of this report, as it is considered the more relevant one for bar performance. The lower T_g values do not satisfy the contemporary GFRP bar specification (ASTM-D7957-17, 2017) of 212°F (100°C), but the upper ones do.

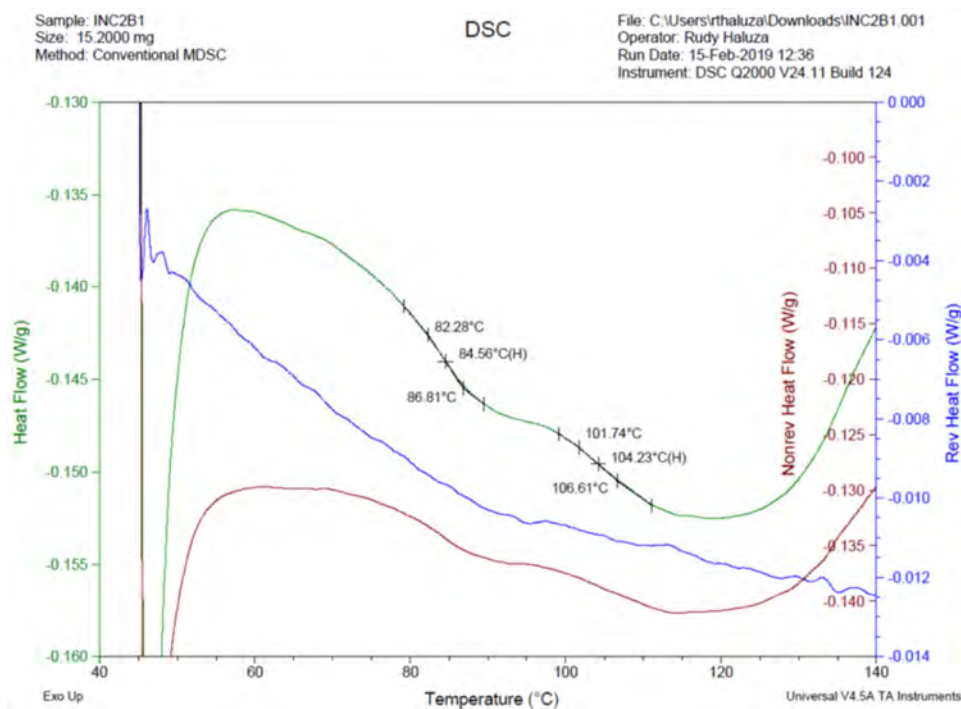
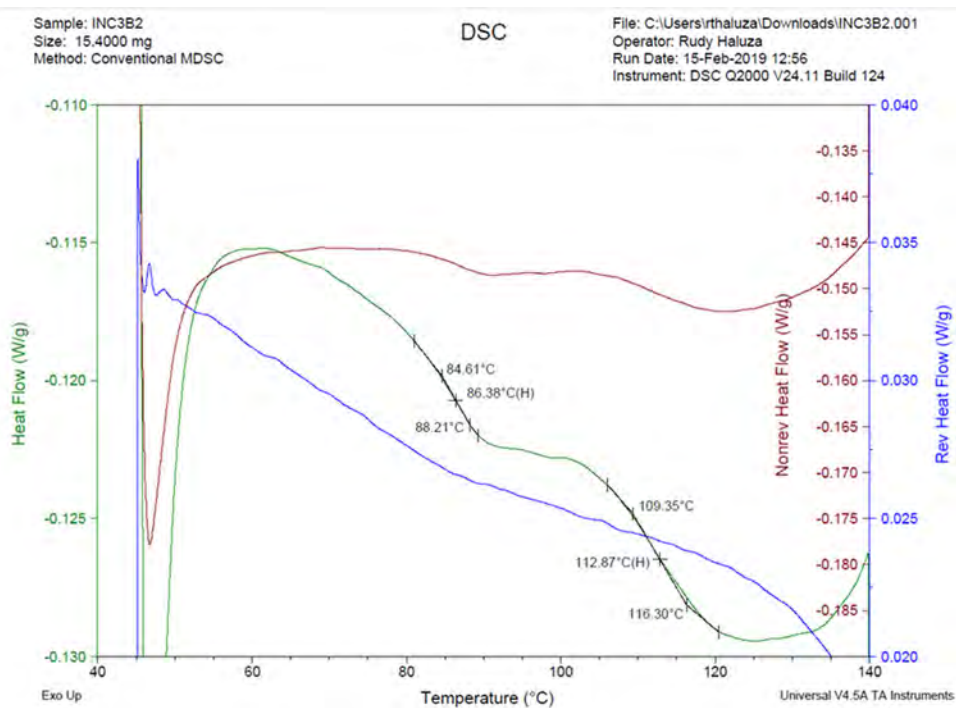
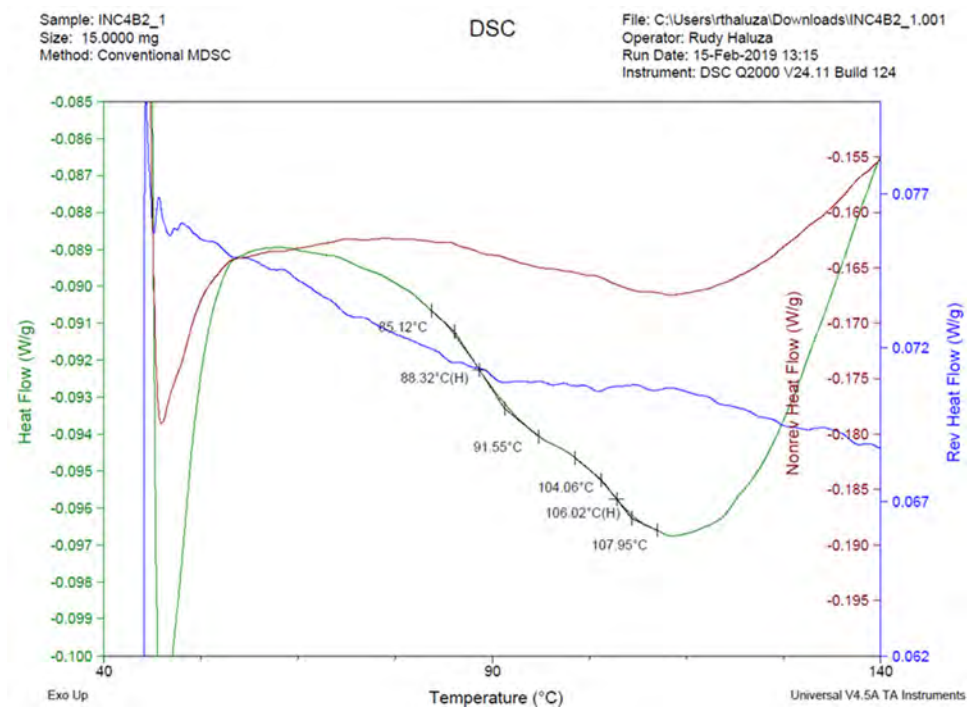
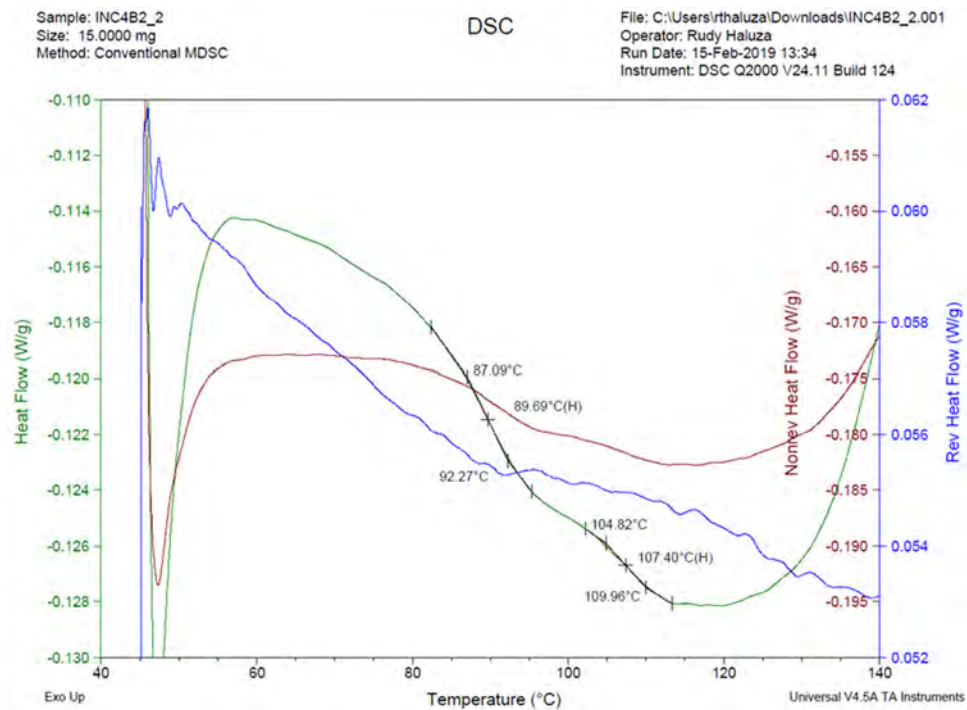
MDSC analysis of bars from the *Thayer Road Bridge* was performed at Penn State University using the procedure described in Section 4.1.4. The results are summarized in Table 51 and the graphical results for each bar are shown in Fig. 47 through Fig. 50. The *Thayer Road* bars displayed no discernable inflection point in the reversible heat flow curves, although all of the total heat flow curves for these bars had two separate T_g values. The lower and upper T_g values are both reported for the bars in Table 51. Only the lower T_g average is reported in the main body of this report, as it is considered the more relevant one for bar performance. The lower T_g values do not satisfy the contemporary GFRP bar specification (ASTM-D7957-17, 2017) of 212°F (100°C), but the upper ones do.

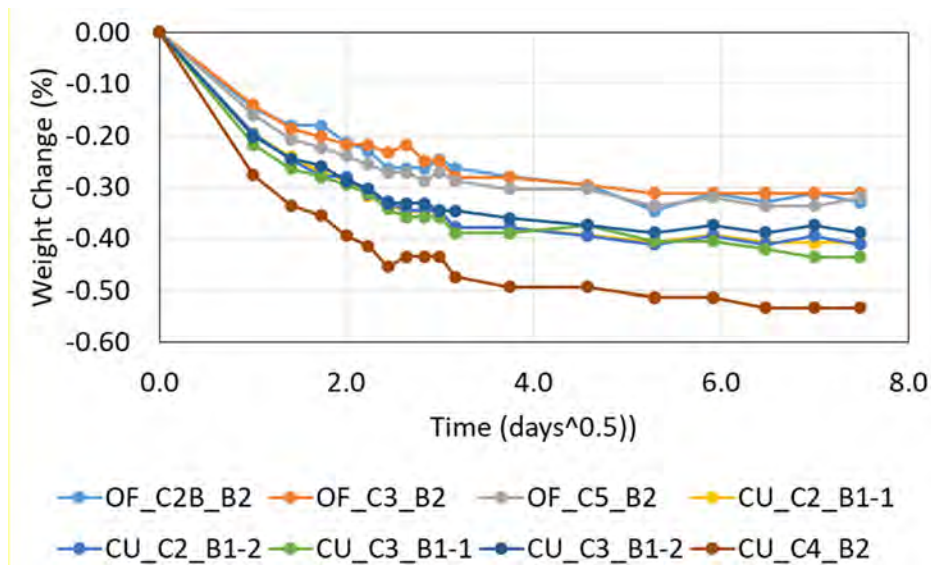
Fig. 51. O'Fallon (OF) weight change versus the square root of drying time, in 176°F (80°C) circulating oven air – PSU

Moisture content for *O'Fallon Park Bridge* was performed at Penn State University according to the method described in Section 4.1.6. All dry-out specimens reached equilibrium after 56 days at 176°F (80°C). A plot of percent weight loss versus the square root of time (in days) is shown in Fig. 51. The acronym used for the *O'Fallon Park Bridge* here is OF instead of CO. It can be seen that the weight loss is not monotonic. It is suspected that the deviations from monotonic weight loss are due to abnormal humidity conditions in the laboratory, although this possibility cannot be verified.

The weight changes at equilibrium, as a percent of weight before the drying procedure, are listed in Table 52. Overall, the weight losses from the dry-out procedure ranged from 0.31% to 0.32%. Upon conversion of these results to weight gains from a substantially dry initial state, the as-received moisture content of these bars due to field exposure likewise ranged from 0.31% to 0.32%. It should be kept in mind that the moisture content of the bars between the several months' time between when the bars were extracted from the bridges and when they were tested could be affected by the environment in which they were stored.

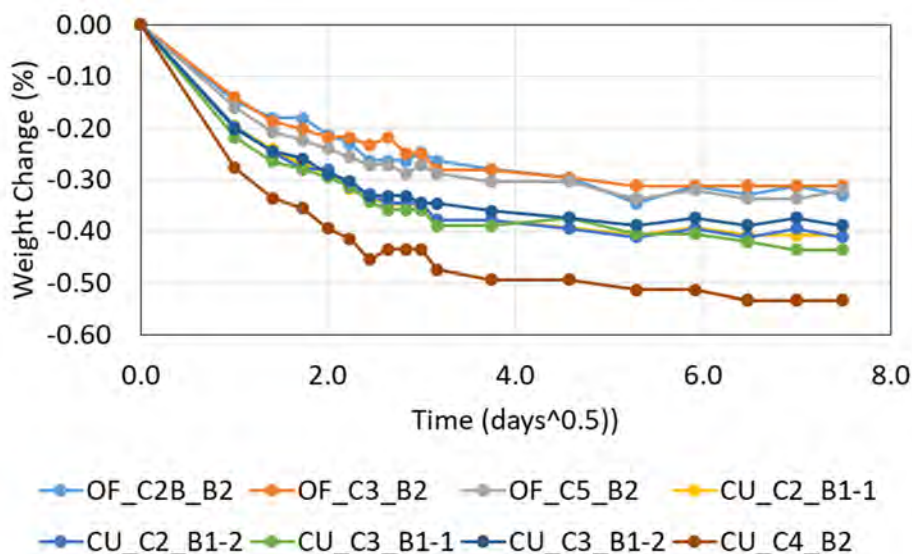
Fig. 52. Cuyahoga weight change versus the square root of drying time, in 176°F (80°C) circulating oven air – PSU

Moisture content for *Cuyahoga Bridge* was performed at Penn State University according to the method described in Section 4.1.6. All dry-out specimens reached equilibrium after 56 days at 176°F (80°C). A plot of percent weight loss versus the square root of time (in days) is shown in Fig. 52. The acronym used for *Cuyahoga Bridge* here is CU instead of OH2. It can be seen that the weight loss is not monotonic. It is suspected that the deviations from monotonic weight loss are due to abnormal humidity conditions in the laboratory, although this possibility cannot be verified.

The weight changes at equilibrium, as a percent of weight before the drying procedure, are listed in Table 53. Overall, the weight losses from the dry-out procedure ranged from 0.38% to 0.53%. Upon conversion of these results to weight gains from a substantially dry initial state, the as-received moisture content of these bars due to field exposure likewise ranged from 0.38% to 0.53%. It should be kept in mind that the moisture content of the bars between the several months' time between when the bars were extracted from the bridges and when they were tested could be affected by the environment in which they were stored.

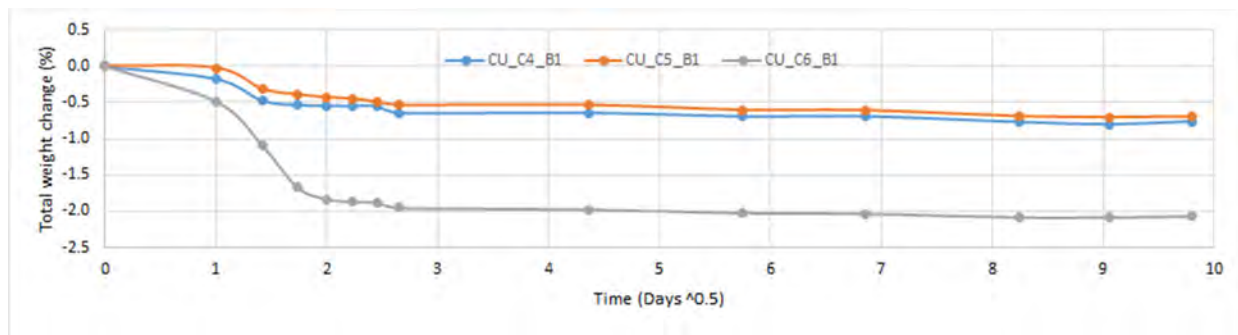
Cuyahoga Bridge was also tested at Missouri S&T. Three bars were used in this test. Results from the moisture content test are shown in Fig. 53. The graph was drawn according to ASTM D5229 requirements, which were to draw the results in term of weight change and days^{0.5}. All specimens reached equilibrium after 68 days at 176° F (80° C). However, the test was continued for a total of 96 days to monitor any abnormal changes in weights. It may be noted in Fig. 53. Cuyahoga weight change versus the square root of drying time, in in 176°F (80°C) circulating oven air that there was no significant change in weight after 68 days (X-axis – at point 8.2), as the curve trend levels off pass that point. However, a slight change in weight can be noticed from core 4 (CU_C4_B1), and it could be due to balance instability. The final weight change percentages respectively were 0.8% for CU_C4_B1, 0.7% for CU_C5_B1 and 2.1% for CU_C6_B1. The higher percentage of moisture content for the larger diameter bar could be related to larger surface area. Moisture content test was not conducted on control bars to benchmark these results. Additional tests are required to improve the dataset and validate these results. In addition, if test methods exist to measure moisture levels throughout the cross section on thin slices (i.e. relative to distance from the core to the outer surface of the bar) for different bar diameters, this may be examined to better understand moisture content relative to bar surface area and depth.

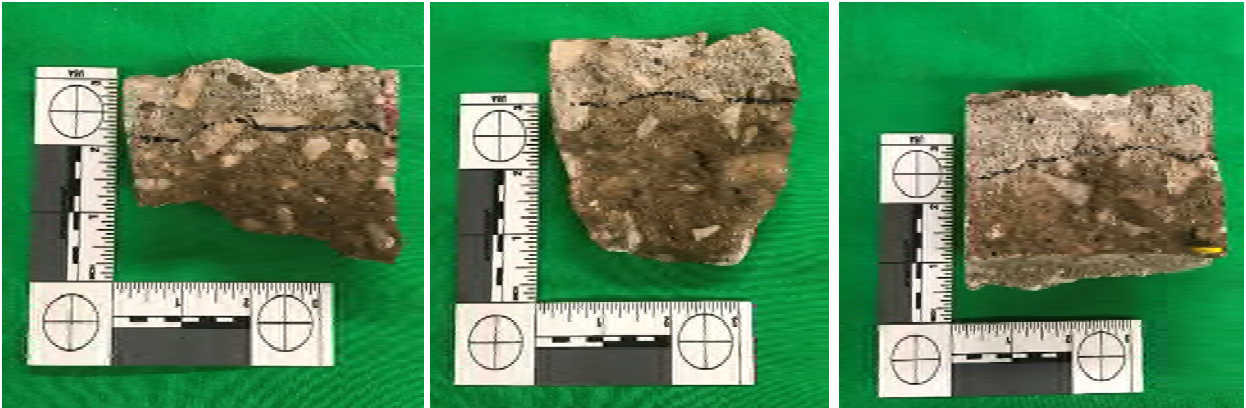
Fig. 1. Bettendorf chloride penetration samples

Chloride penetration depth was determined for three concrete samples from the *Bettendorf Bridge*. The chloride penetration appears to be approximately 1-in. from the exposed face of the concrete, as shown in Fig. 1.

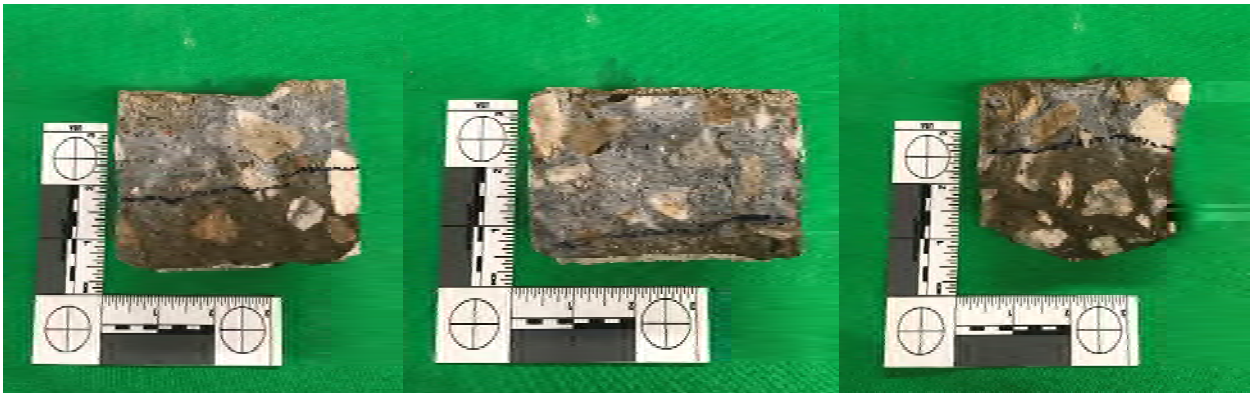
Fig. 2. Cuyahoga chloride penetration samples

Chloride penetration depth was determined for three concrete samples from the *Cuyahoga Bridge*. The chloride penetration varied from approximately 1-in to 2.5-in from the exposed face of the concrete, as shown in Fig. 2.

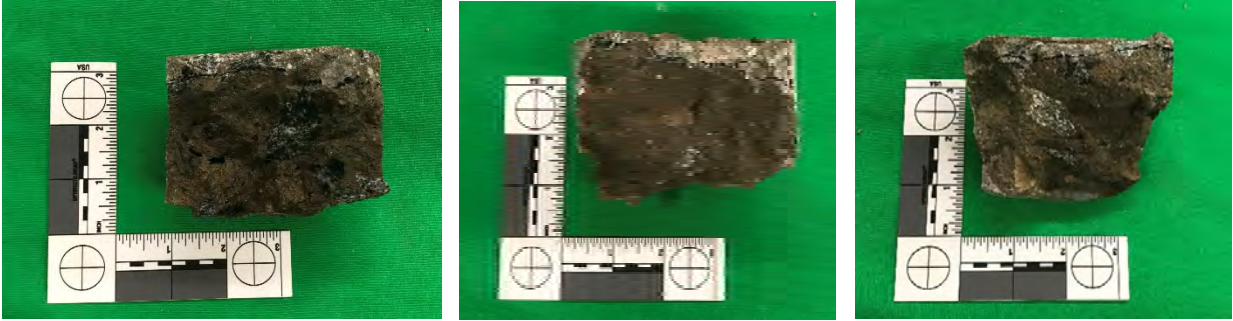
Fig. 3. Gills Creek chloride penetration samples

Chloride penetration depth was determined for three concrete samples from the *Gills Creek Bridge*. The chloride penetration for Gills Creek was small, less than 0.5-in from the exposed face of the concrete, as shown in Fig. 3.

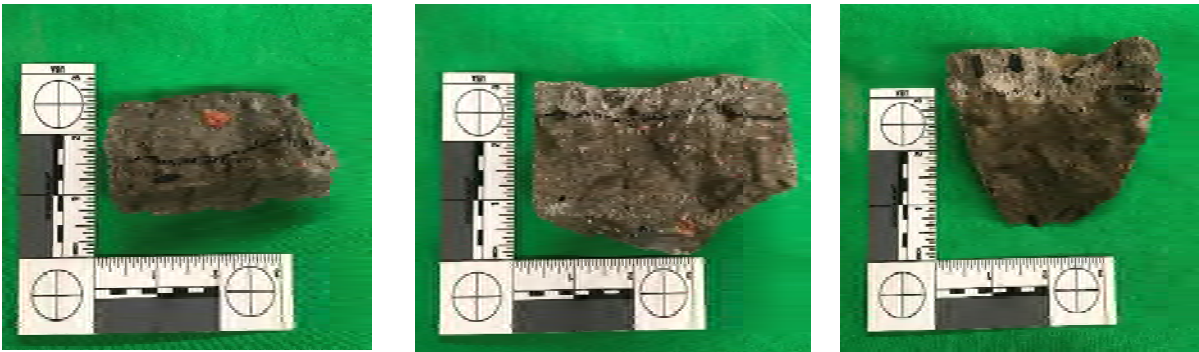
Fig. 4. O'Fallon Park chloride penetration samples

Chloride penetration depth was determined for three concrete samples from the *O'Fallon Park Bridge*. The chloride penetration depth for *O'Fallon Park Bridge* appears to be less than 1-in from the exposed face of the concrete, as shown in *Fig. 4*.

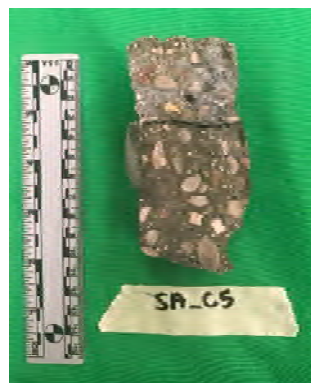
Fig. 5. Salem Ave chloride penetration sample

Chloride penetration depth was determined for one concrete sample from the *Salem Ave Bridge*. The chloride penetration was approximately 1.5-in. from the exposed face of the concrete, as shown in *Fig. 5*.

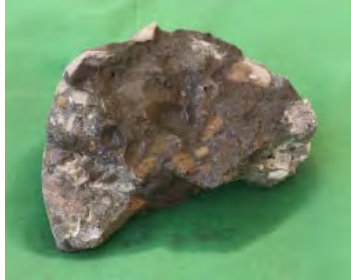
Fig. 6. McKinleyville chloride penetration sample

Chloride penetration depth was determined for one concrete sample from the *McKinleyville Bridge*. Chloride penetration was observed on the very close to the exposed face of the concrete, approximately less than 1-in., as shown in the Fig. 6.

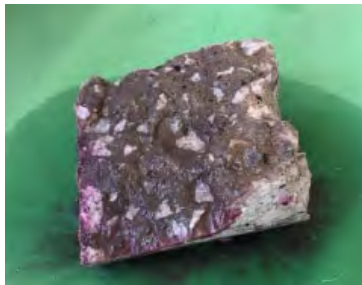
Fig. 7. Thayer Road chloride penetration sample

Chloride penetration depth was determined for one concrete sample from the *Thayer Road Bridge*. Minor chloride penetration appeared near the face of the exposed concrete face, as shown in the Fig. 7.

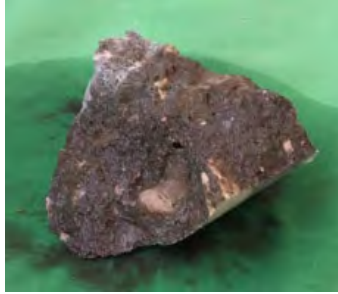
Fig. 8. Roger's Creek chloride penetration sample

No evidence of chloride diffusion was observed in the tested specimens of *Roger's Creek Bridge*. The results are shown in the Fig. 8.

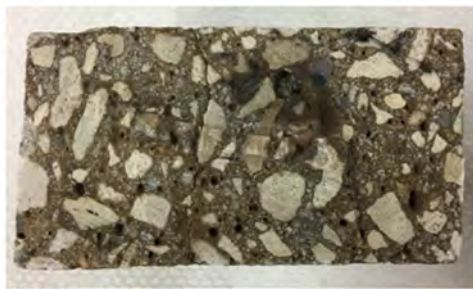
Fig. 9. Walker Box Culvert chloride penetration sample

No clear evidence of chloride diffusion was observed in all the tested specimens using this method. It was noticed that the surface became darker, to a color similar to brown, while there was no visible gray area (*Fig. 9*).

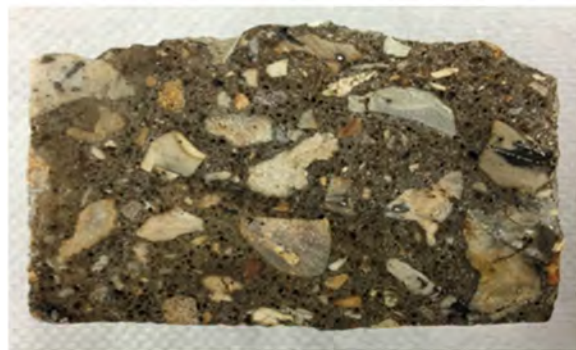
Fig. 10. Southview chloride penetration sample

No clear evidence of chloride diffusion was observed in all the tested specimens of both bridges using this method. It was noticed that the surface became darker, to a color similar to brown, while there was no visible gray area (*Fig. 10*).

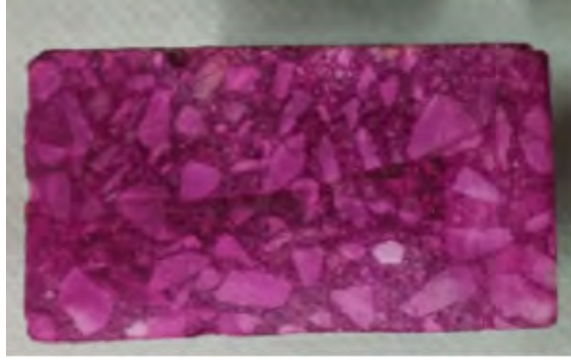
Fig. 17. Walker carbonation depth results

No indication of concrete carbonation was observed in samples extracted from this bridge (*Fig. 17*). While no carbonation of concrete can be considered beneficial to steel rebars because the pH remains at high values, the opposite is true for GFRP reinforcement that is more sensitive to high alkalinity. Thus, the GFRP bars extracted from these cores were subject to an alkaline environment over the 17 years of service in *Walker Box Culvert Bridge*.

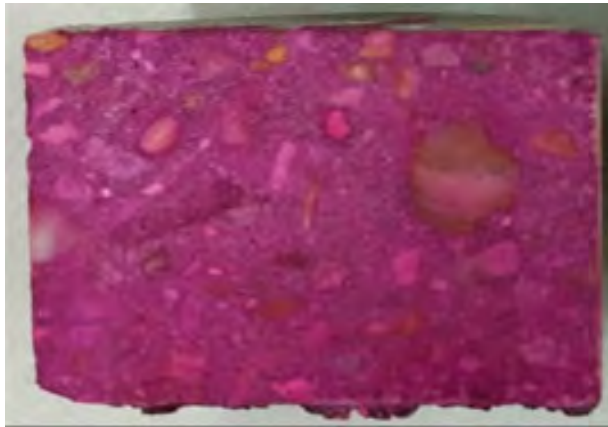
Fig. 18. Southview carbonation depth results

No indication of concrete carbonation was observed in samples extracted from Southview Bridge (*Fig. 18*). While no carbonation of concrete can be considered beneficial to steel rebars because the pH remains at high values, the opposite is true for GFRP reinforcement that is more sensitive to high alkalinity. Thus, the GFRP bars extracted from these cores were subject to an alkaline environment over the 11 years of service.

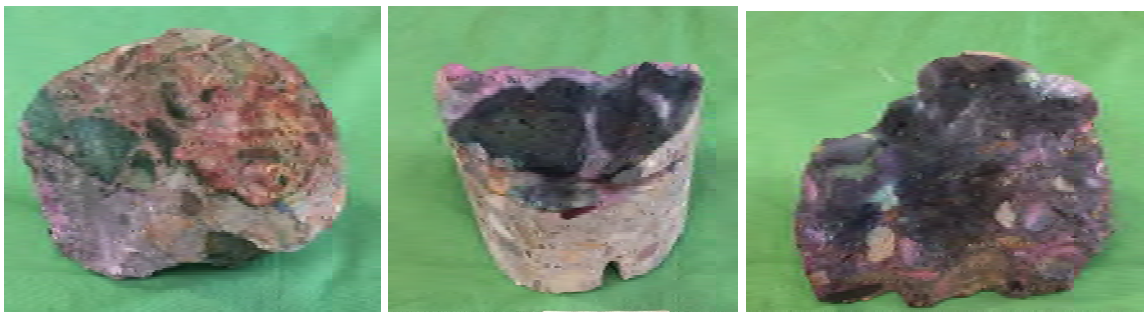
Fig. 30. McKinleyville pH test

All the core samples were tested with the rainbow indicator and the value varied between samples and location of where the indicator was applied. *McKinleyville Bridge* samples indicated a pH of 13 in the inside of the concrete sample and a pH between 7 and 13 on the outside face of the concrete core, as seen in Fig. 30.
