FINAL PROJECT REPORT #00059416

Durability of GFRP Bar Reinforcement Extracted from In-service Concrete Structures

Participating Consortium Member:
Missouri University of Science and Technology

RE-CAST:
REsearch on Concrete Applications for
Sustainable Transportation
Tier 1 University Transportation Center

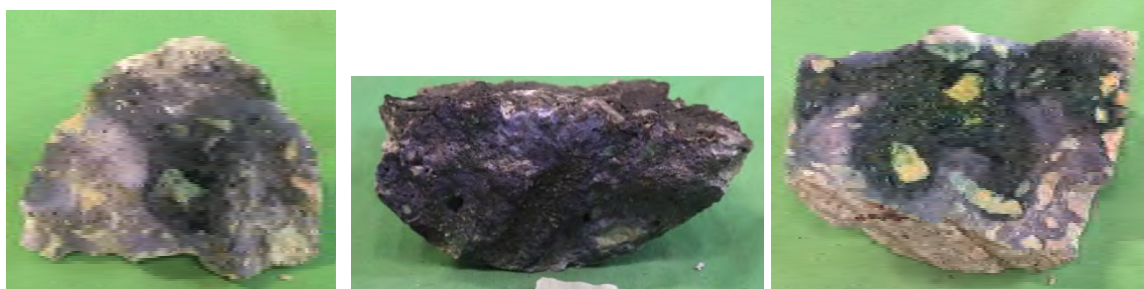
Fig. 31. Thayer Road pH test

The pH obtained for *Thayer Road Bridge* concrete samples only varied between 11 and 13, as shown in Fig. 31.

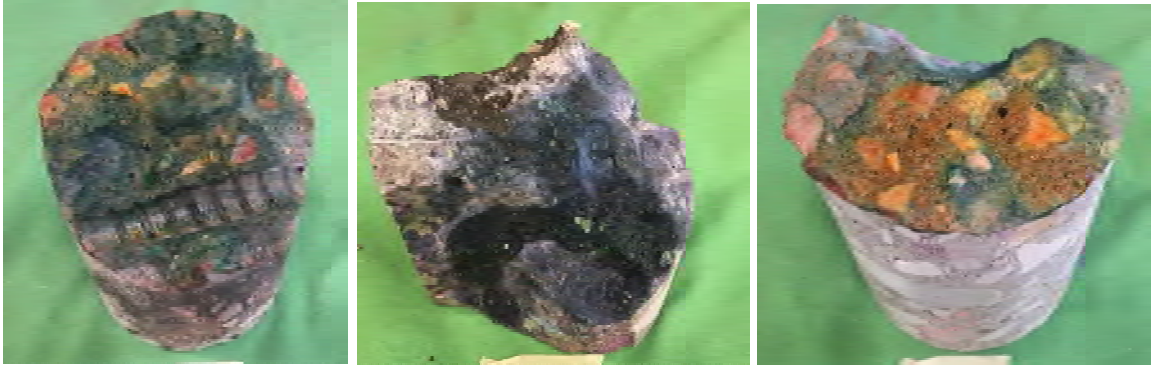
Fig. 32. Roger's Creek pH test

A rainbow indicator was used to observe the pH of the concrete samples. The pH varied between 7 and 13, as shown in *Fig. 32*.

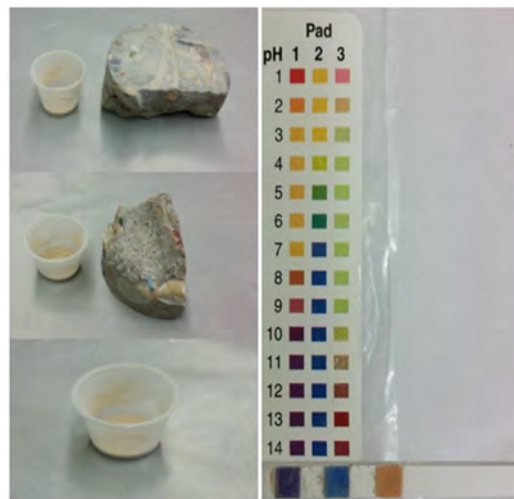
The measured pH values range between 11 and 12 (*Fig. 33*) which is considered acceptable for that type of concrete and age (Grubb et al., 2007). The procedure was performed in three different locations and the results are consistent results for all locations.

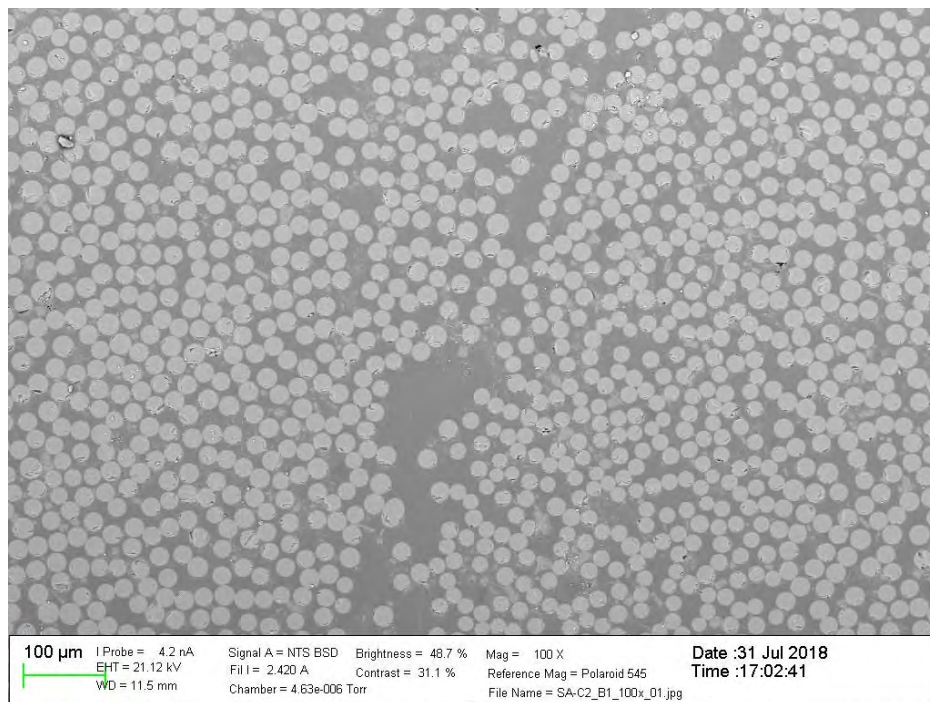
Fig. 19: OH1_C2_B1 at 100x magnification

SEM imaging for *Salem Ave. Bridge* was performed at the University of Miami. The results of each bar is shown in Fig. 19 through Fig. 27.

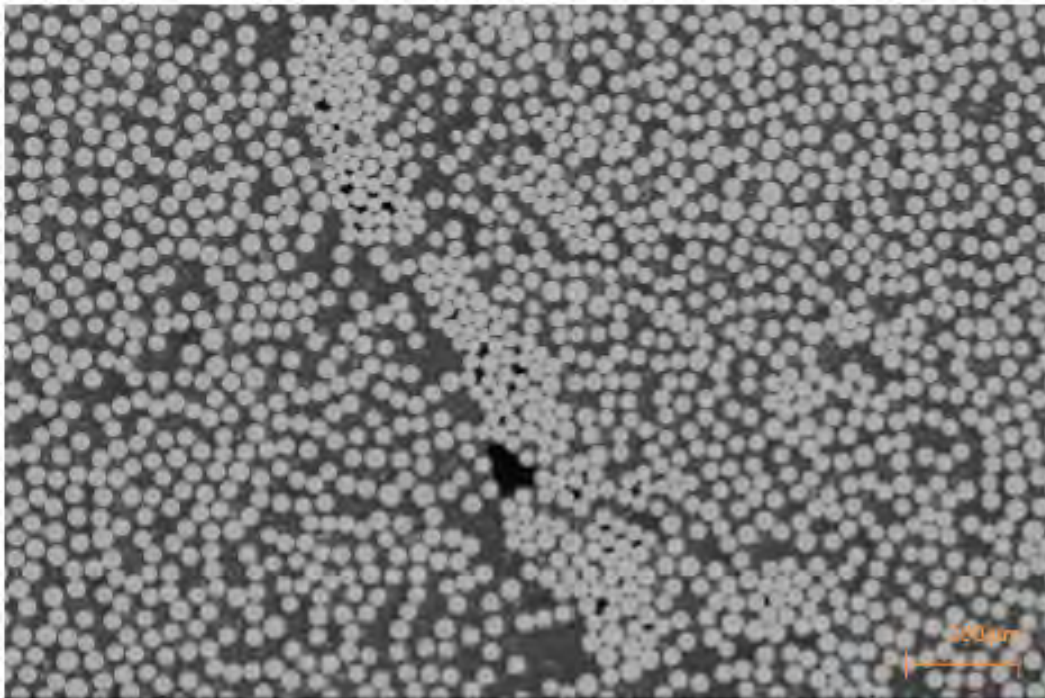
Fig. 33: OH2_C5_B2

SEM imaging for *Cuyahoga Bridge* was performed at Owens Corning. GFRP rebar extracted from Cuyahoga bridges show some damage on 0.05 to 0.12 % of the glass fibers. This is much less than expected or predicted by accelerated test methods, and has a negligible impact on mechanical properties. The affected fibers were typically on the outer edge of the rebar. The results of each bar is shown in Fig. 32 through Fig. 35.

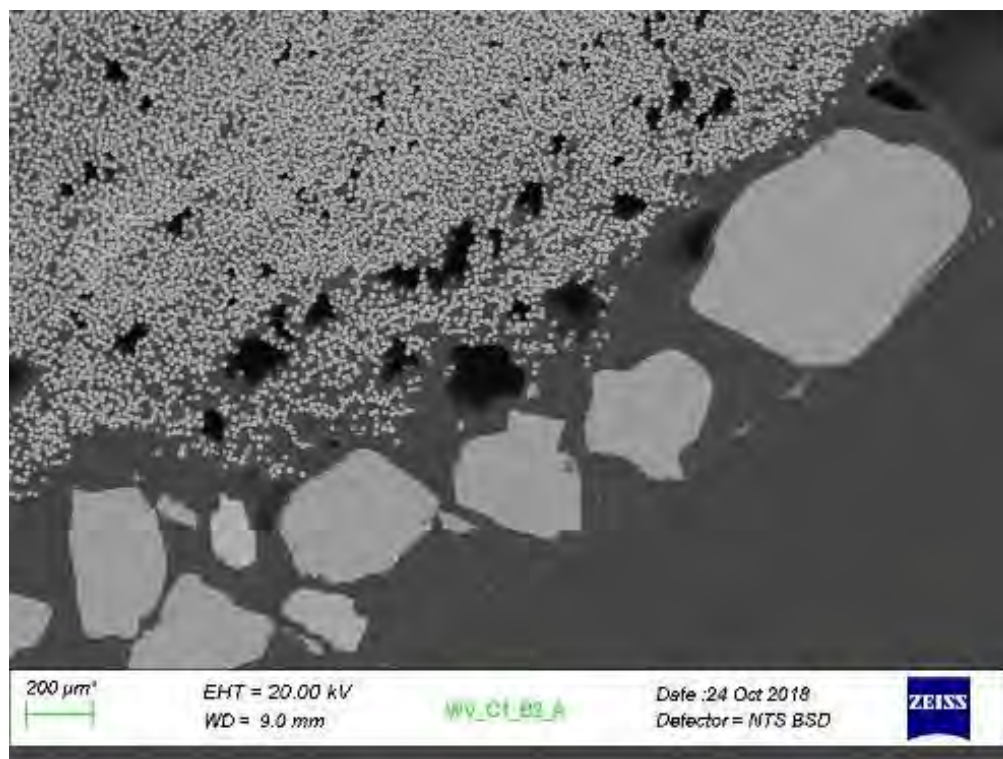
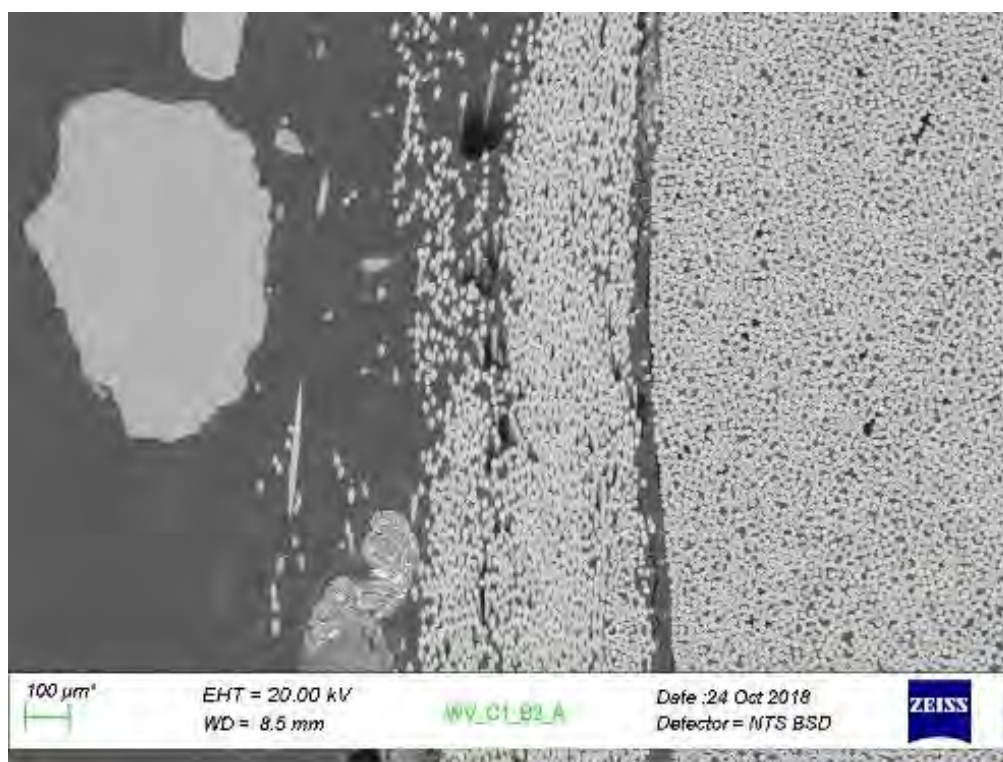
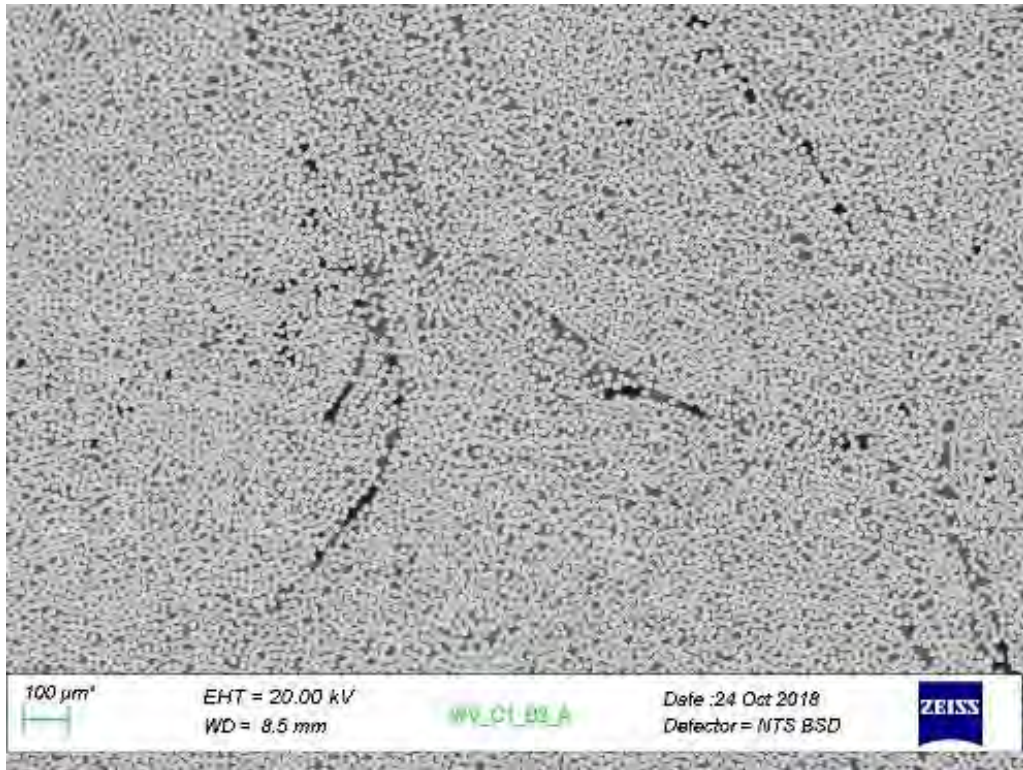
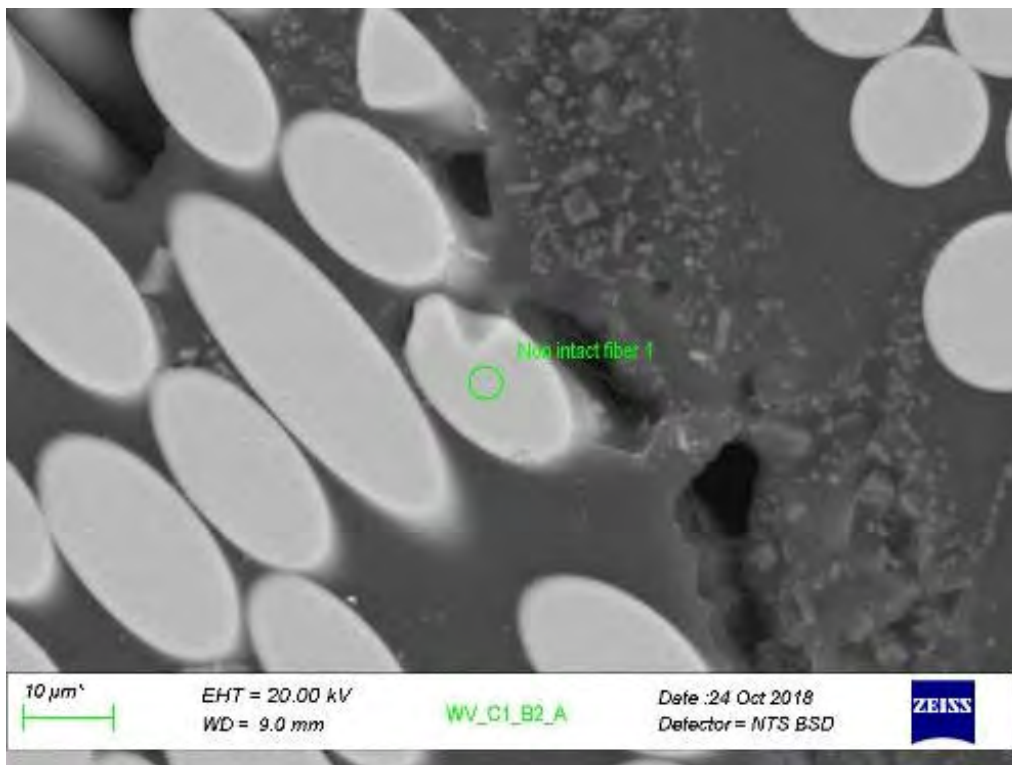
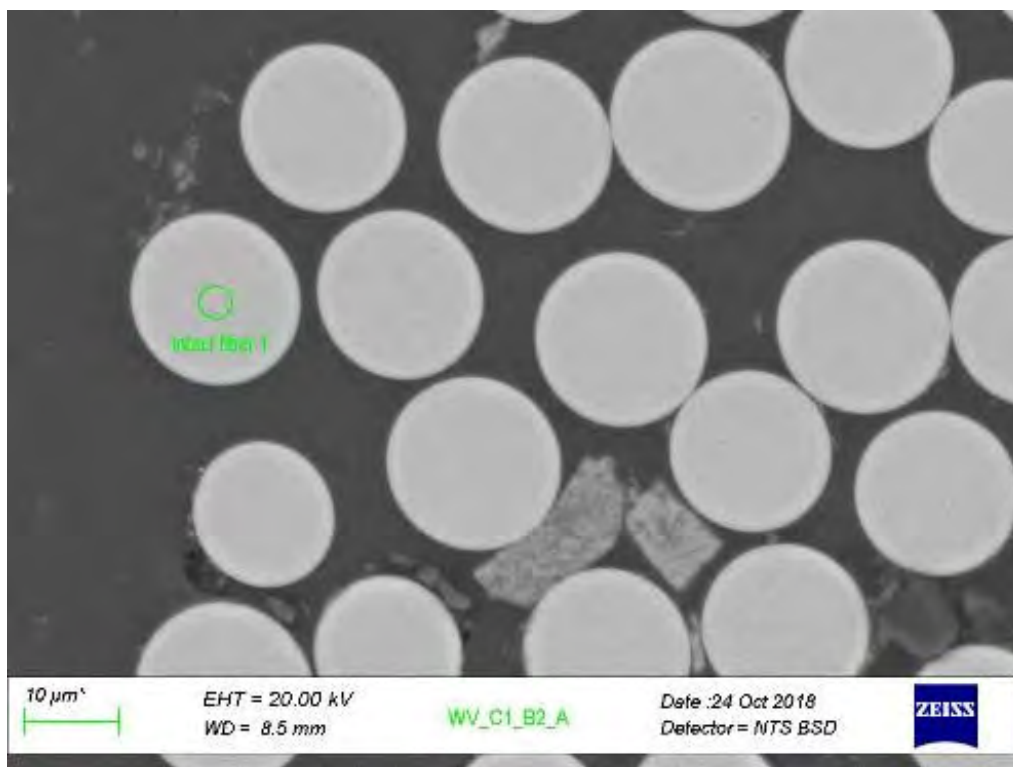
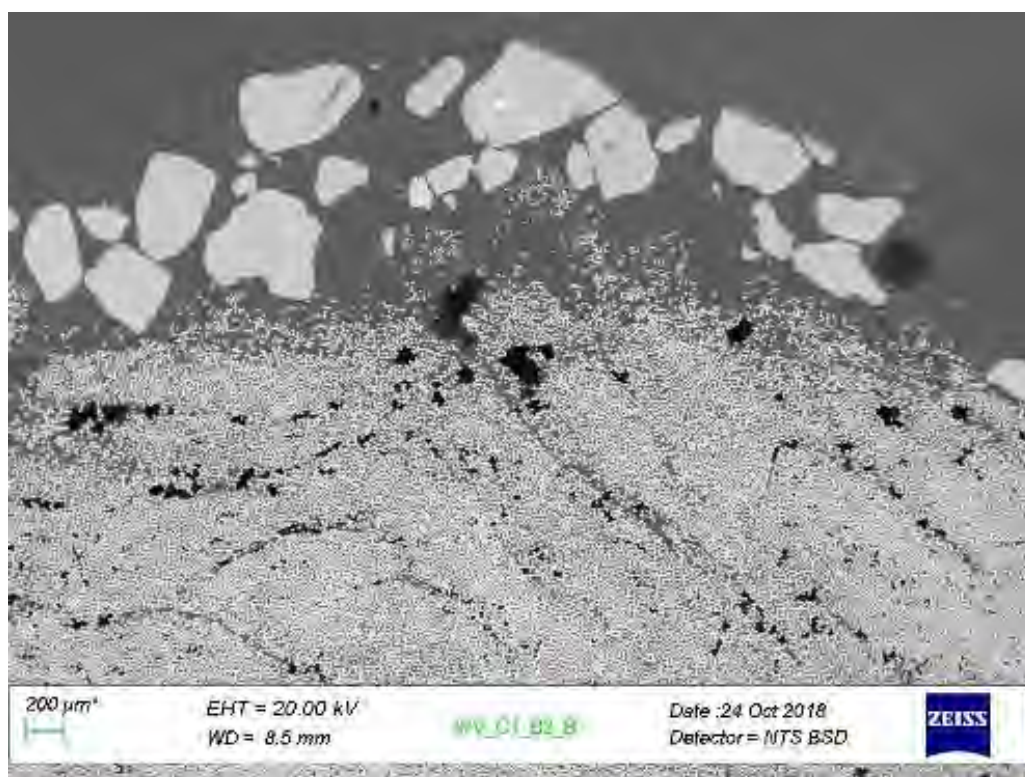
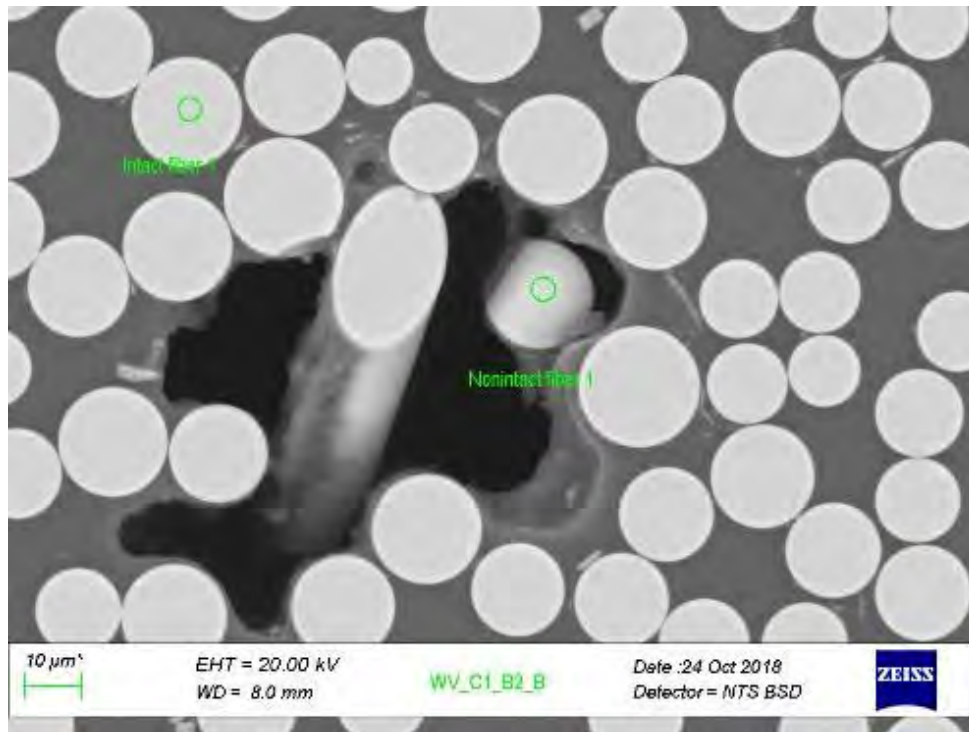
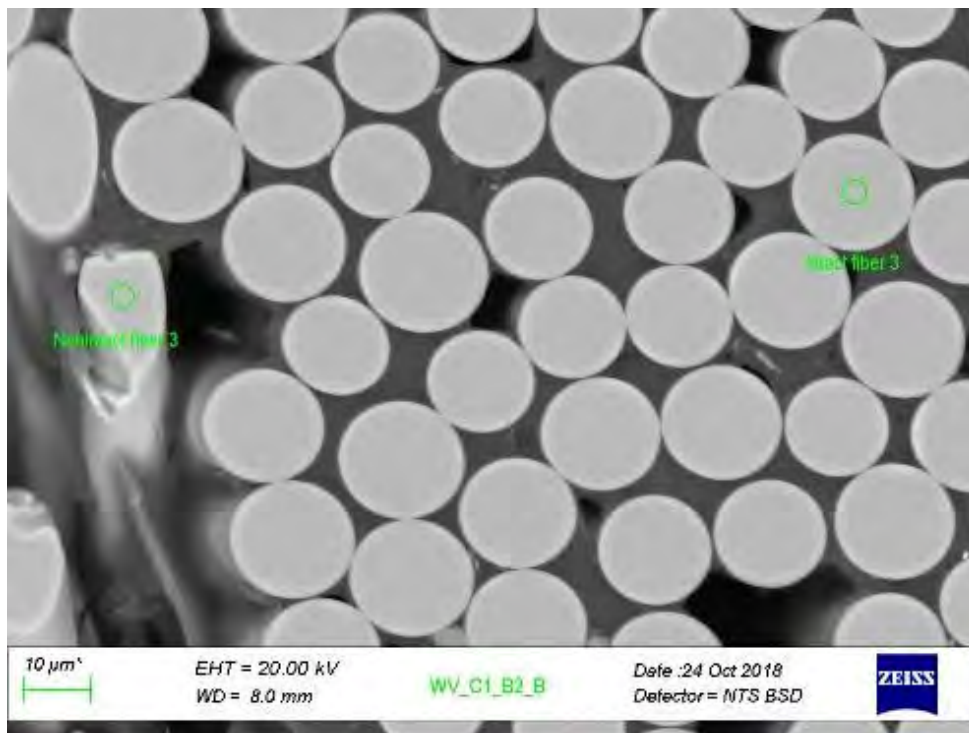
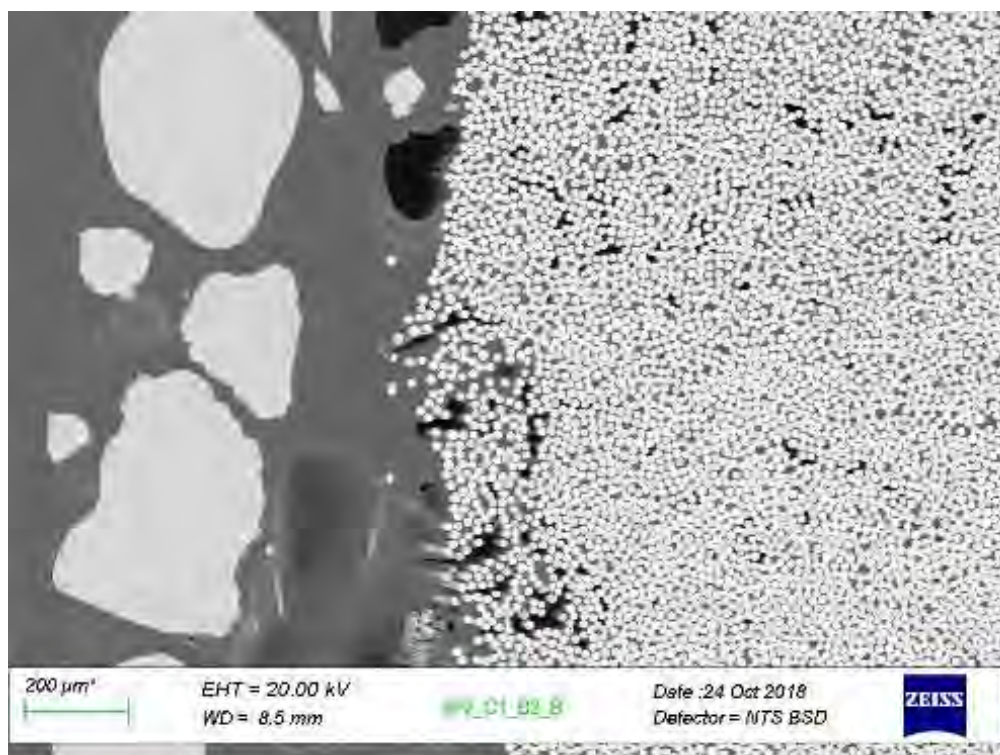
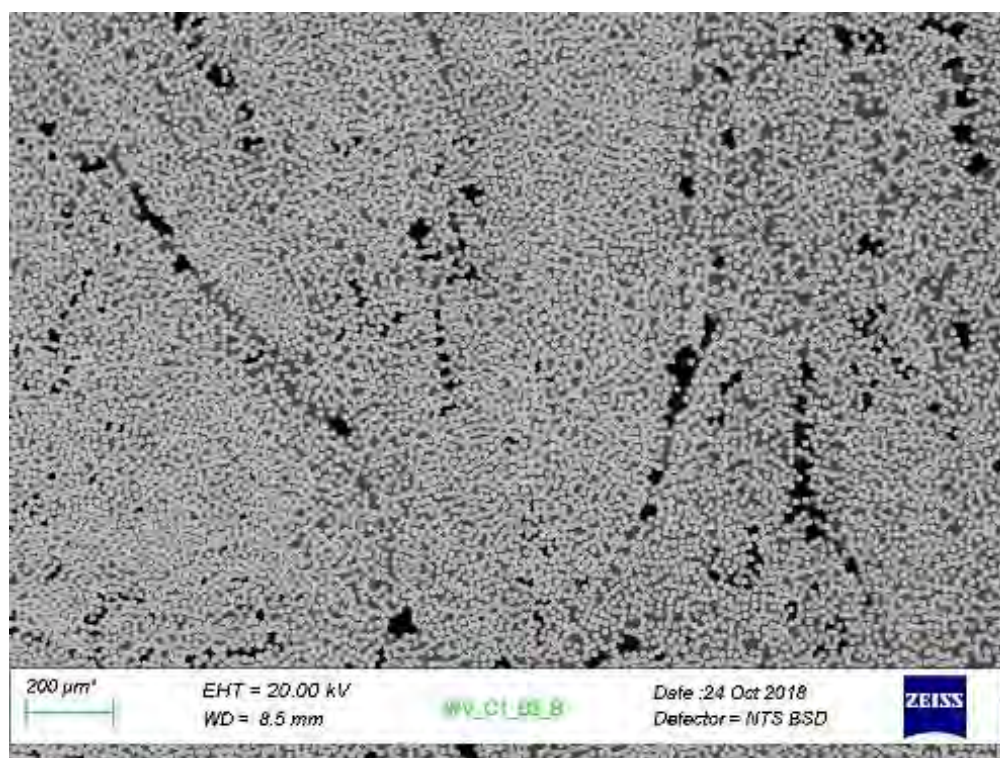
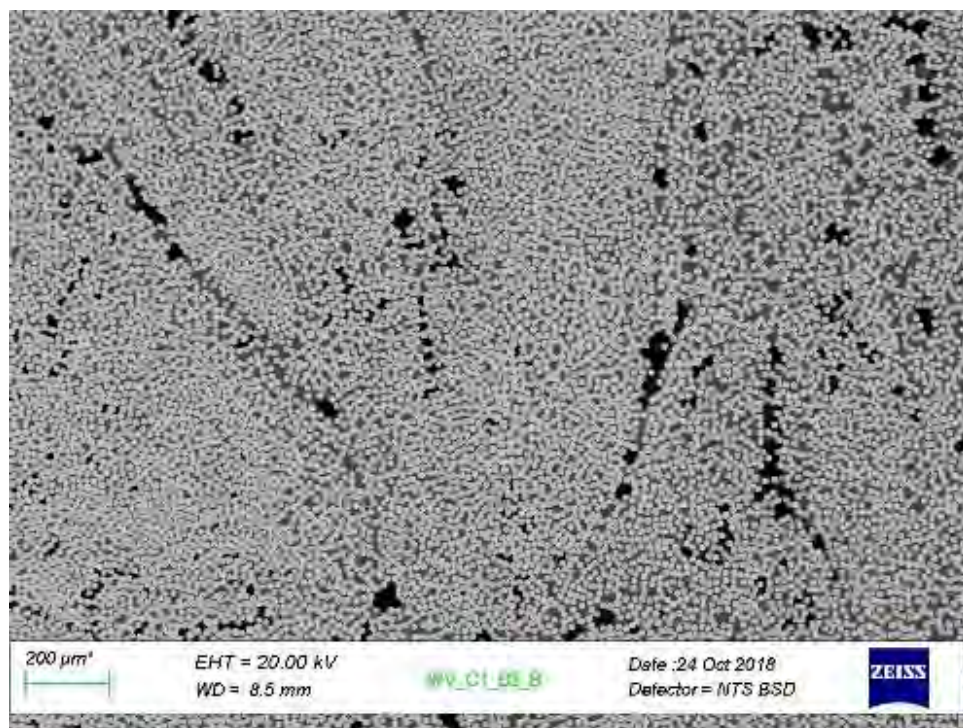
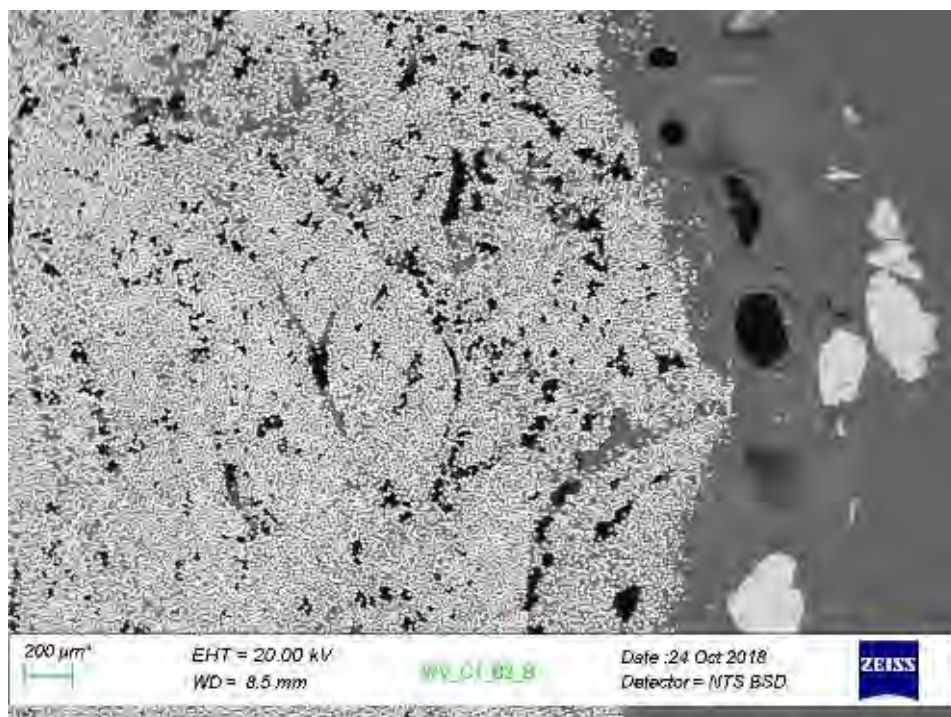
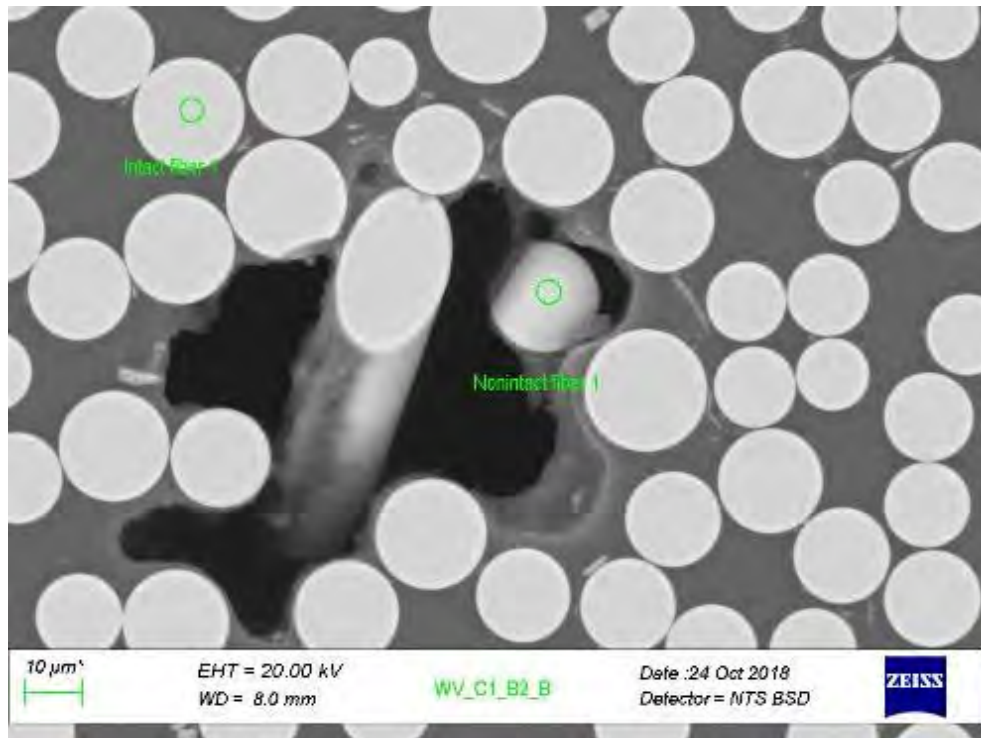
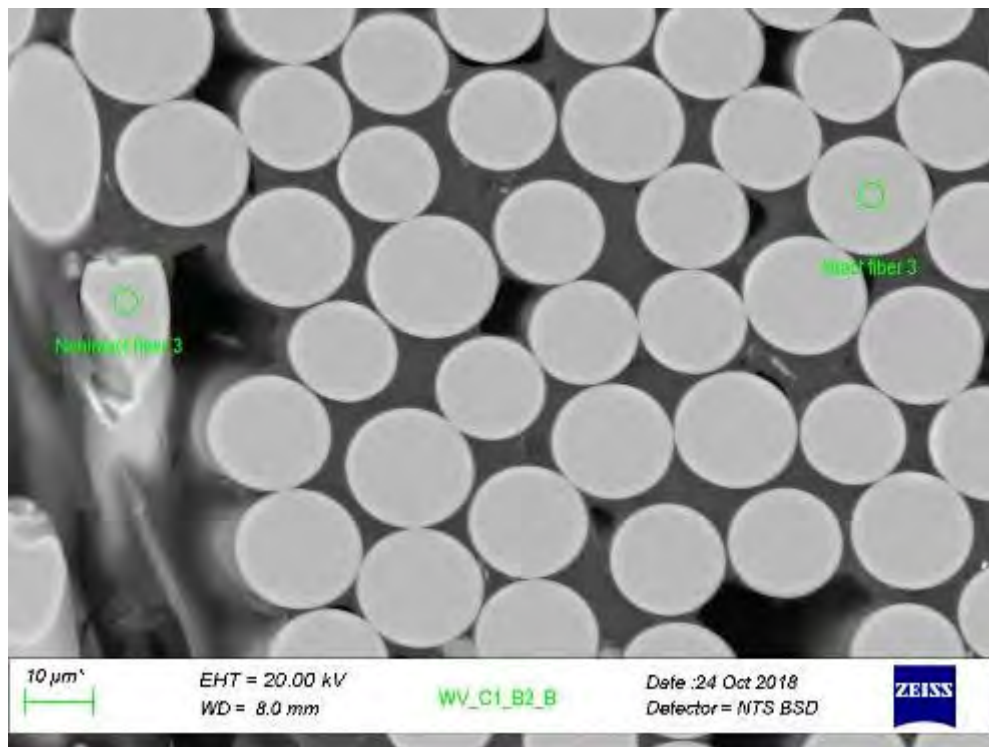
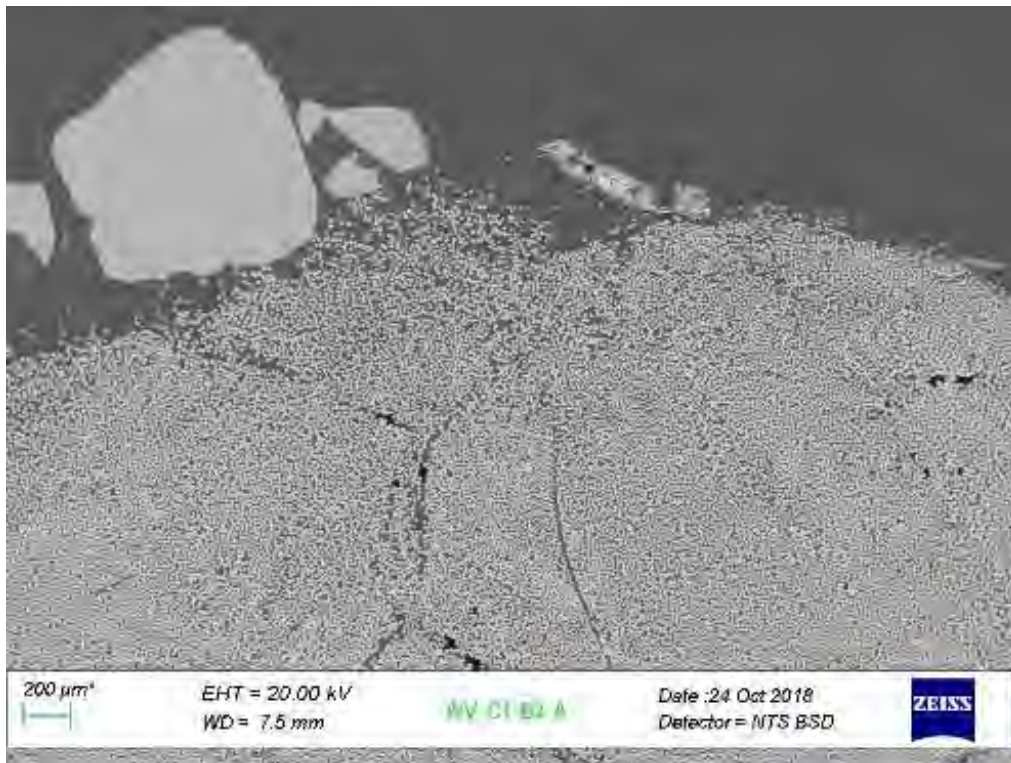
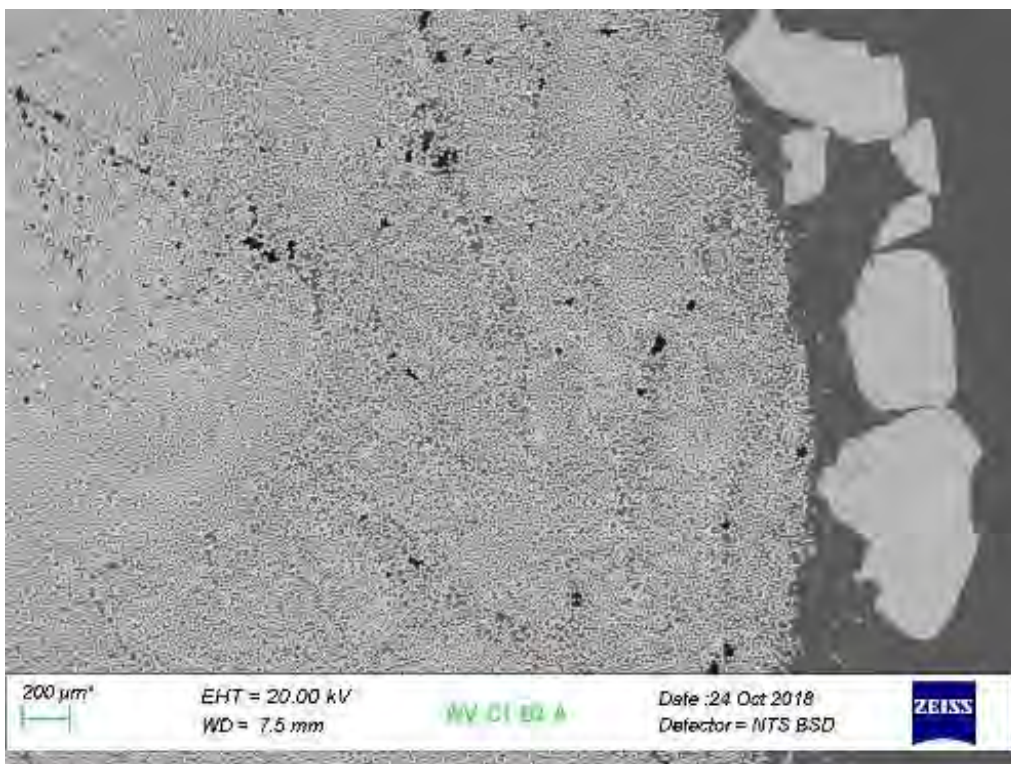
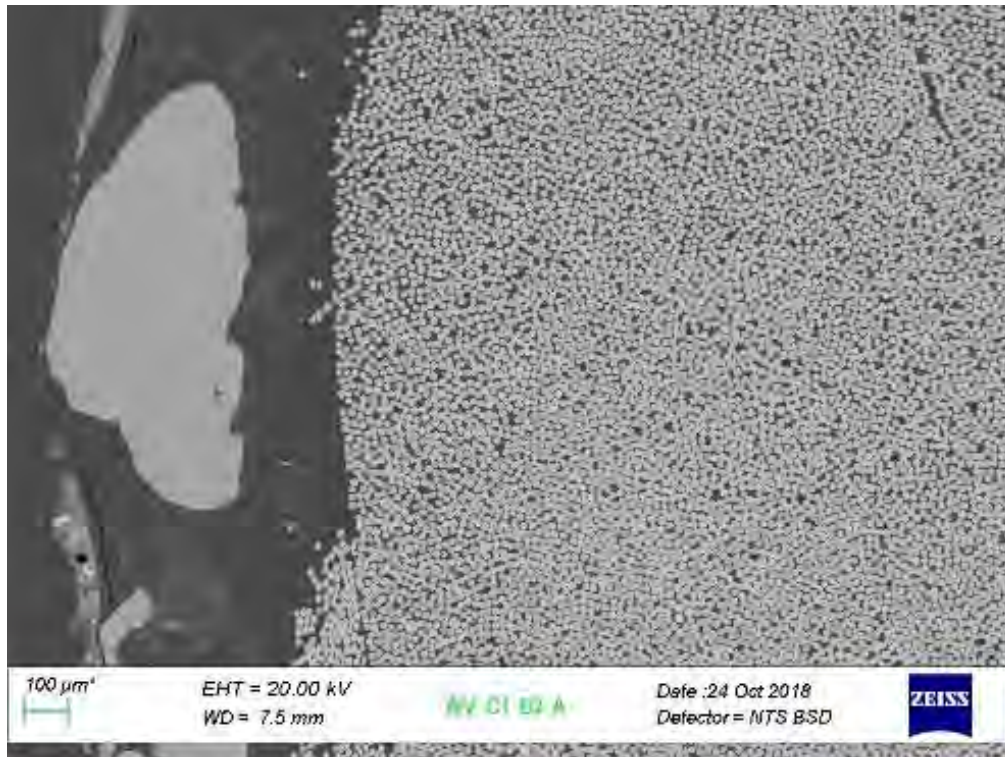
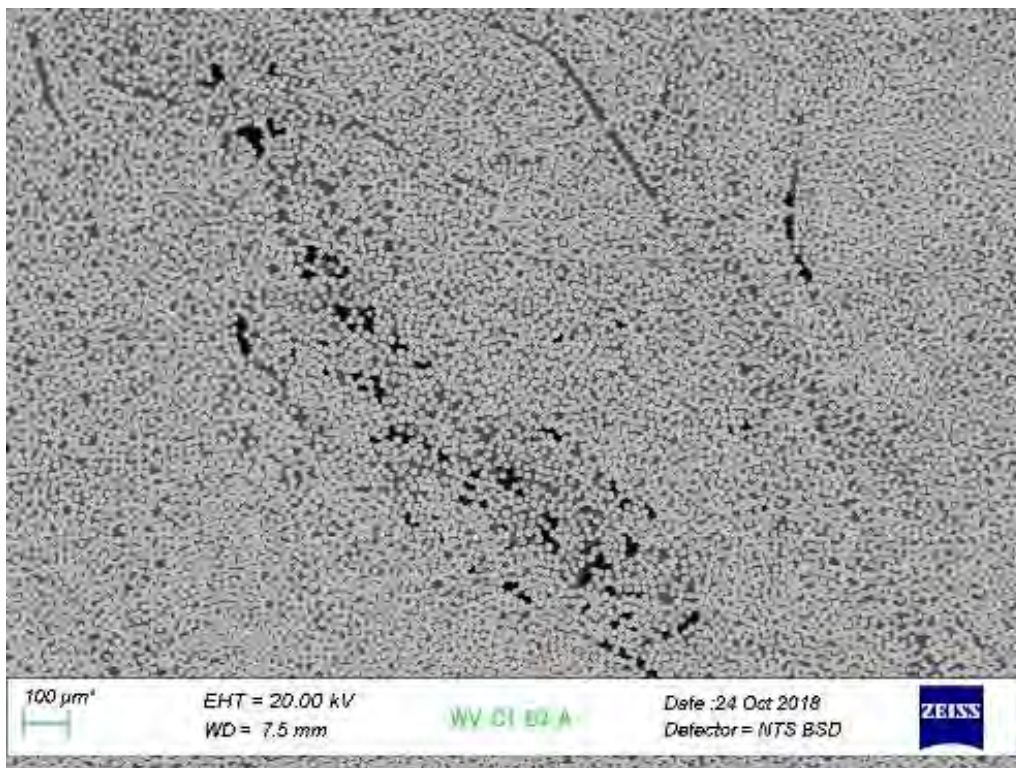
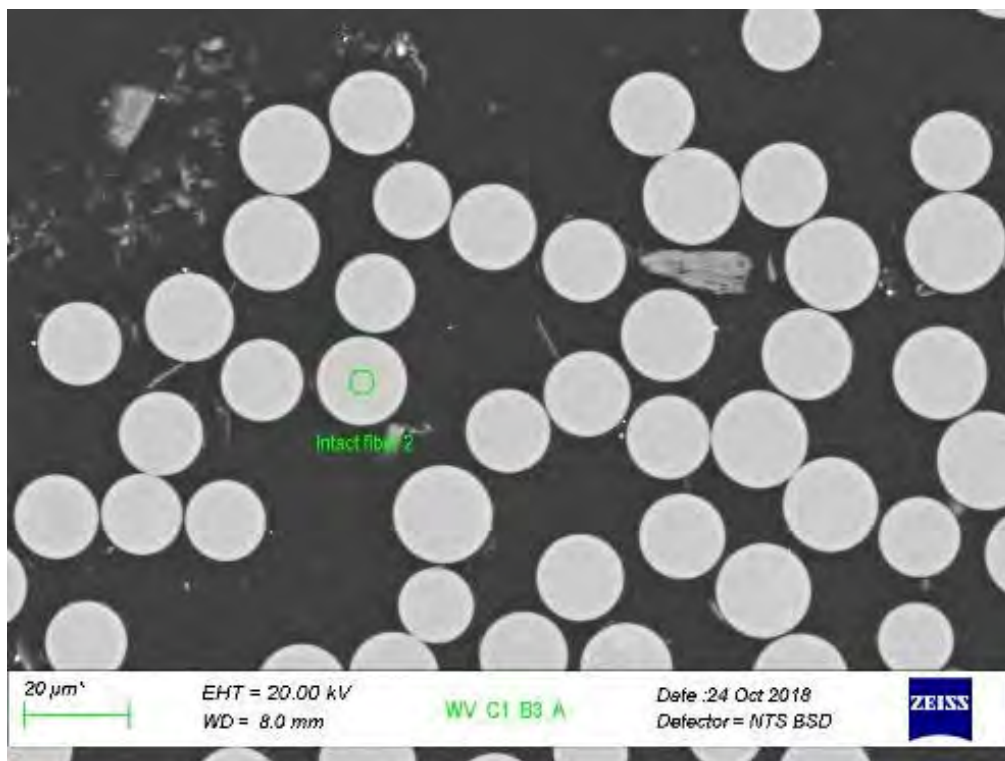
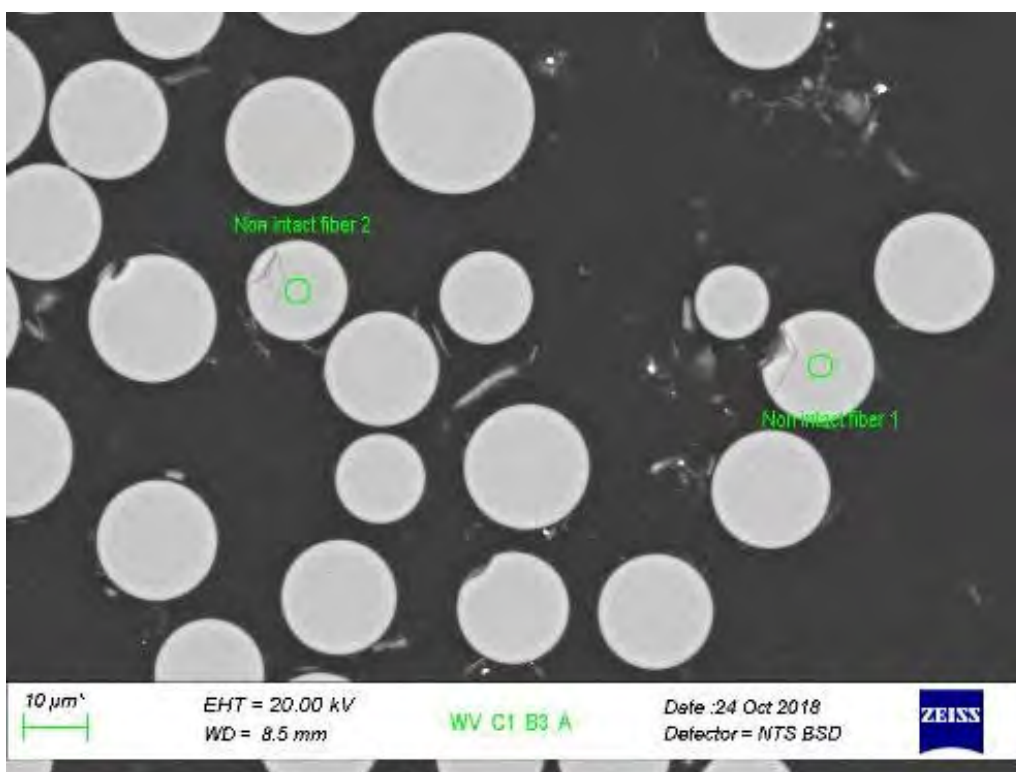
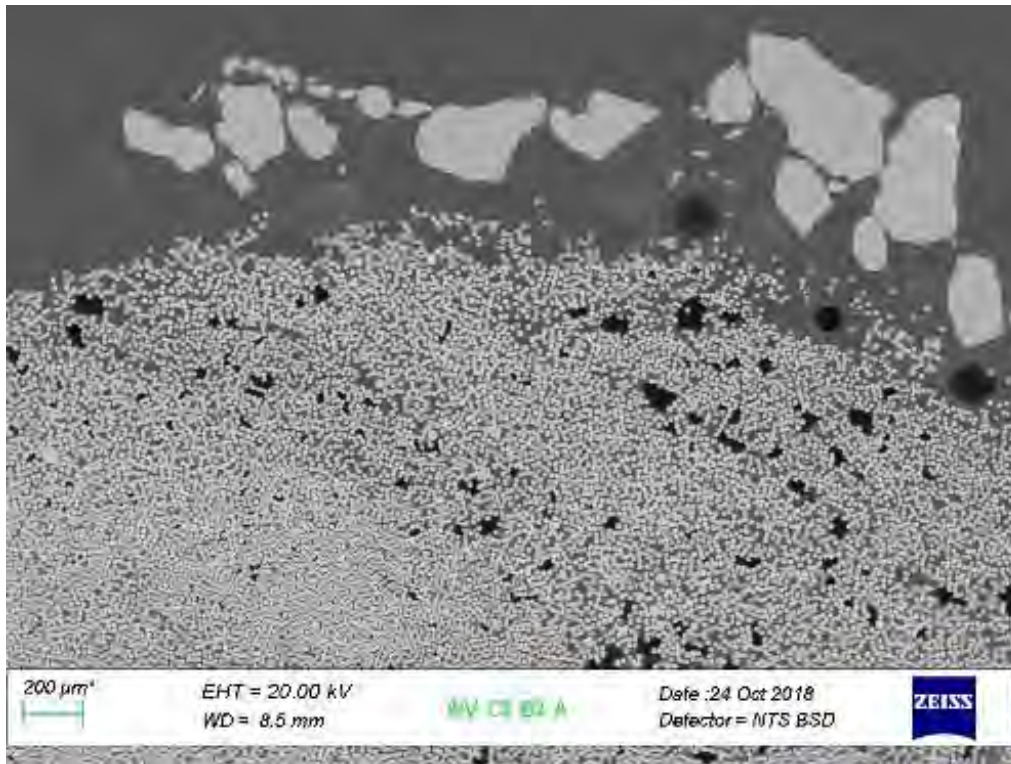
SEM imaging for *McKinleyville Bridge* was performed at Owens Corning. Nearly no negatively affected fibers were observed on the interior or exterior of in-service rebar. The few negatively affected fibers appear to have physical damage from specimen preparation as they are near resin voids. The SEM images of each bar is shown in Fig. 36 through Fig. 80.
