FINAL PROJECT REPORT #00059416

Durability of GFRP Bar Reinforcement Extracted from In-service Concrete Structures

Participating Consortium Member:
Missouri University of Science and Technology

RE-CAST:
REsearch on Concrete Applications for
Sustainable Transportation
Tier 1 University Transportation Center

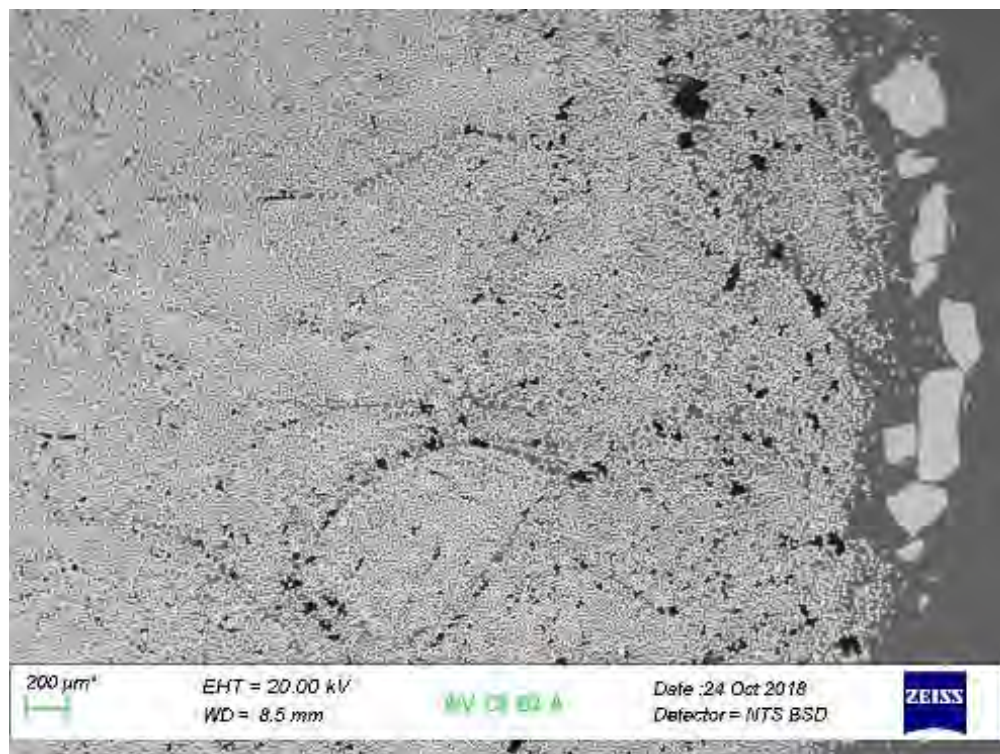
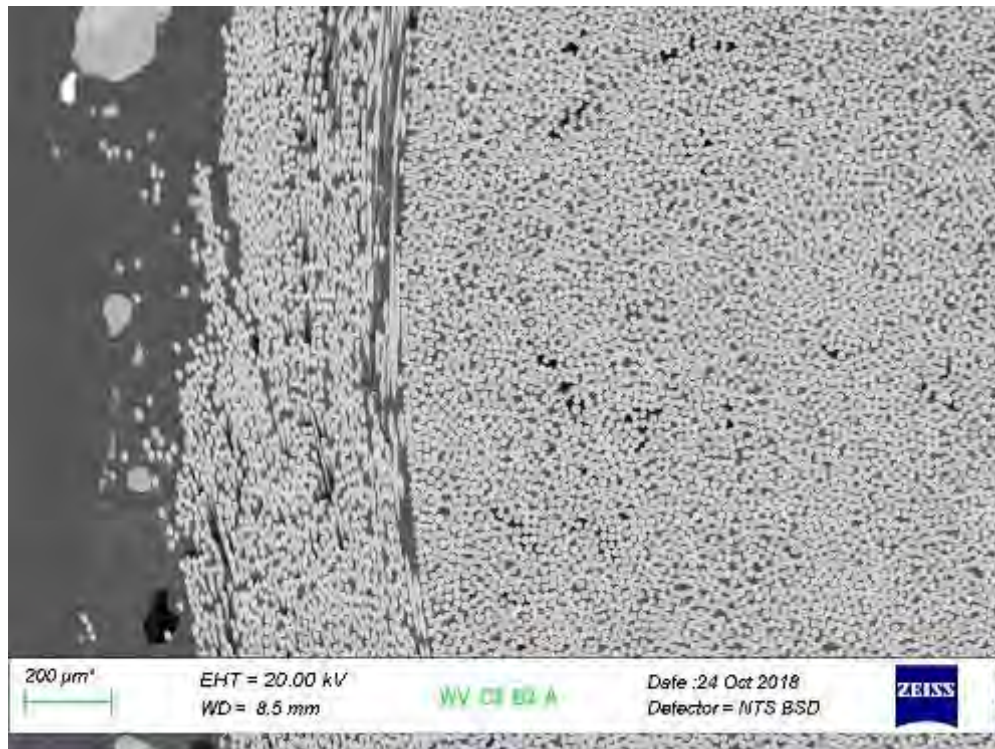
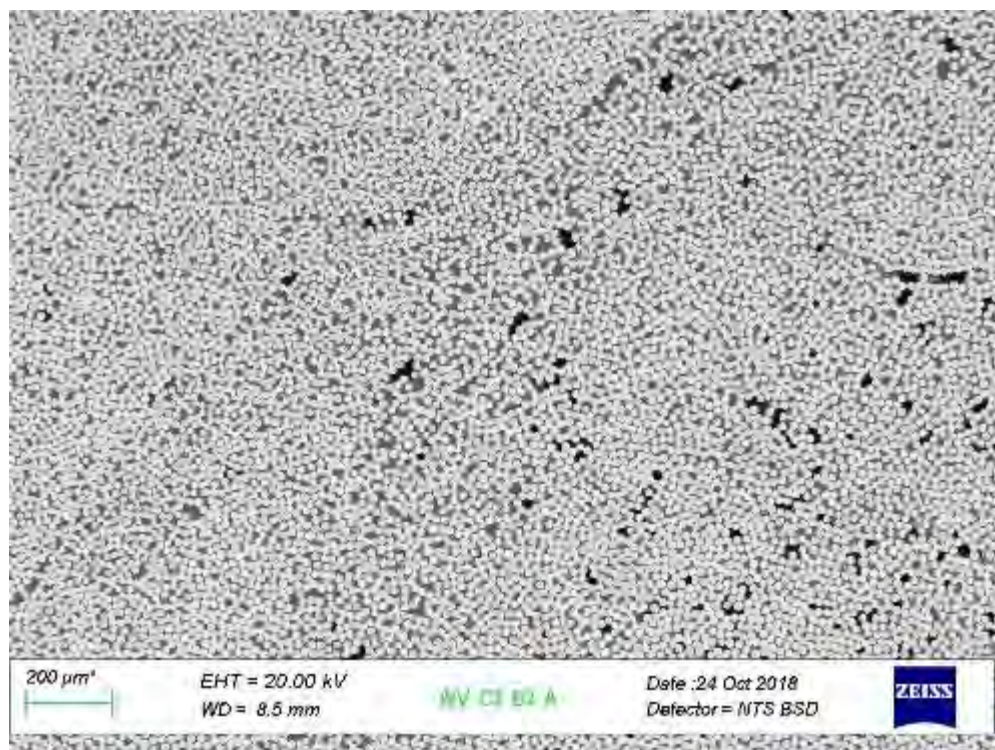
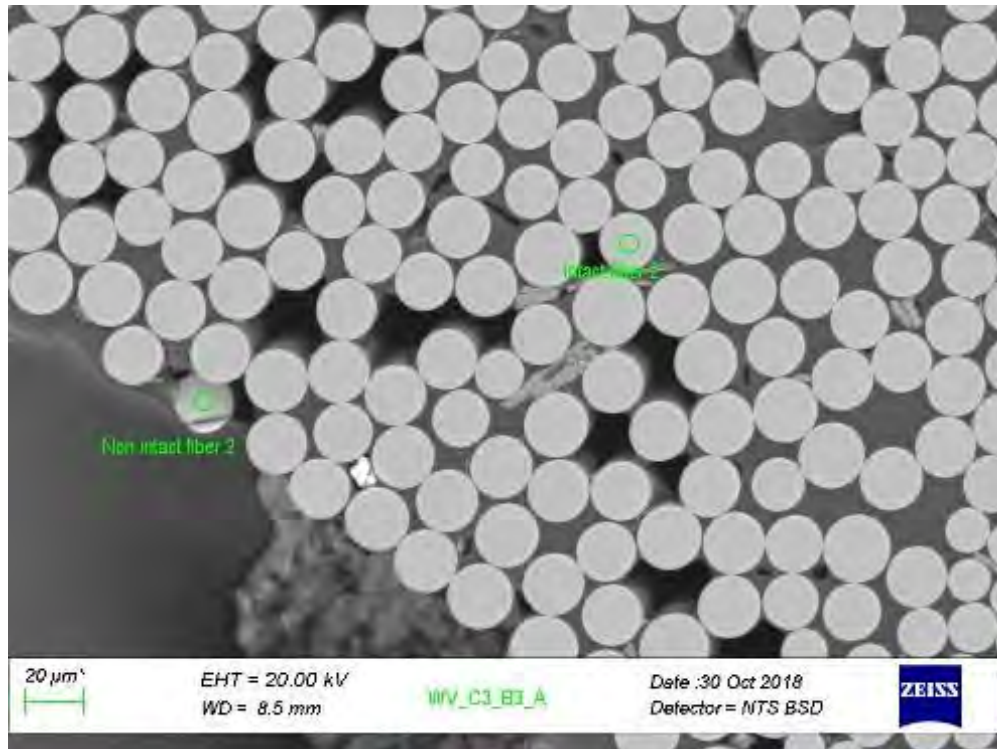
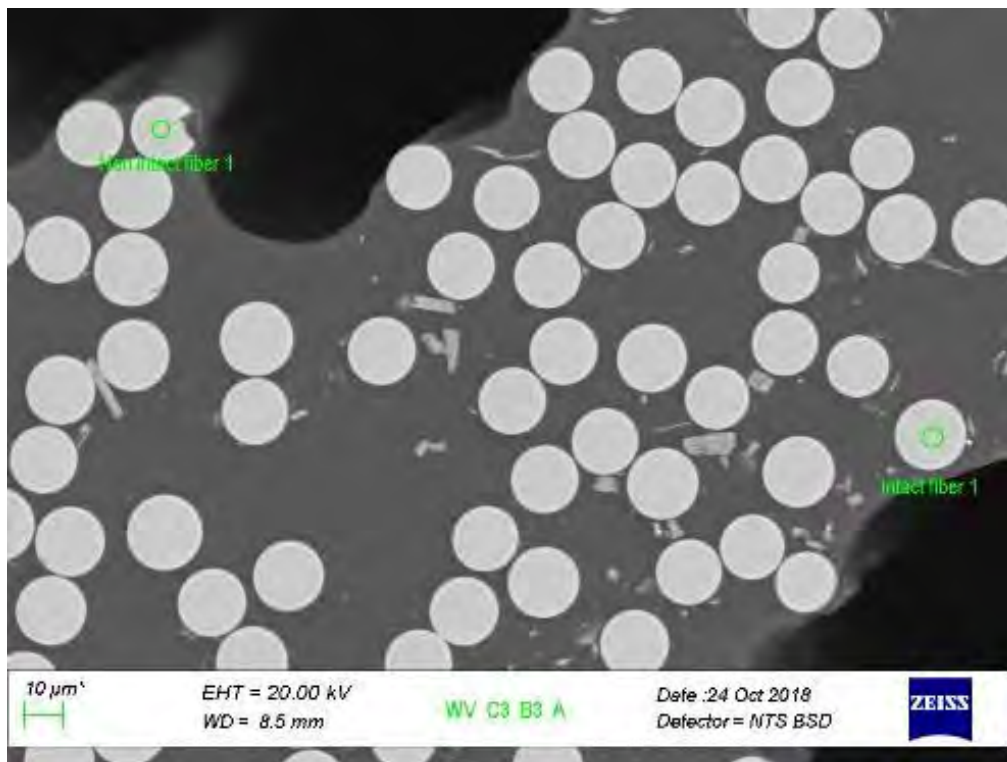
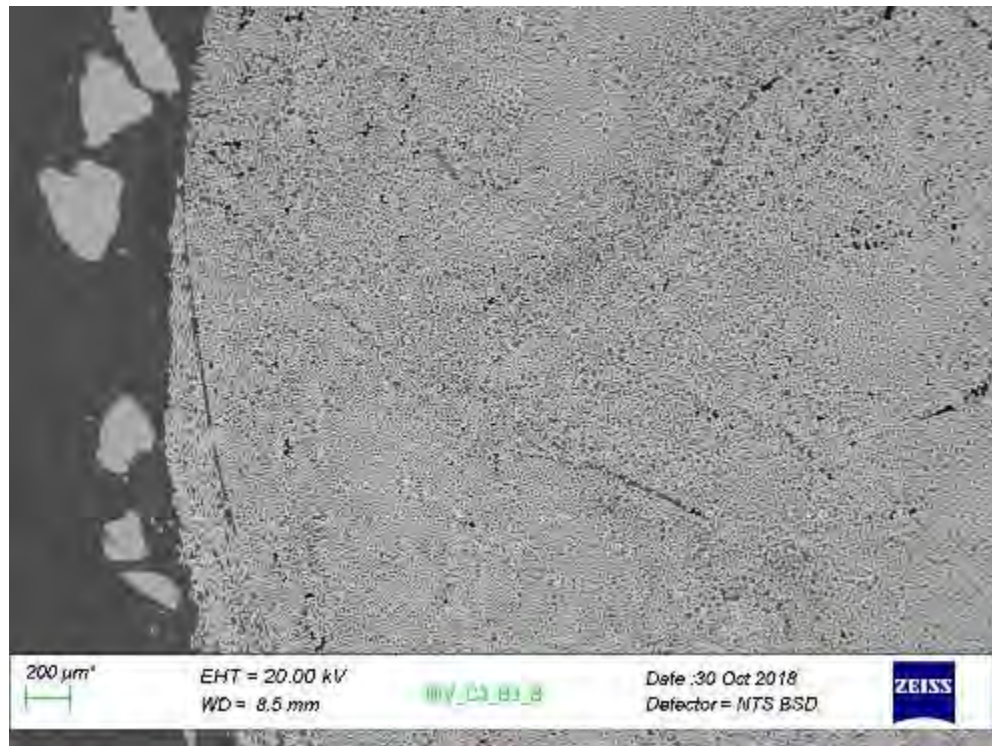
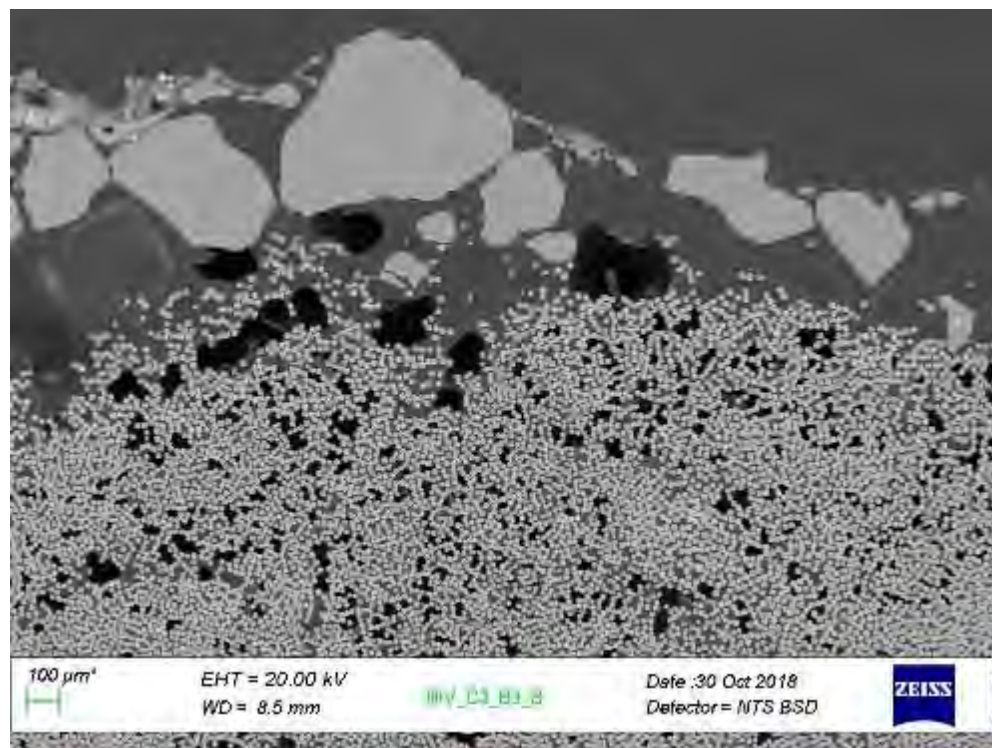
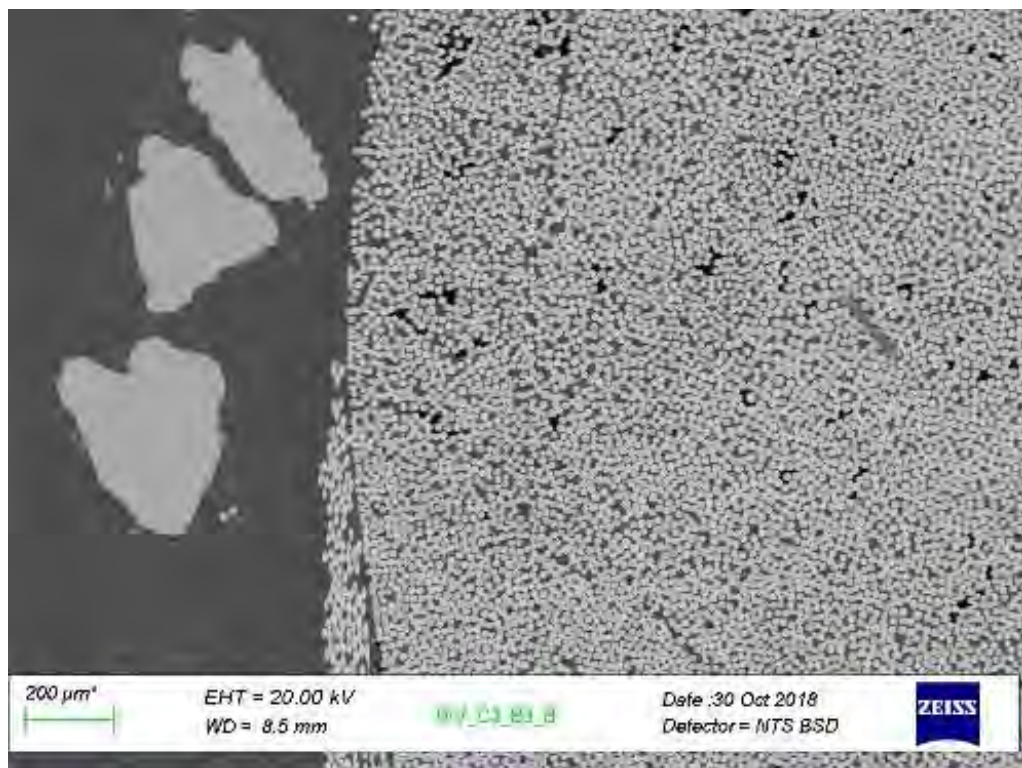
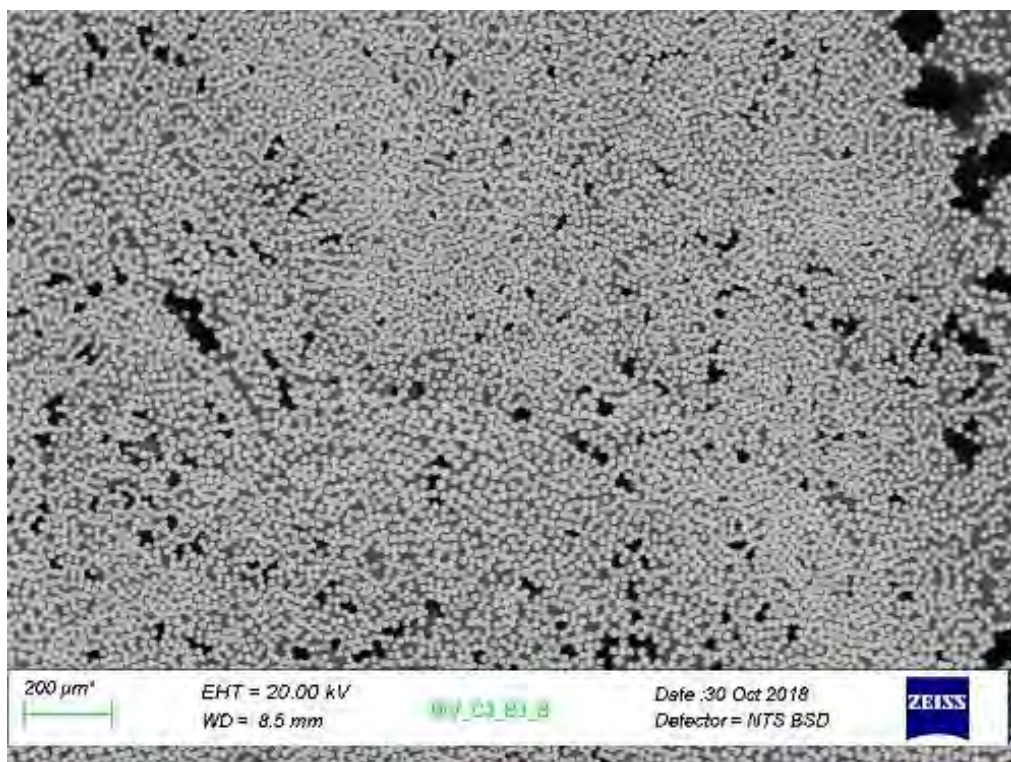
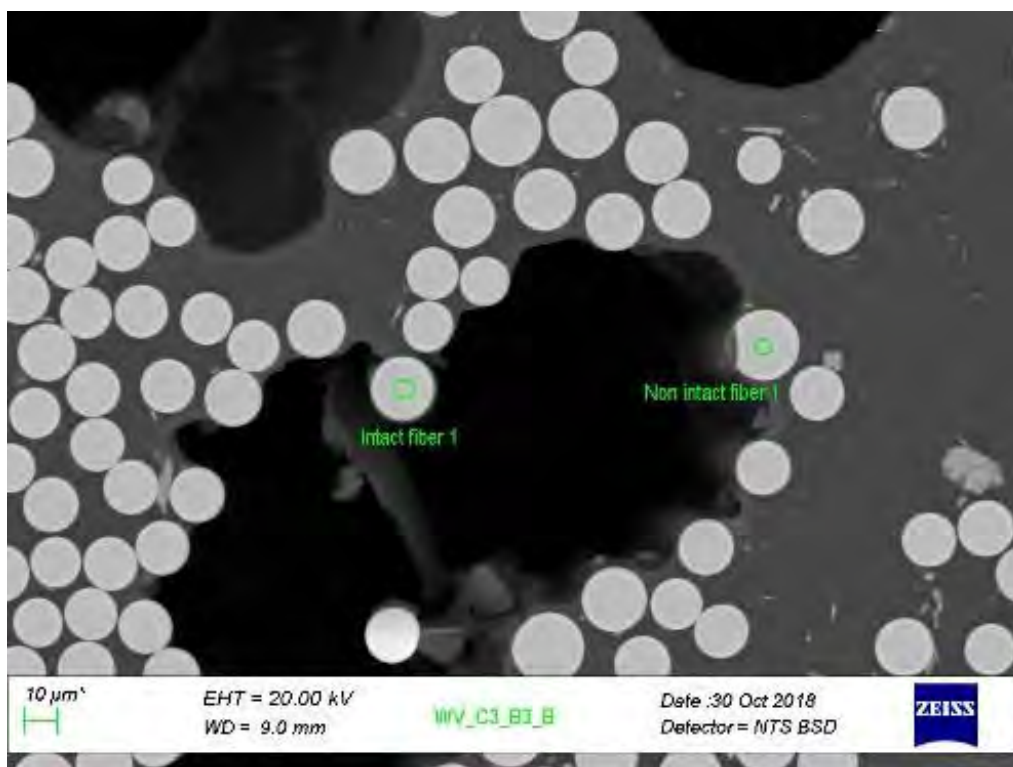
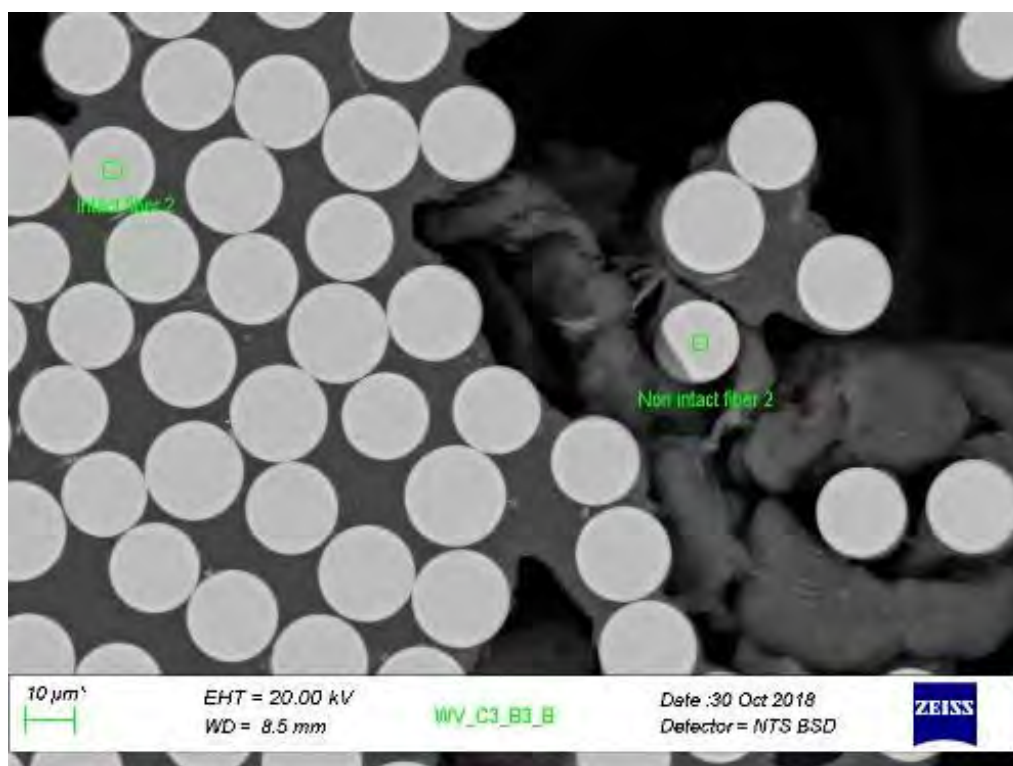
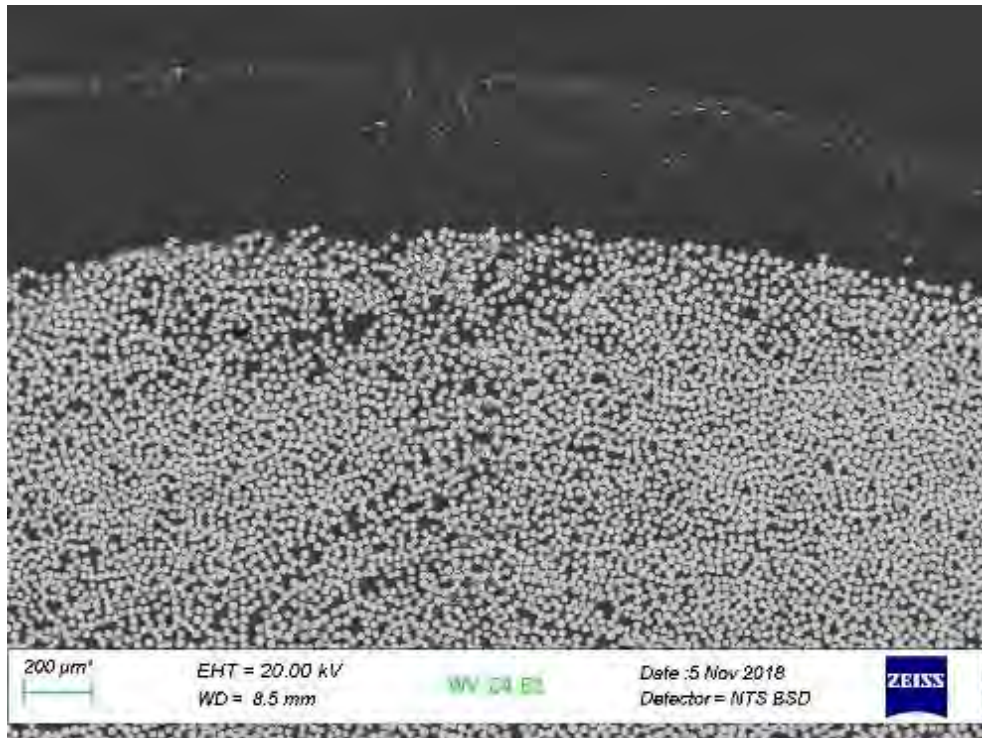
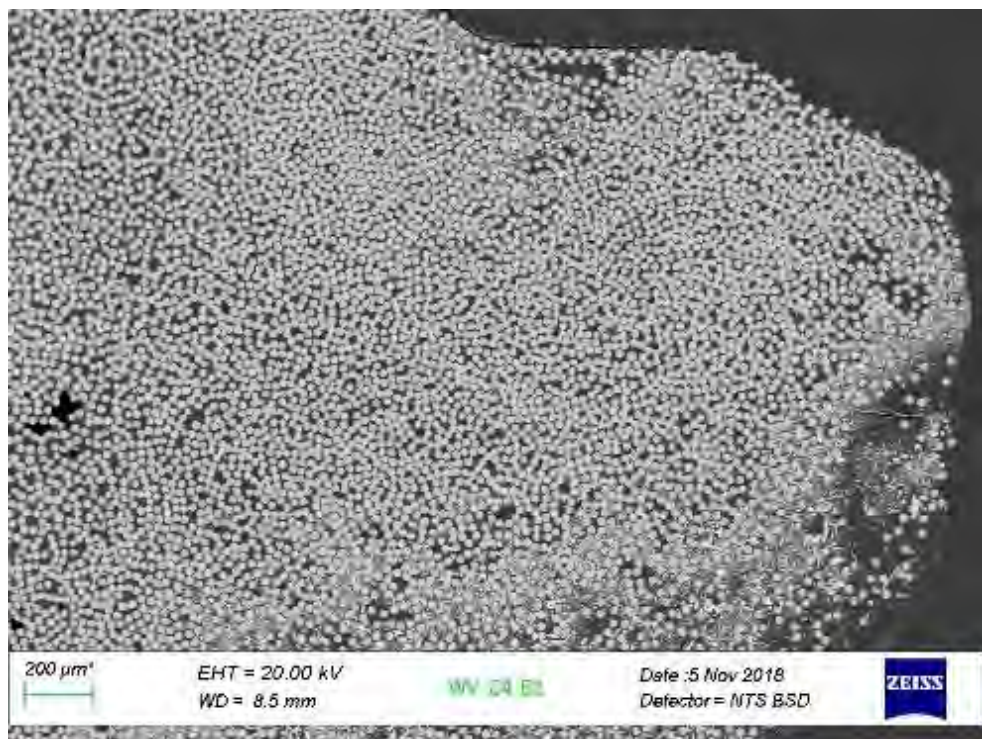
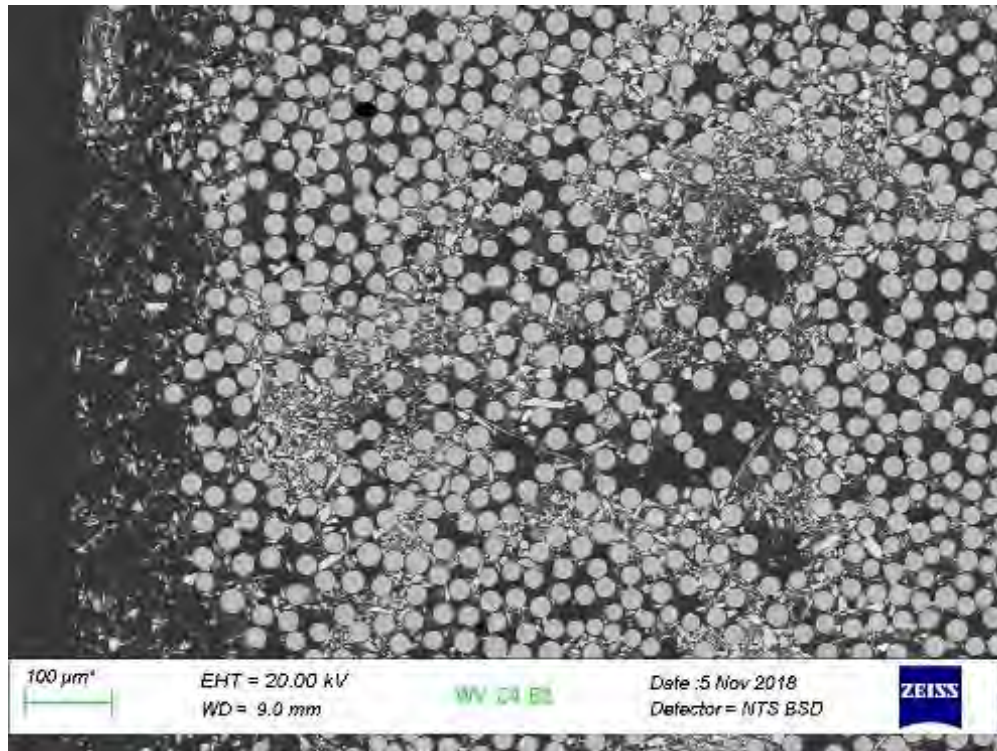
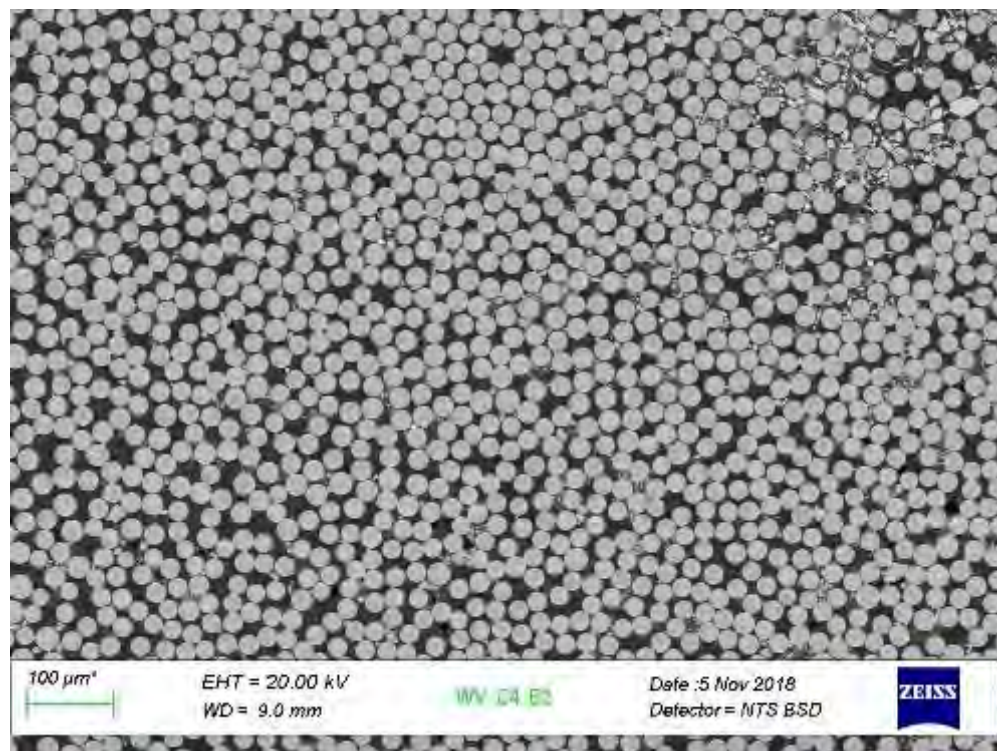
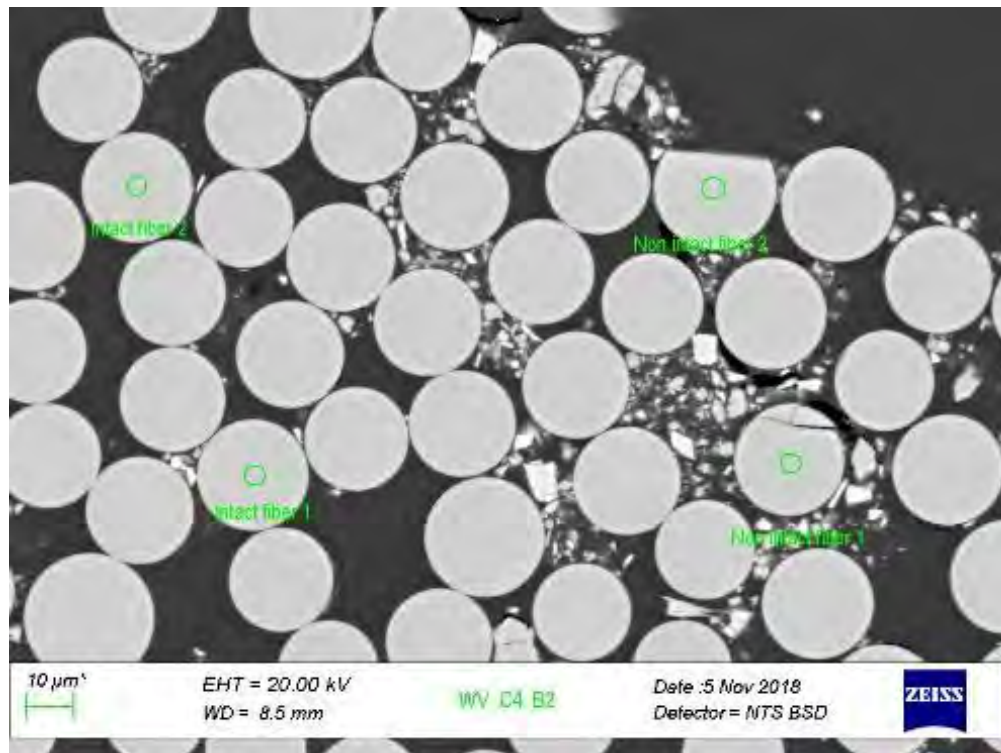
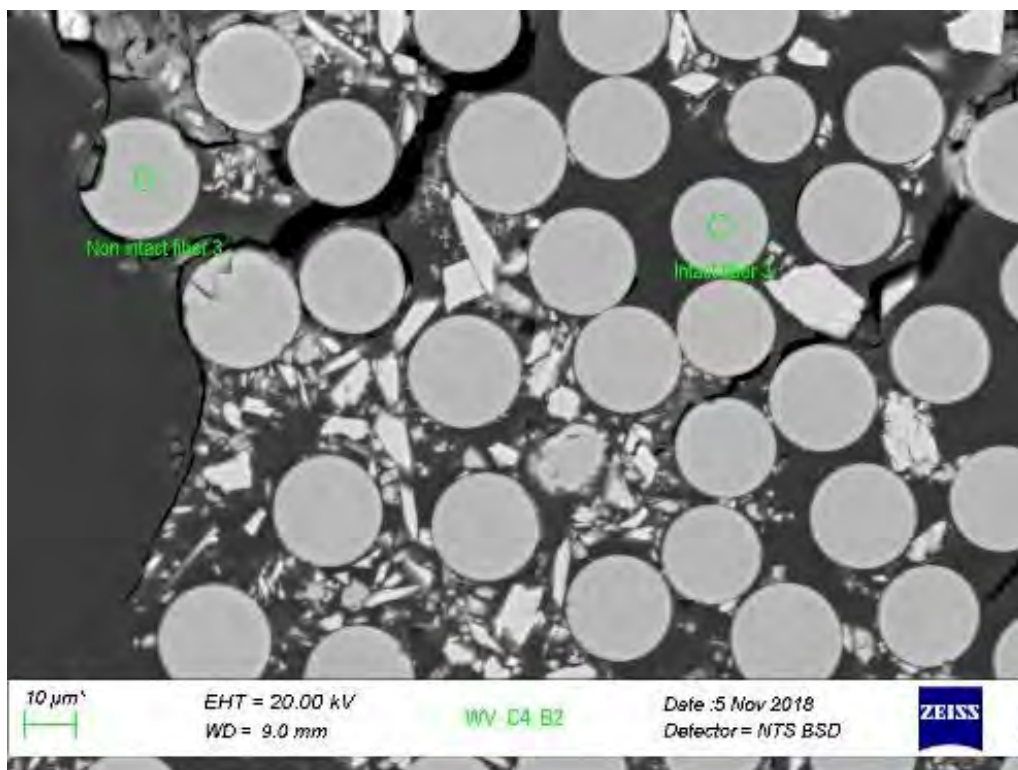
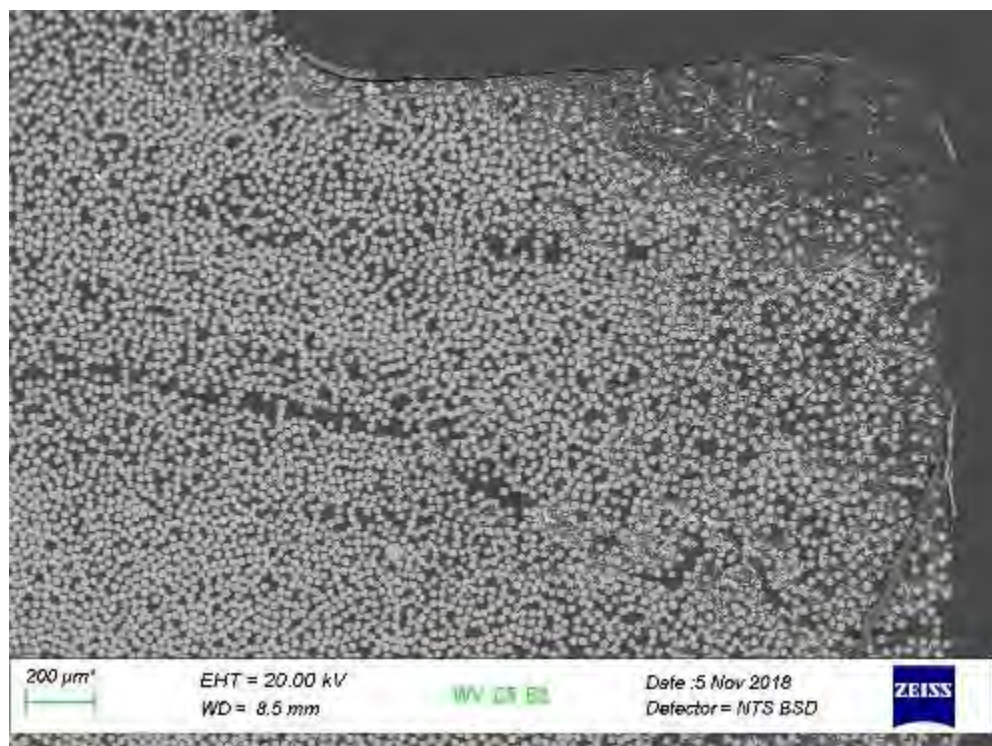
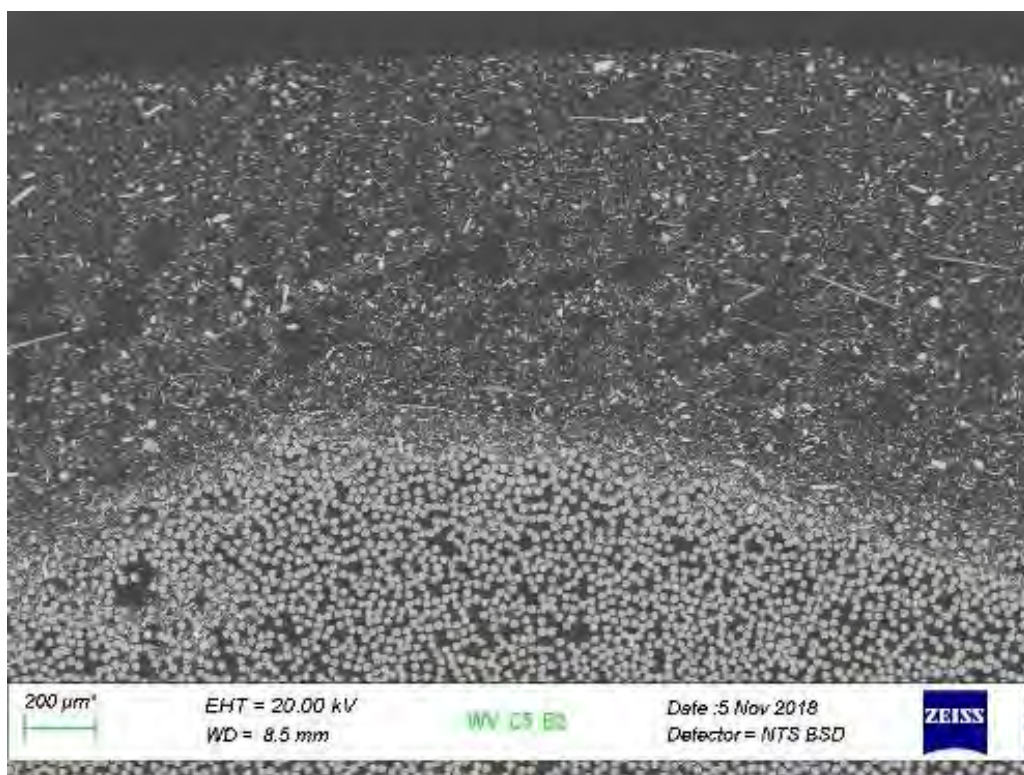
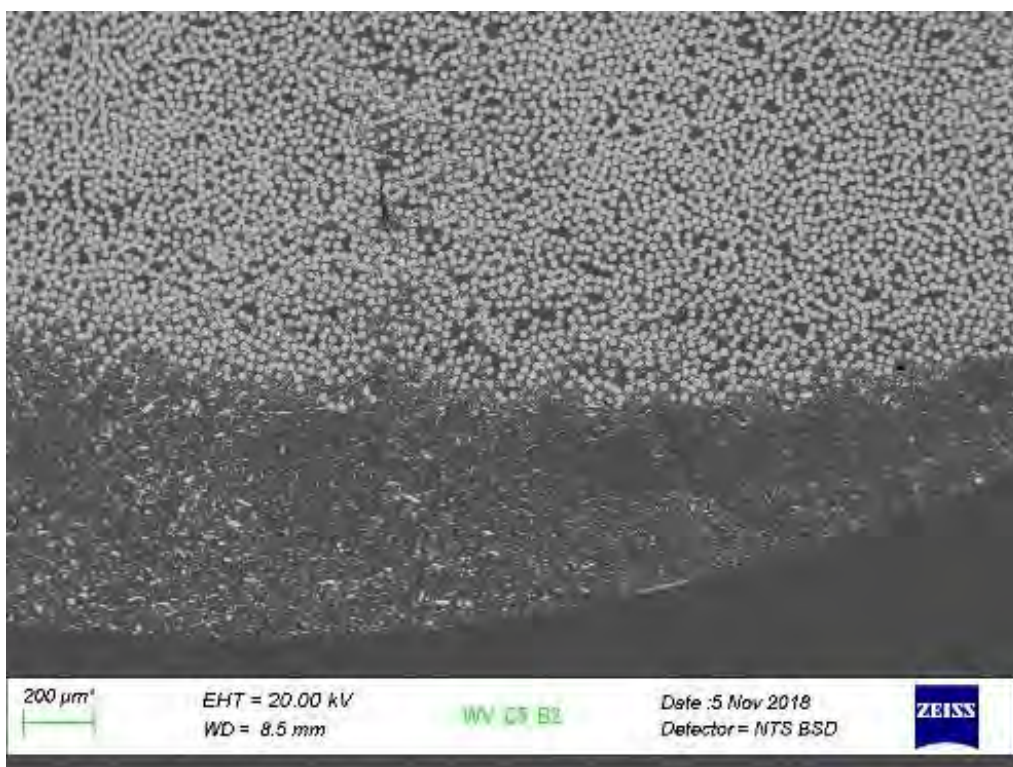
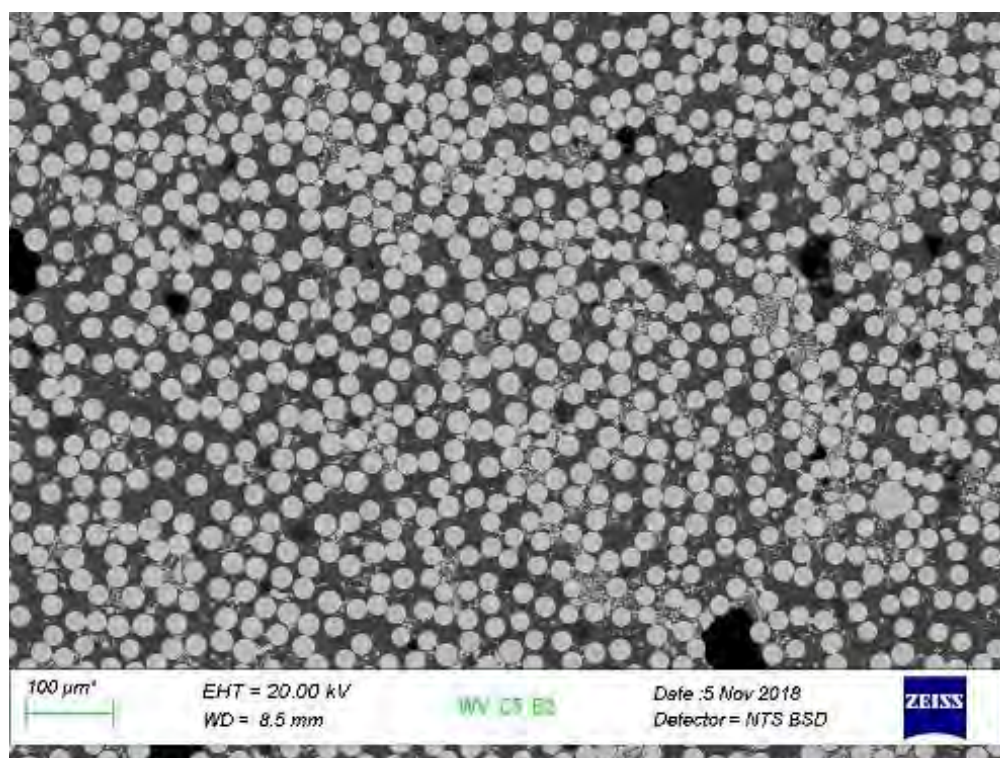
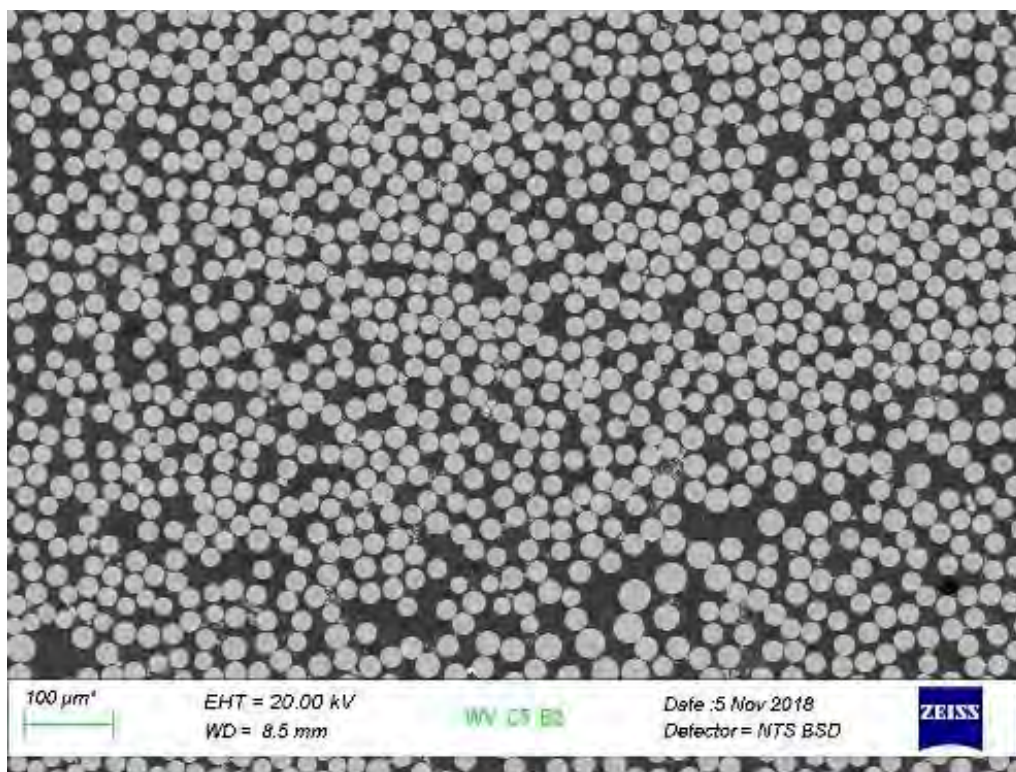
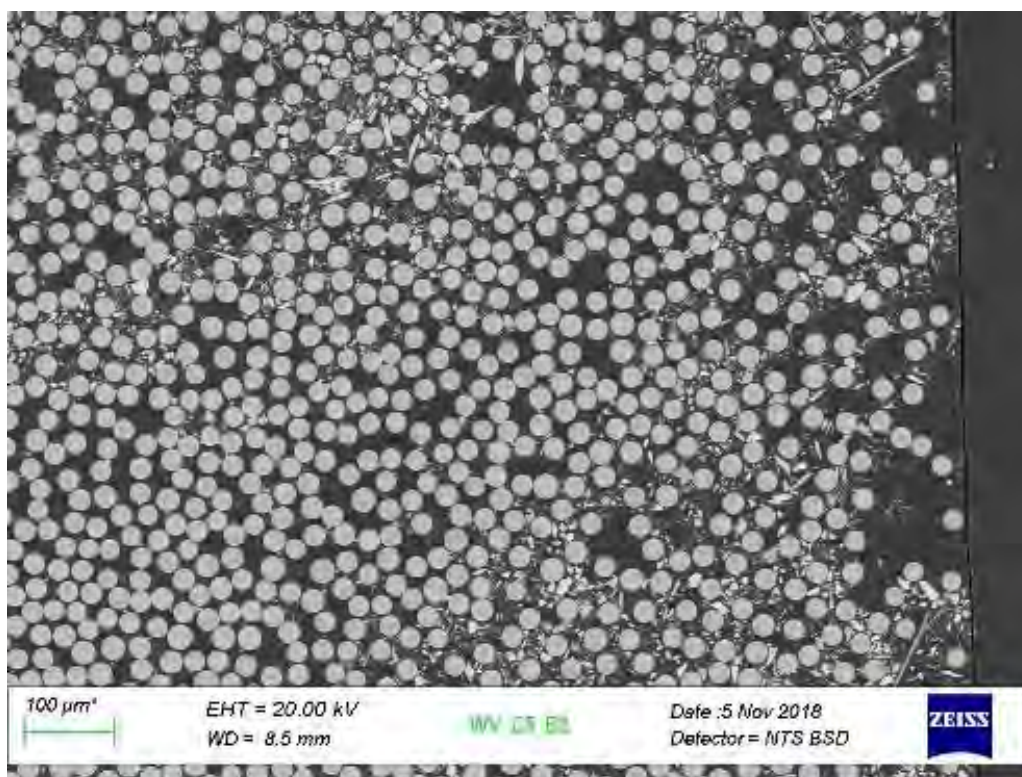
SEM imaging for *McKinleyville Bridge* was performed at Owens Corning. Nearly no negatively affected fibers were observed on the interior or exterior of in-service rebar. The few negatively affected fibers appear to have physical damage from specimen preparation as they are near resin voids. The SEM images of each bar is shown in Fig. 36 through Fig. 80.
