FINAL PROJECT REPORT #00059416

Durability of GFRP Bar Reinforcement Extracted from In-service Concrete Structures

Participating Consortium Member:
Missouri University of Science and Technology

RE-CAST:
REsearch on Concrete Applications for
Sustainable Transportation
Tier 1 University Transportation Center

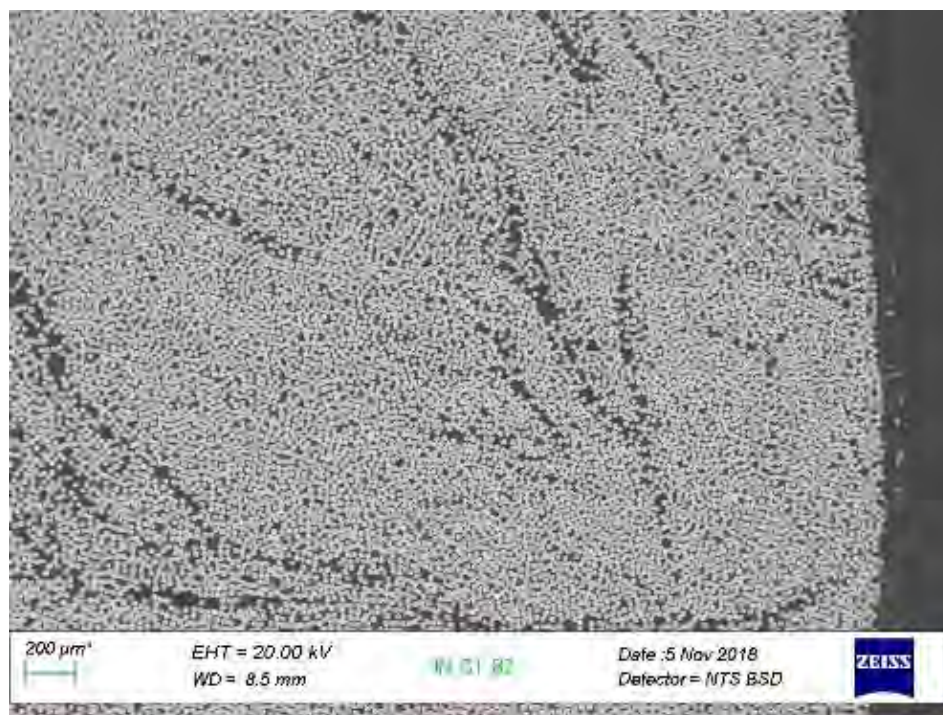
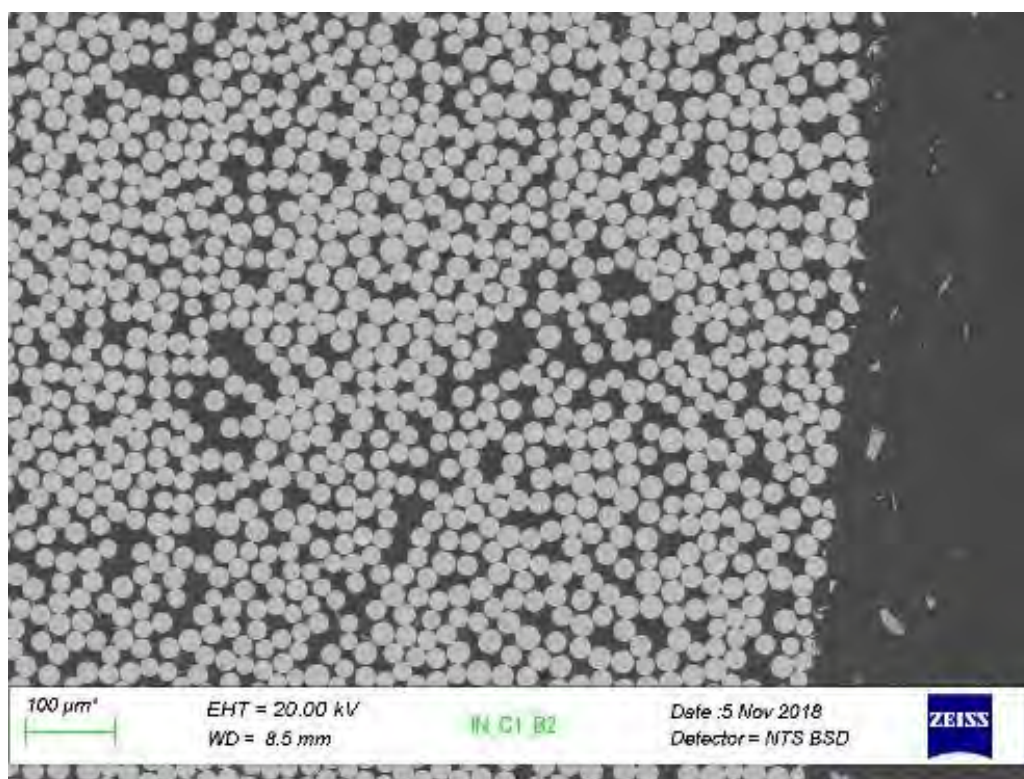
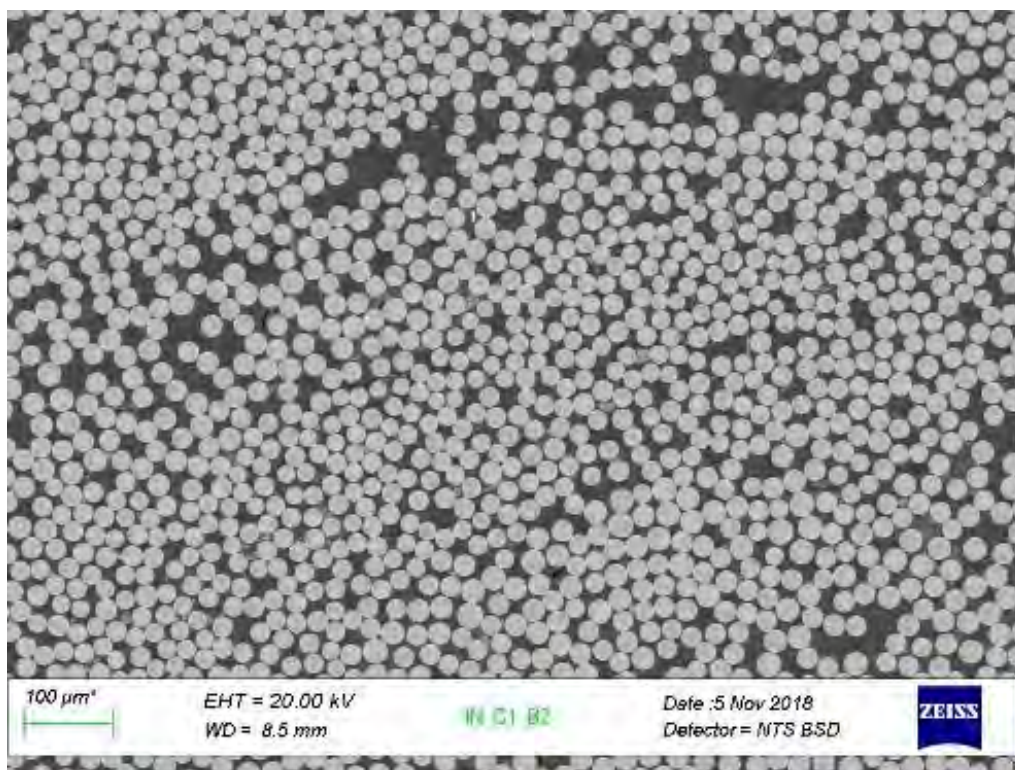
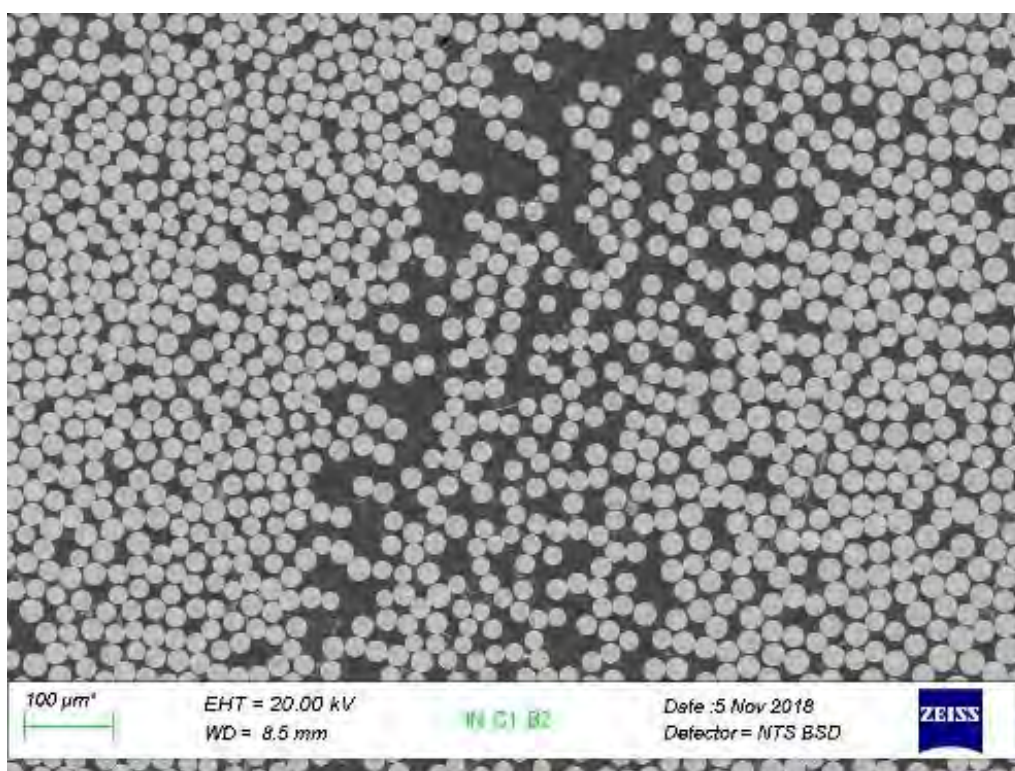
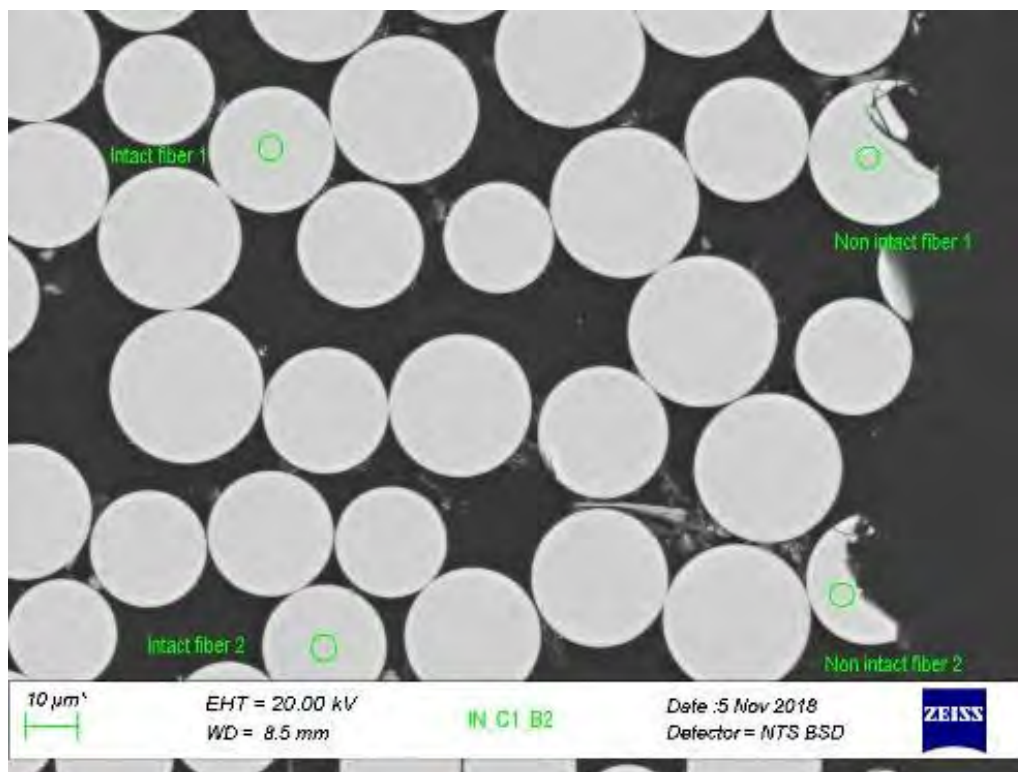
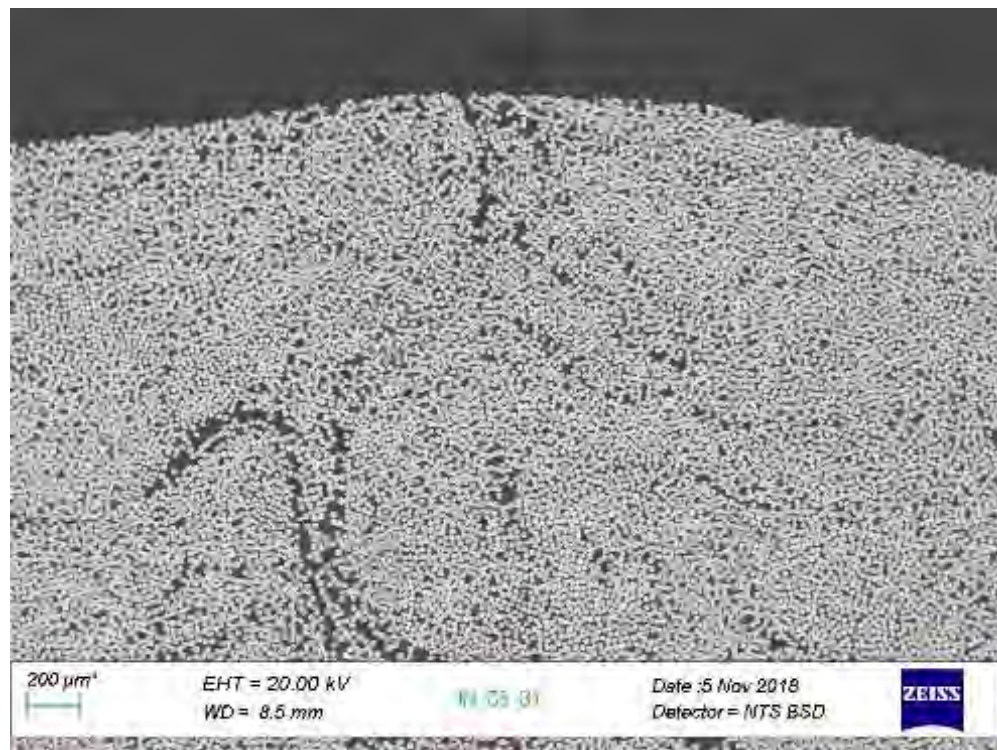
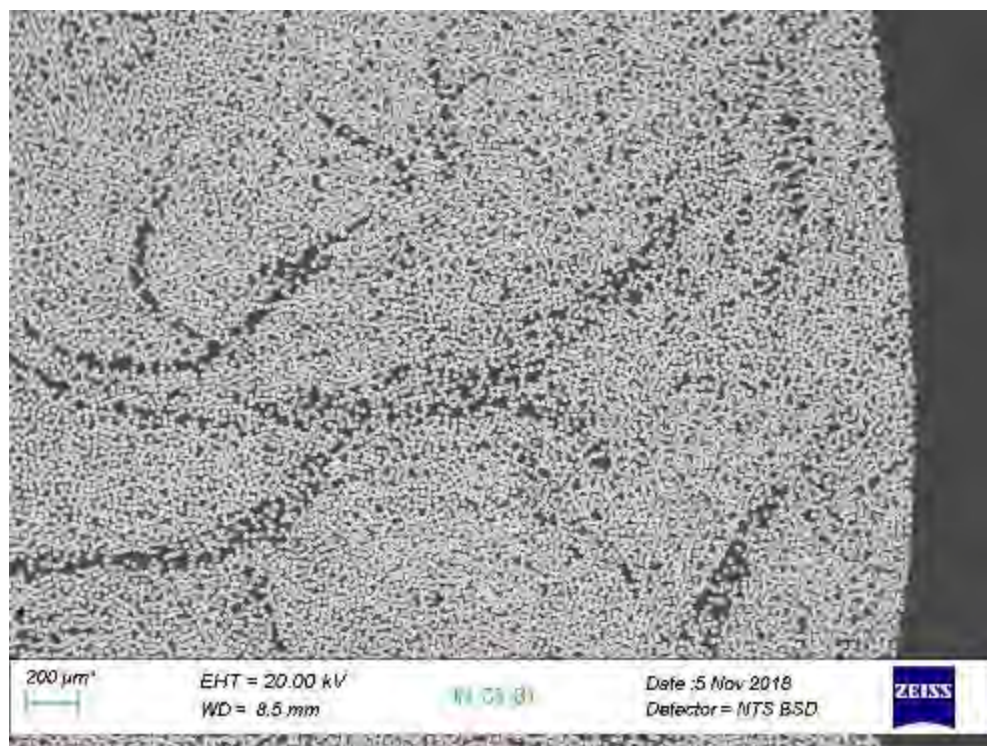
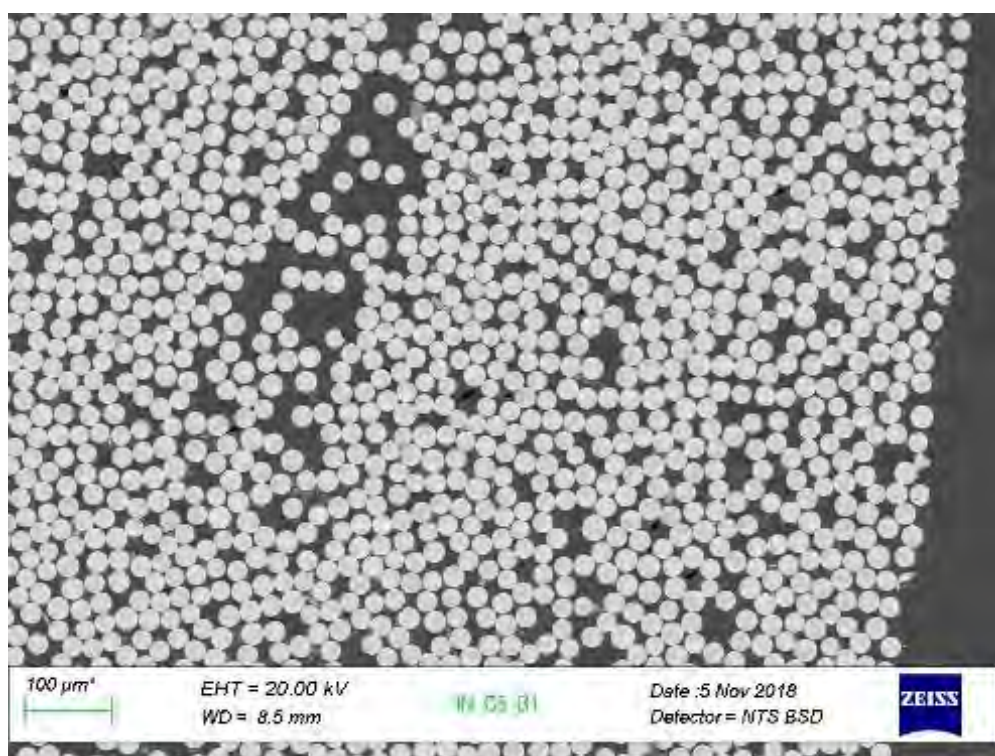
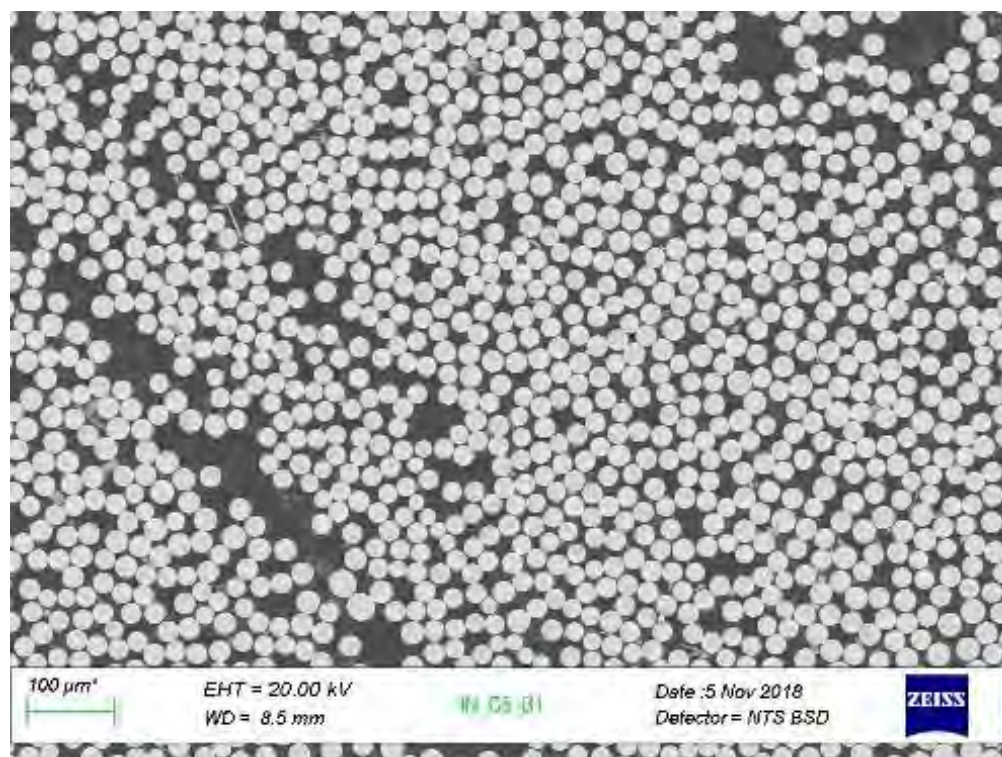
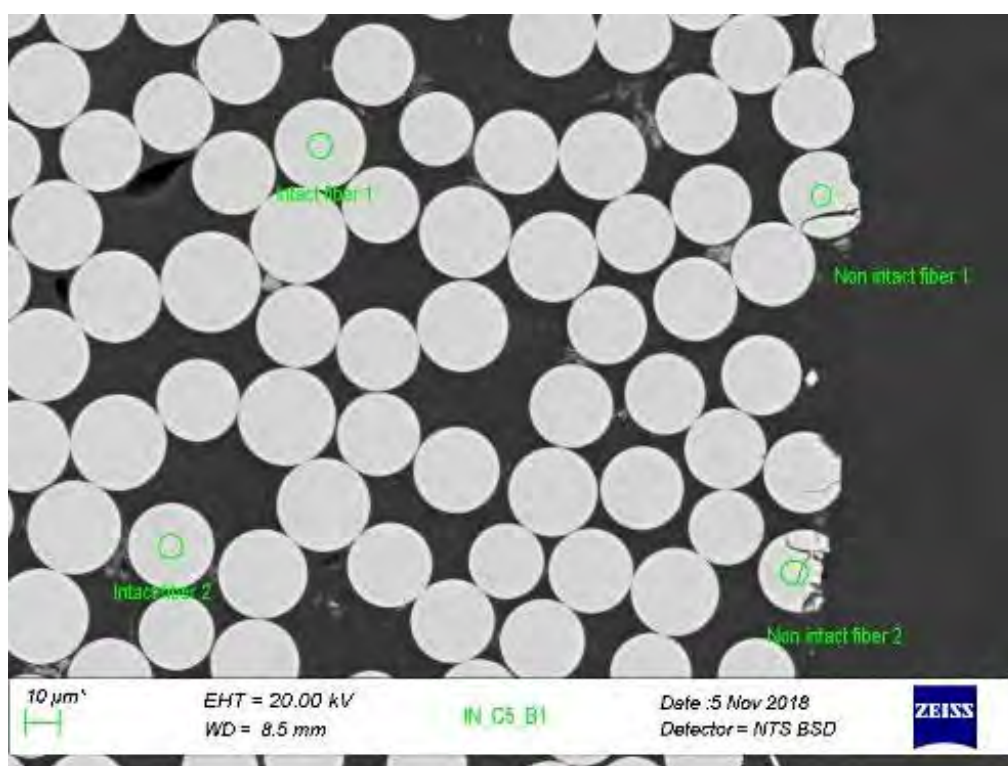
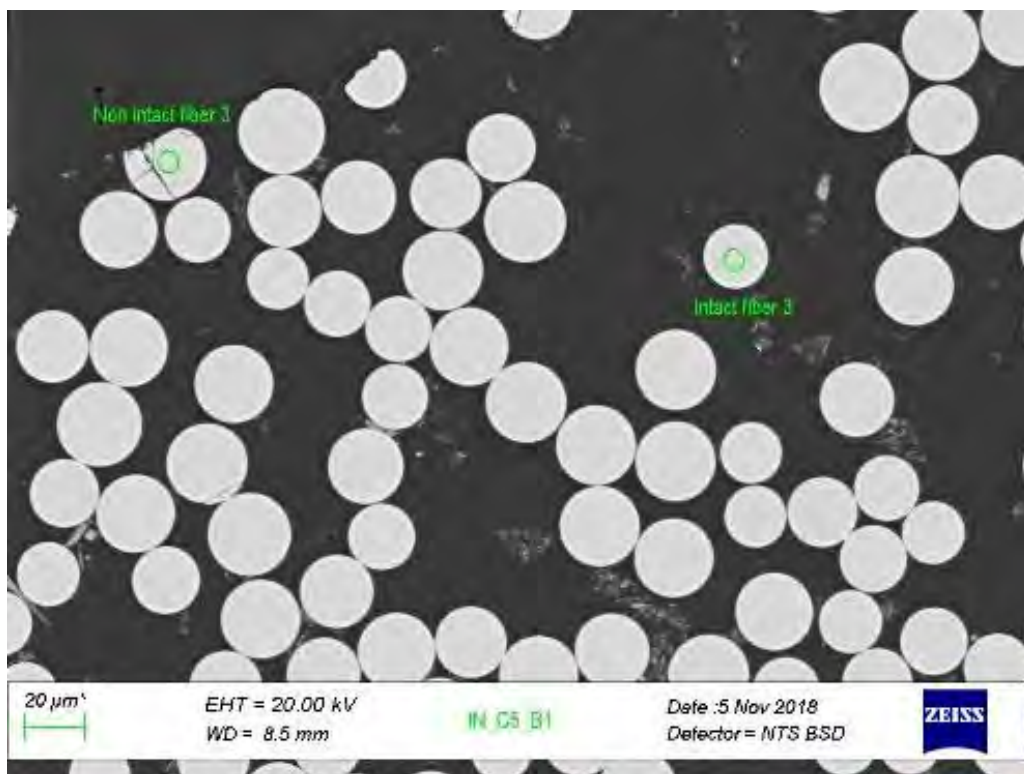
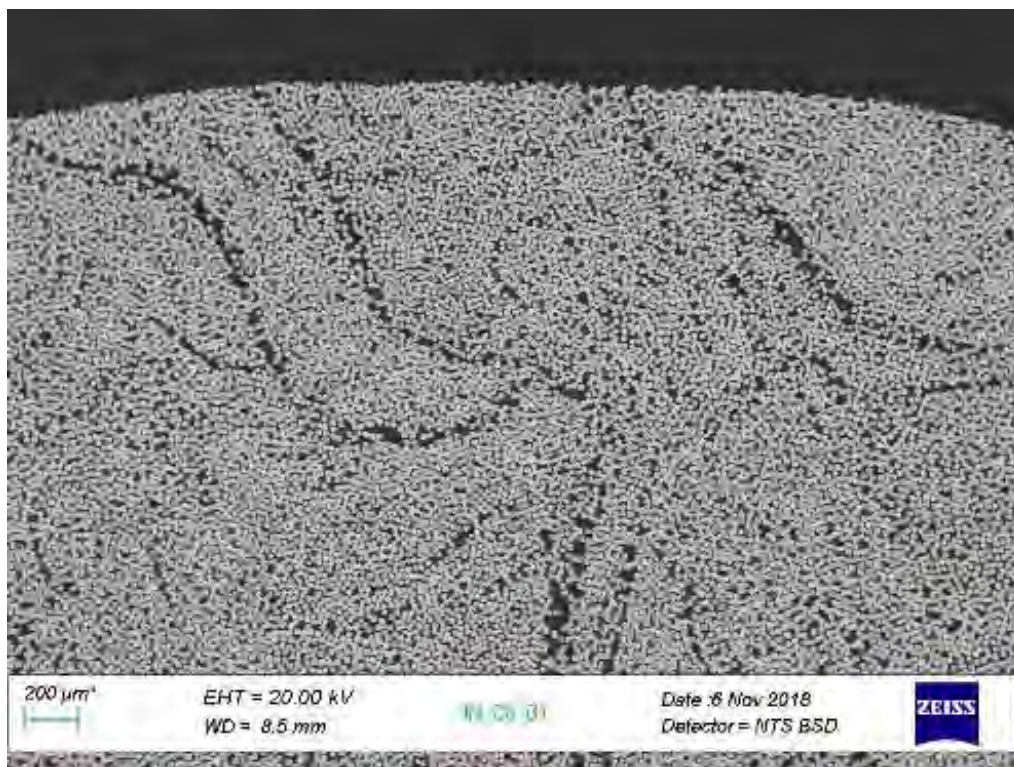
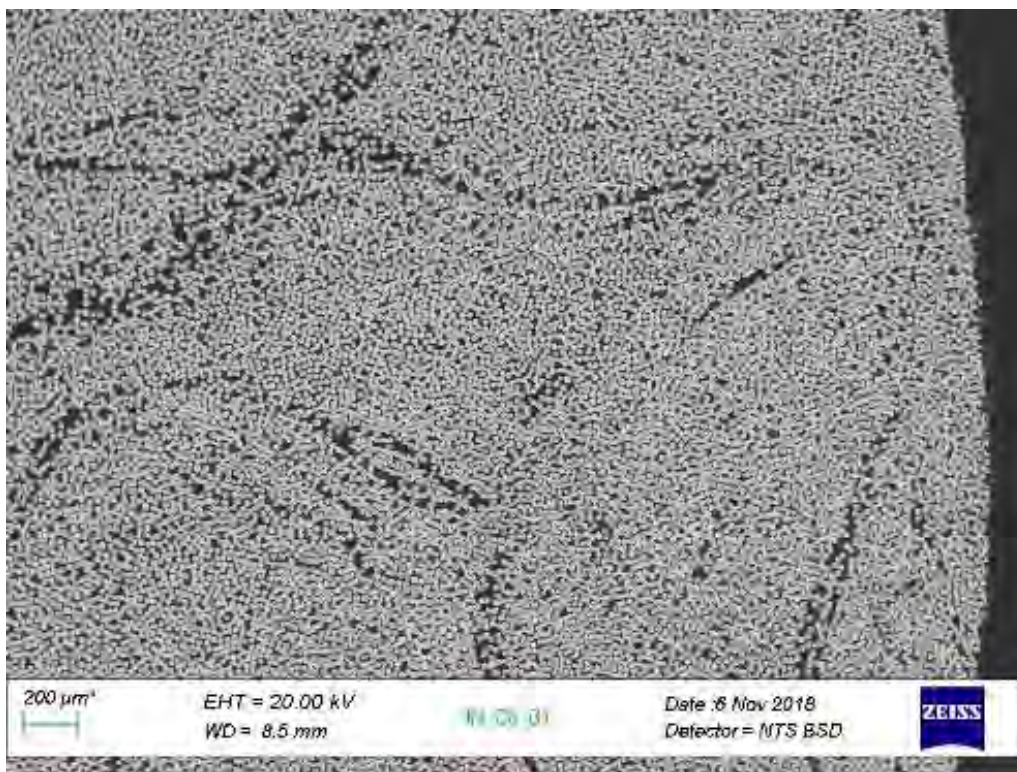
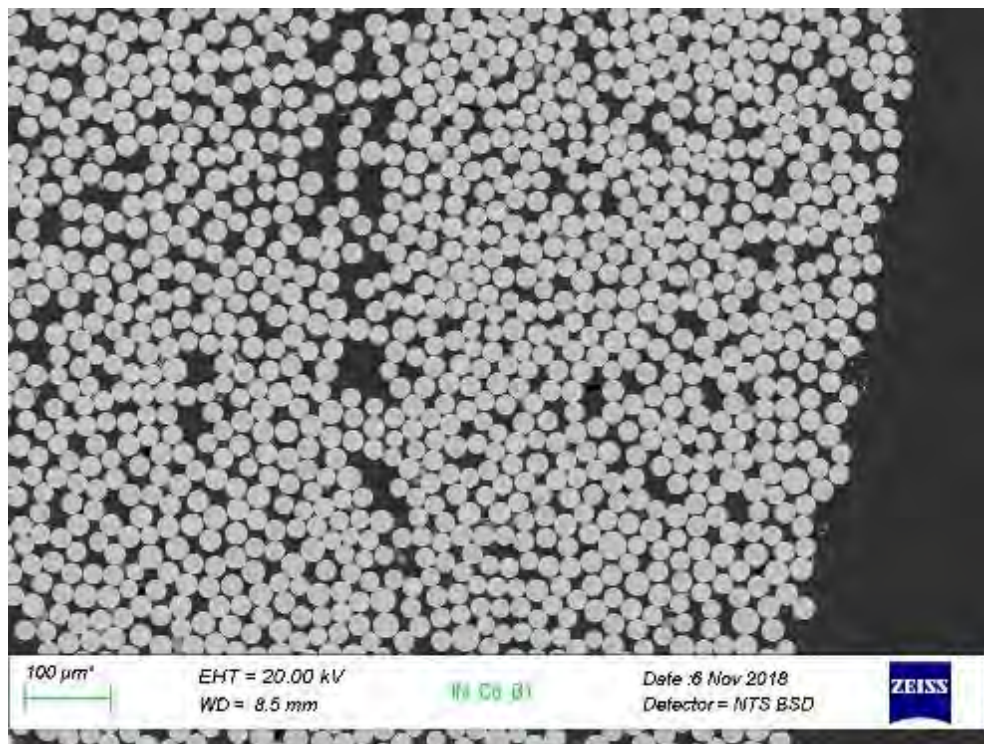
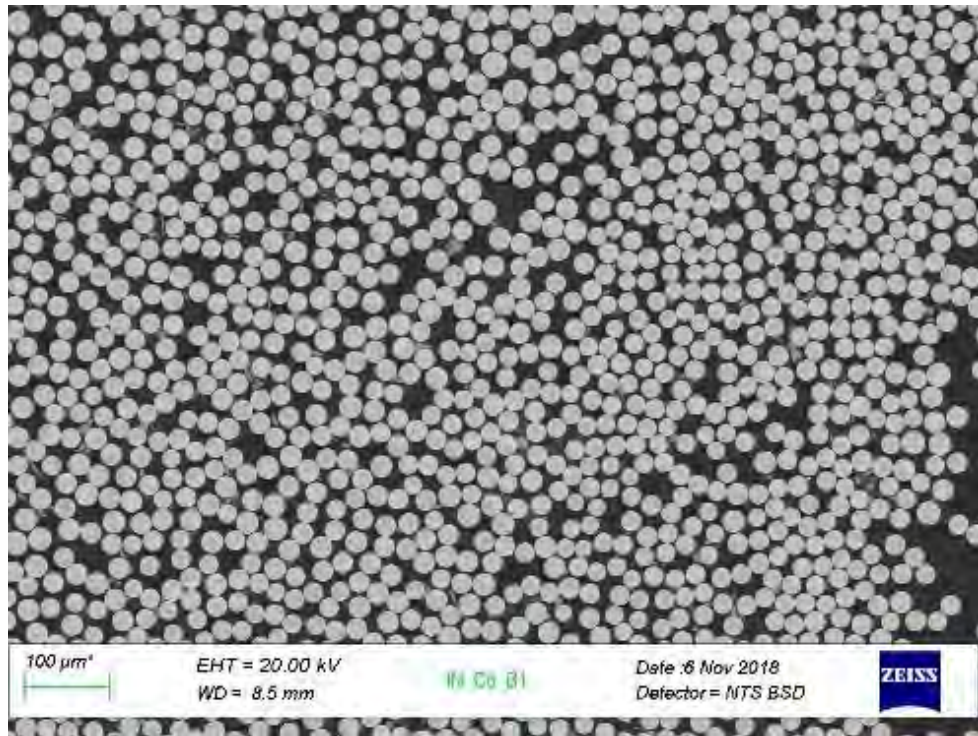
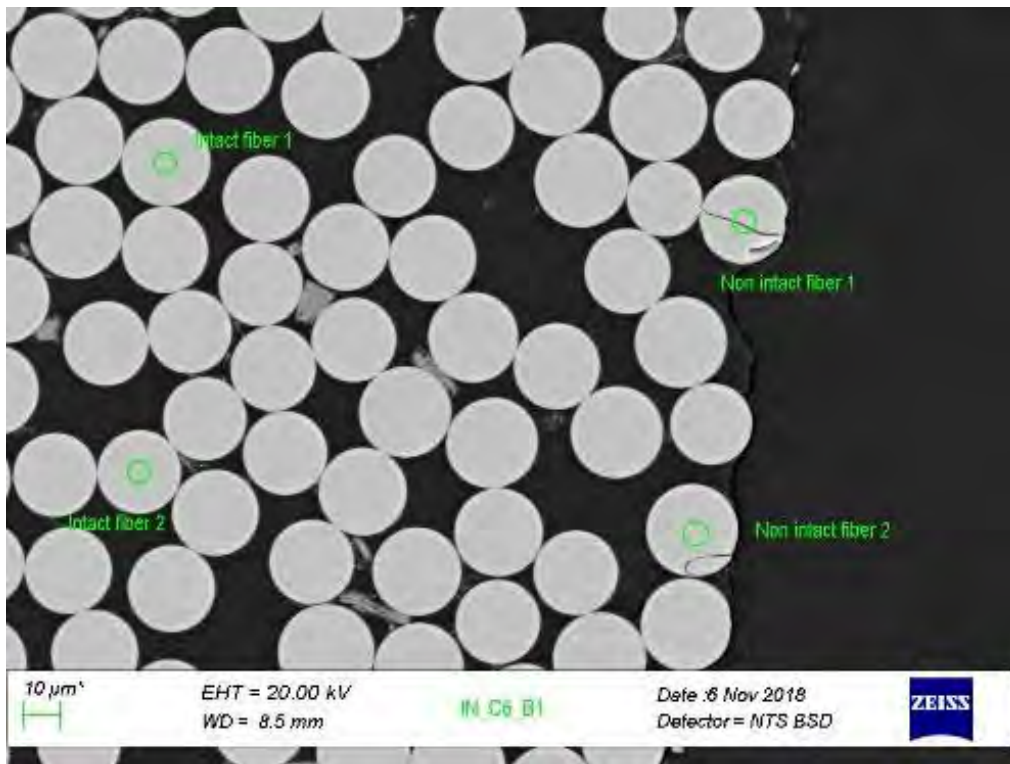
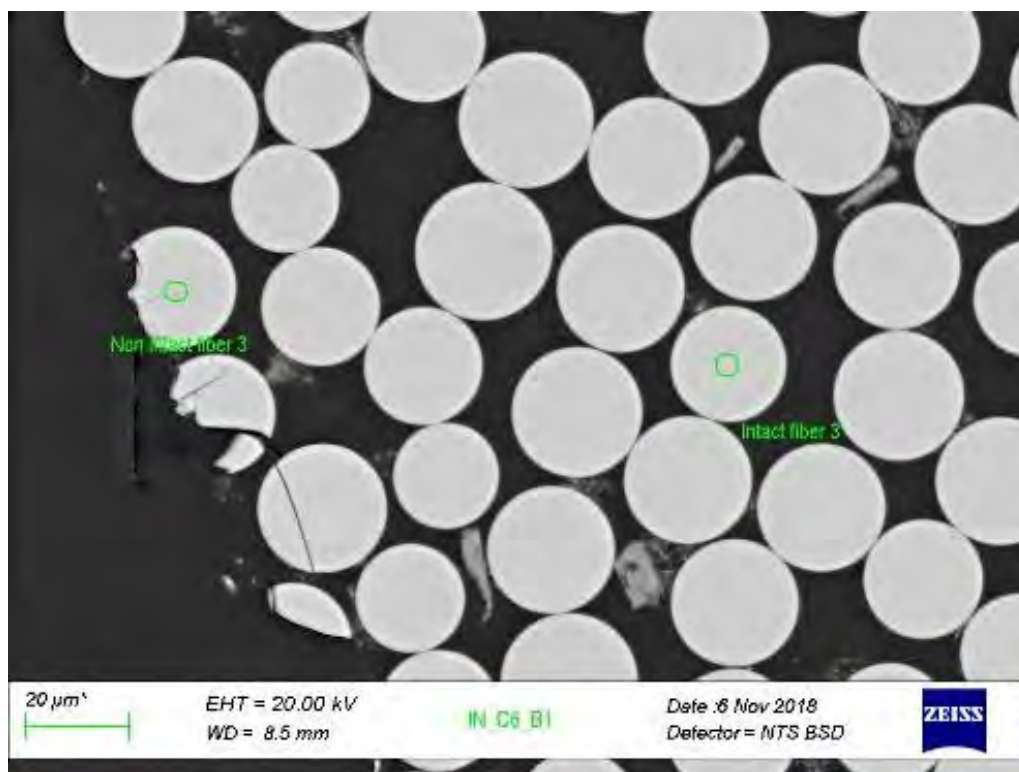
SEM imaging for *Thayer Road Bridge* was performed at Owens Corning. A few negatively affected fibers were observed but appeared to be isolated on the outer perimeter of in-service rebar. The affected fibers only indicated physical damage, likely from manufacturing process. Extrapolated damage was not visible in this sample. Swirls observed in optical microscopy can be seen in low magnification images and are related to resin rich areas. The SEM imaging of each bar is shown in Fig. 81 through Fig. 98.

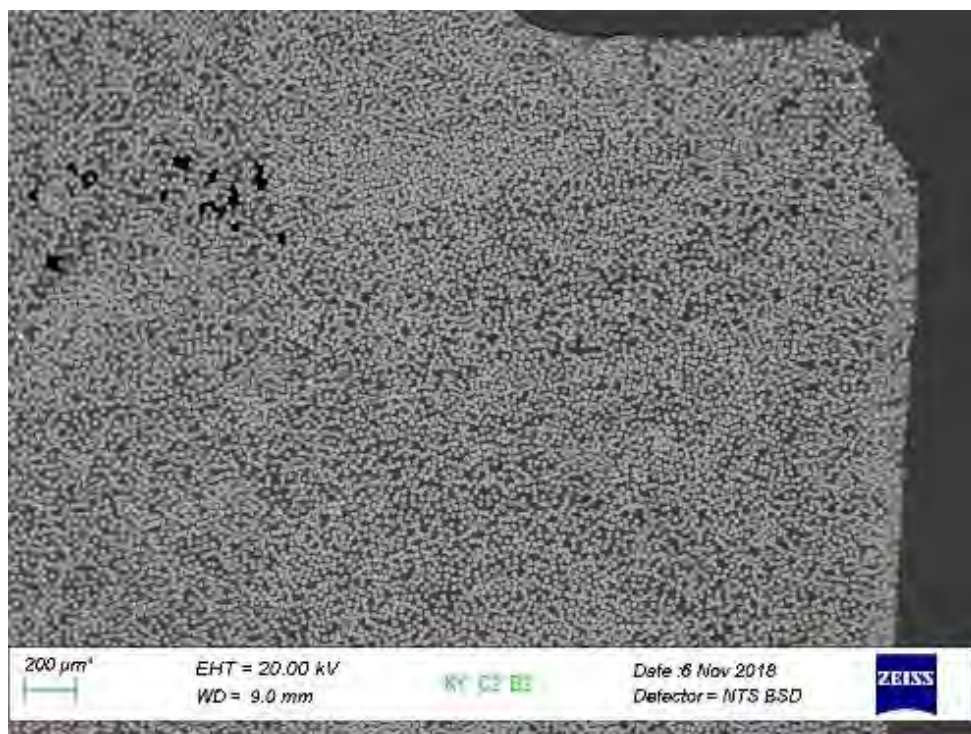
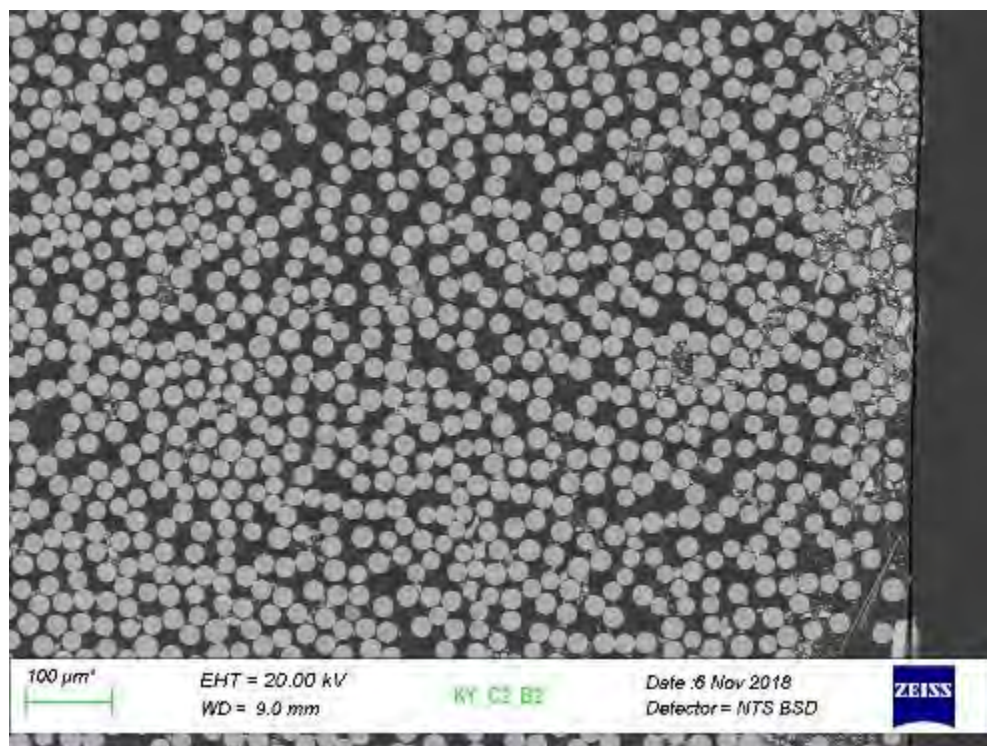
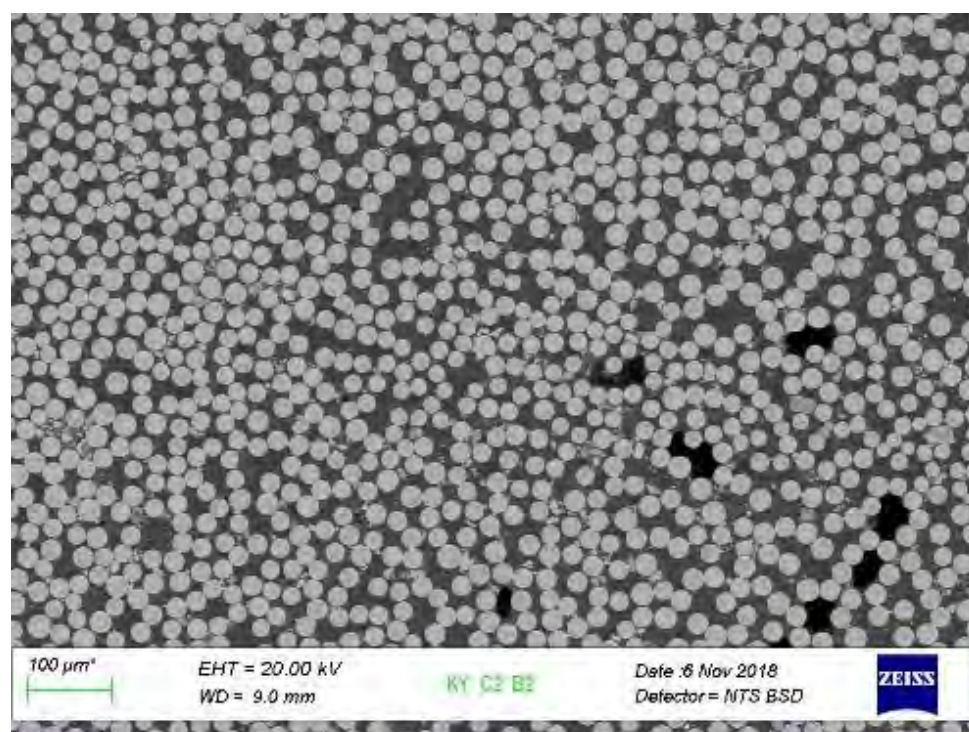
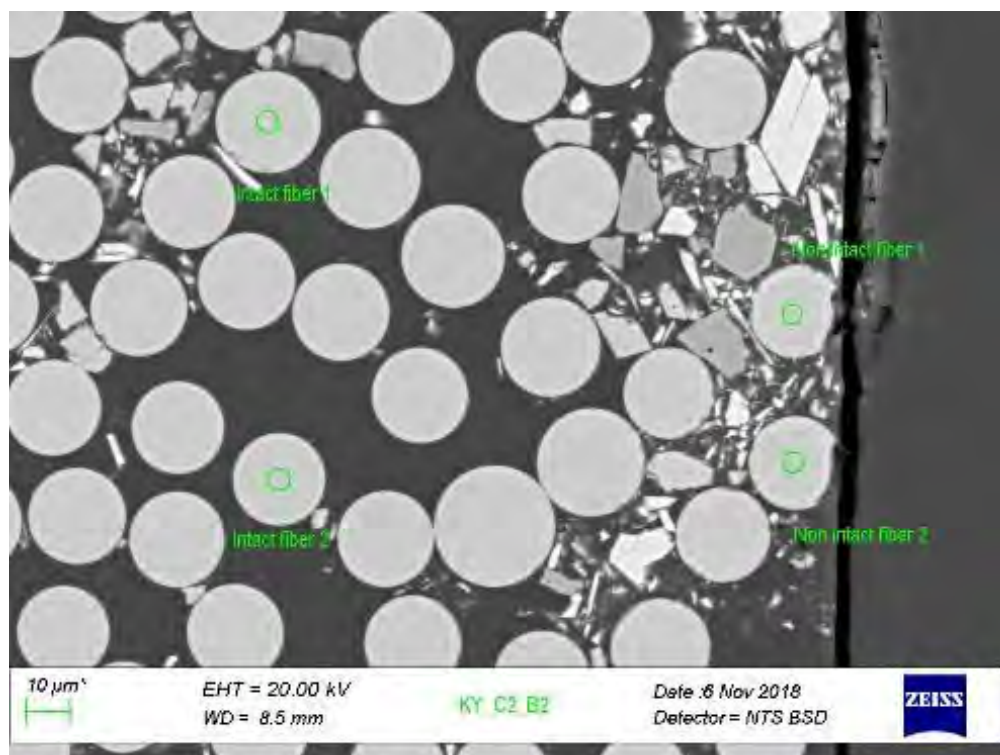
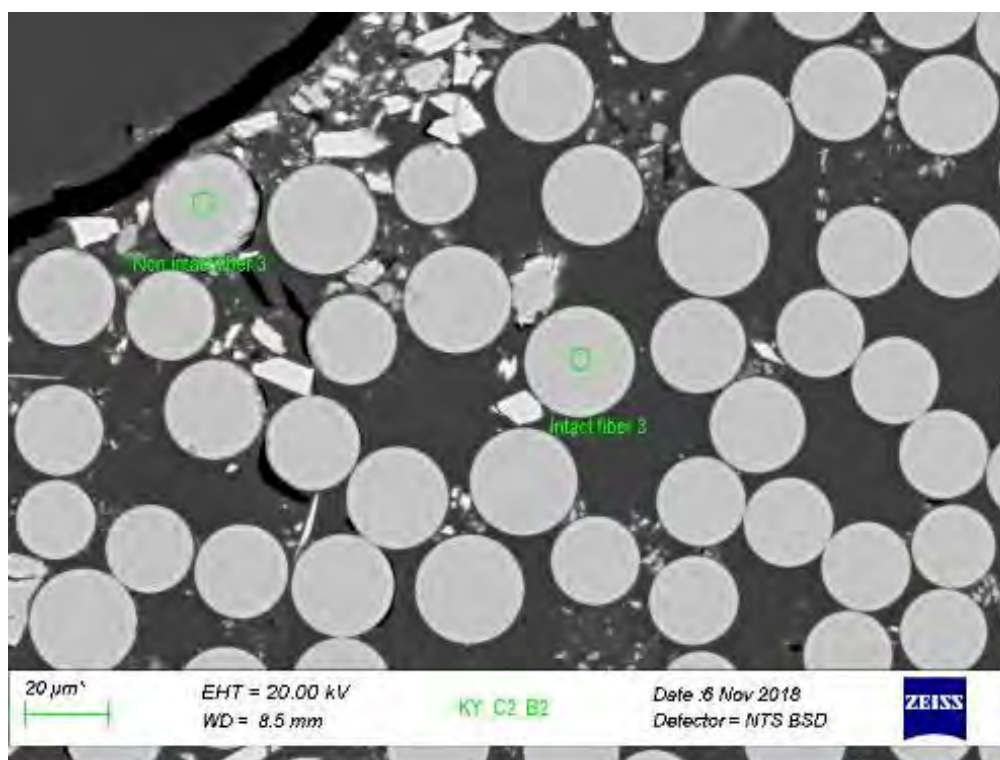
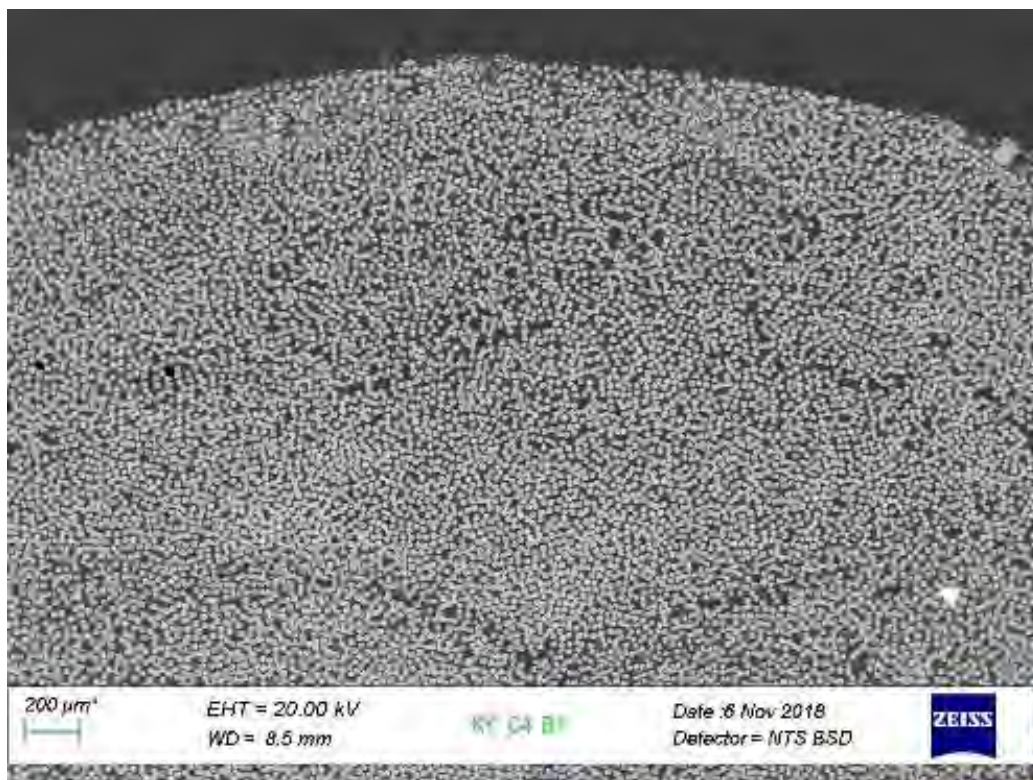
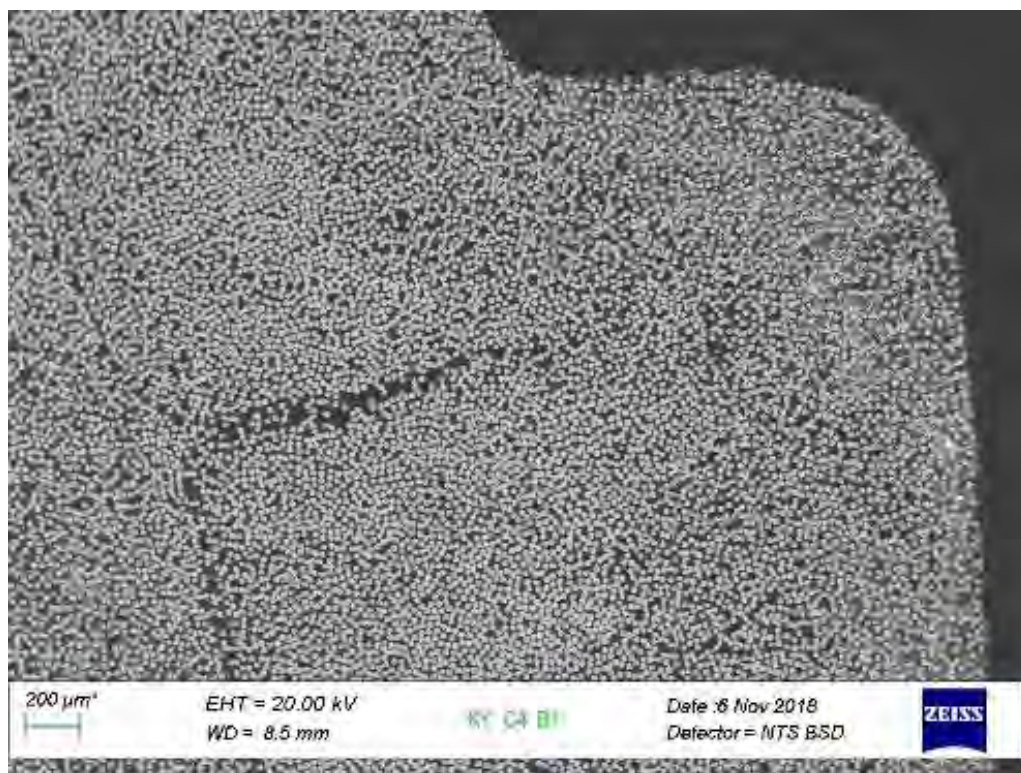
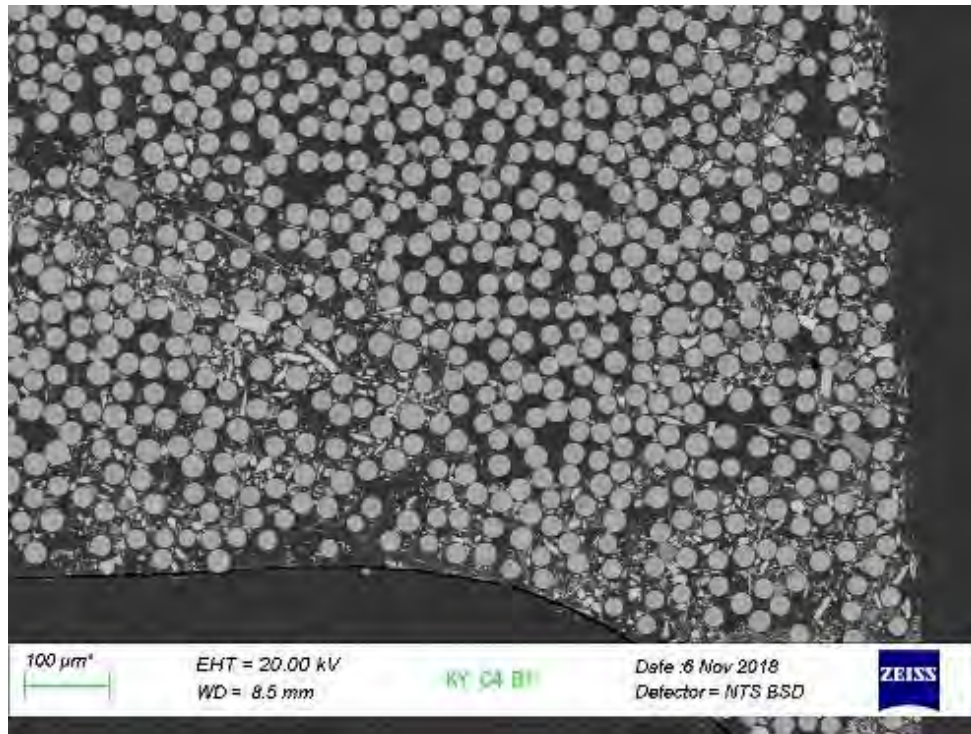
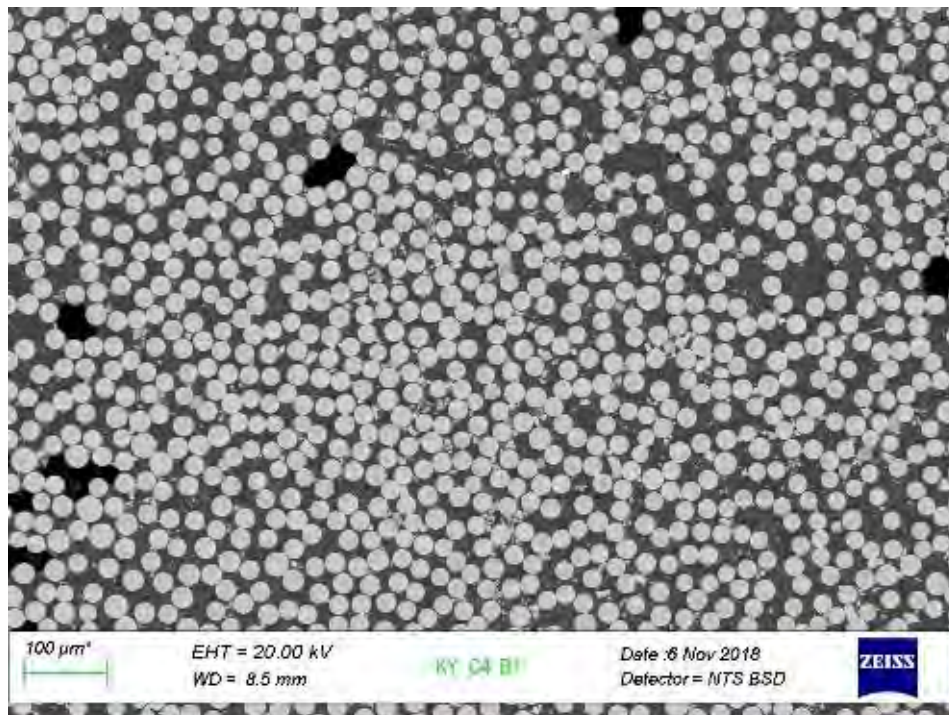
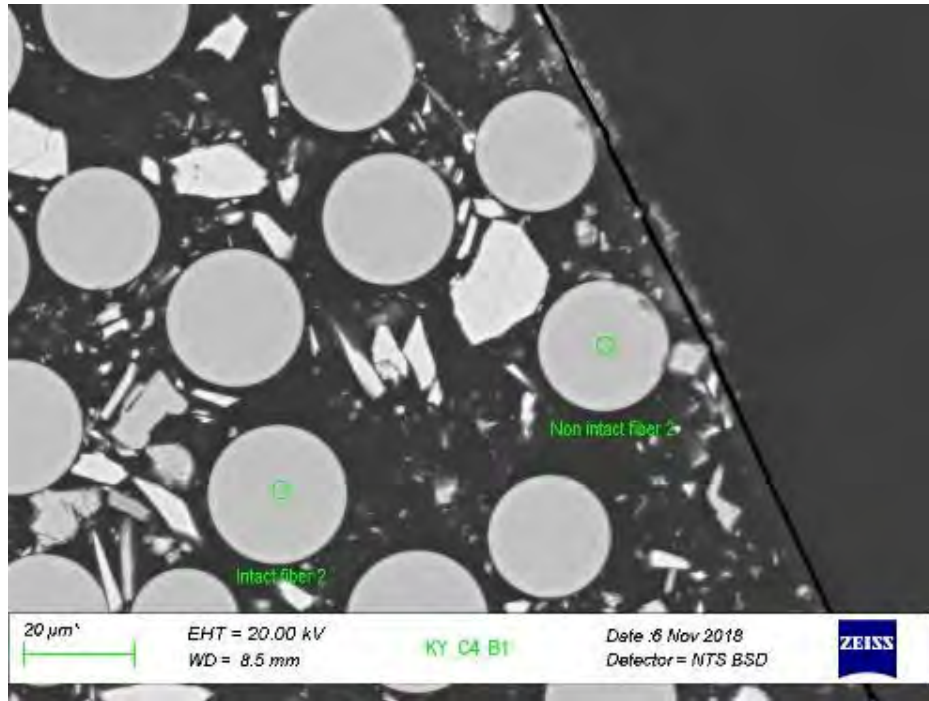
SEM imaging for *Roger's Creek Bridge* was performed at Owens Corning. The fibers from *Roger's Creek Bridge* showed some evidence of being negatively affected by concrete exposure. Of the few negatively affected, they were located on the exterior or near large cracks. The number of affected fibers is expected to be similar or less than the Cuyahoga or Gills Creek samples. The SEM imaging of each bar is shown in Fig. 99 through Fig. 109.

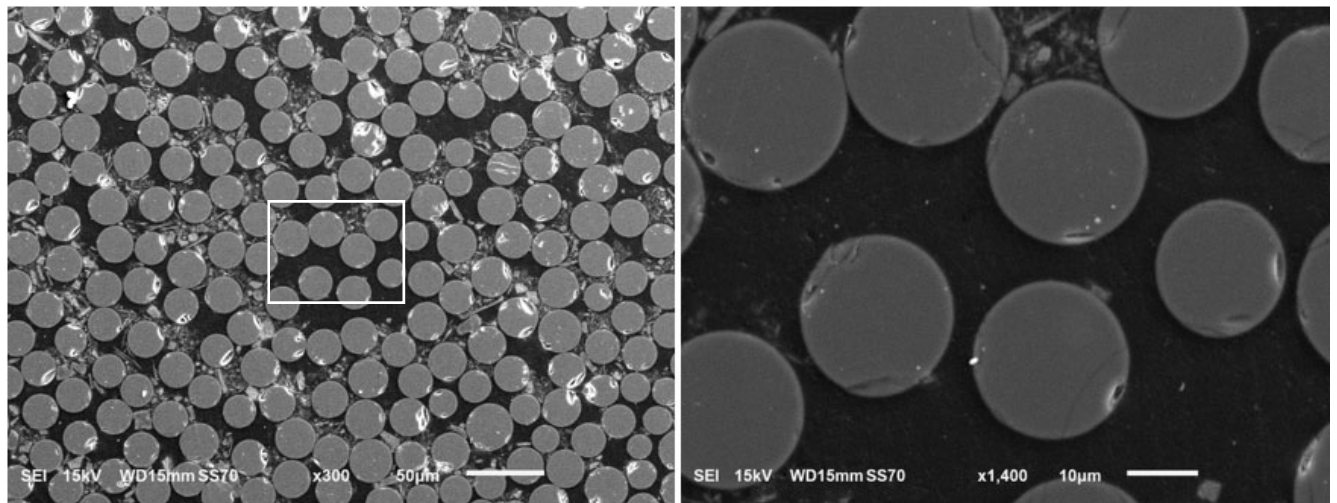
Fig. 110. SEM images of fibers at magnifications of 300X (left) and 1400X (right))

The full cross-sections of three slices of No.5 GFRP bars were scanned at different levels of magnification and images were taken at random locations. A representative image is shown in Fig. 110. The image of a single fiber is shown in Fig. 111.

SEM analysis confirmed that there was no sign of deterioration in the GFRP coupons. Glass fibers were intact without a loss of cross-sectional area. Similarly, fibers were surrounded by the resin matrix and no sign of loss of bond between matrix and fiber was observed.

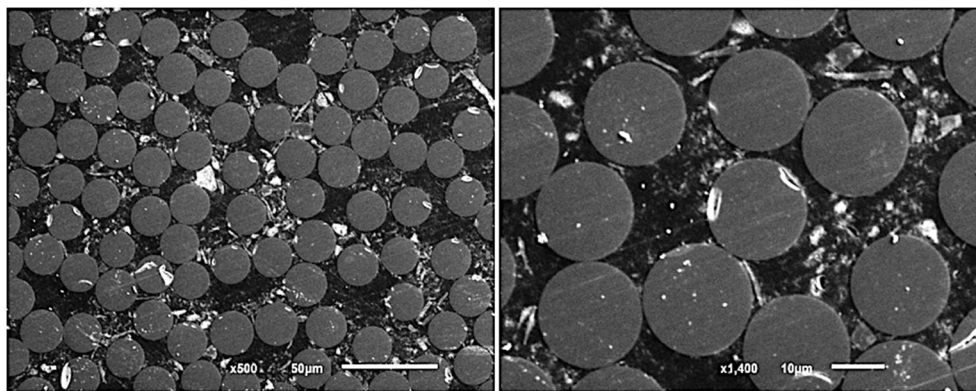
Fig. 114. SEM images of GFRP bar after 11 years if service in Southview Bridge at magnifications of 500x (left) and 1400x (right)

SEM imaging for *Southview Bridge* was performed at the University of Miami. The results of each bar is shown in Fig. 114 through Fig. 110. SEM analysis suggests that there was no apparent sign of deterioration in the GFRP coupons. No damage was observed in the matrix and at the matrix-fiber interface. Glass fibers appeared to be intact without no loss of cross-sectional area.

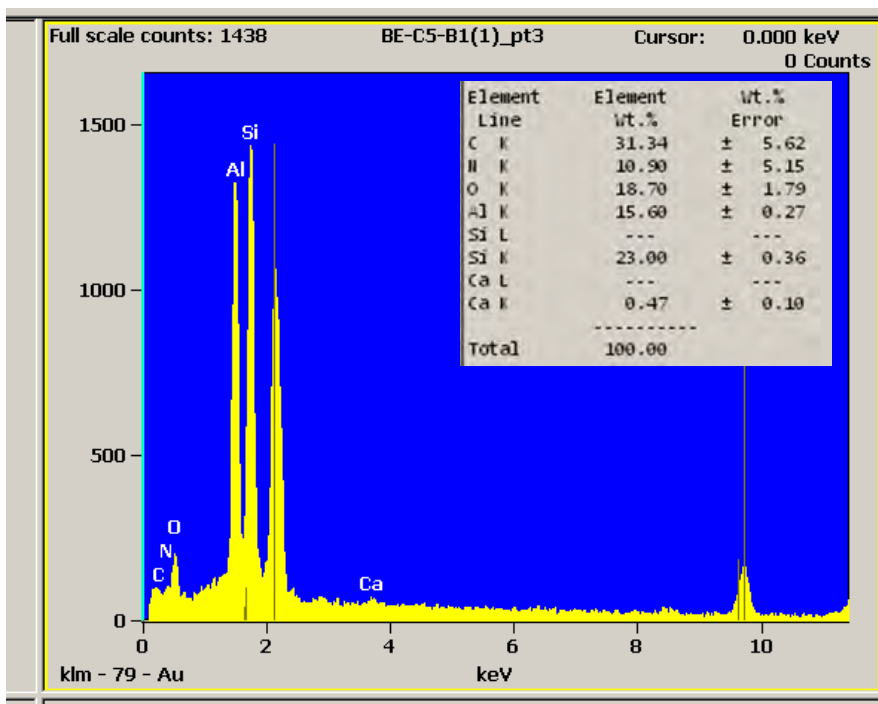
Fig. 119. BE_C5_B1-1 pt.3 gold not included. Presence of C, O and N and yielded high aluminum.

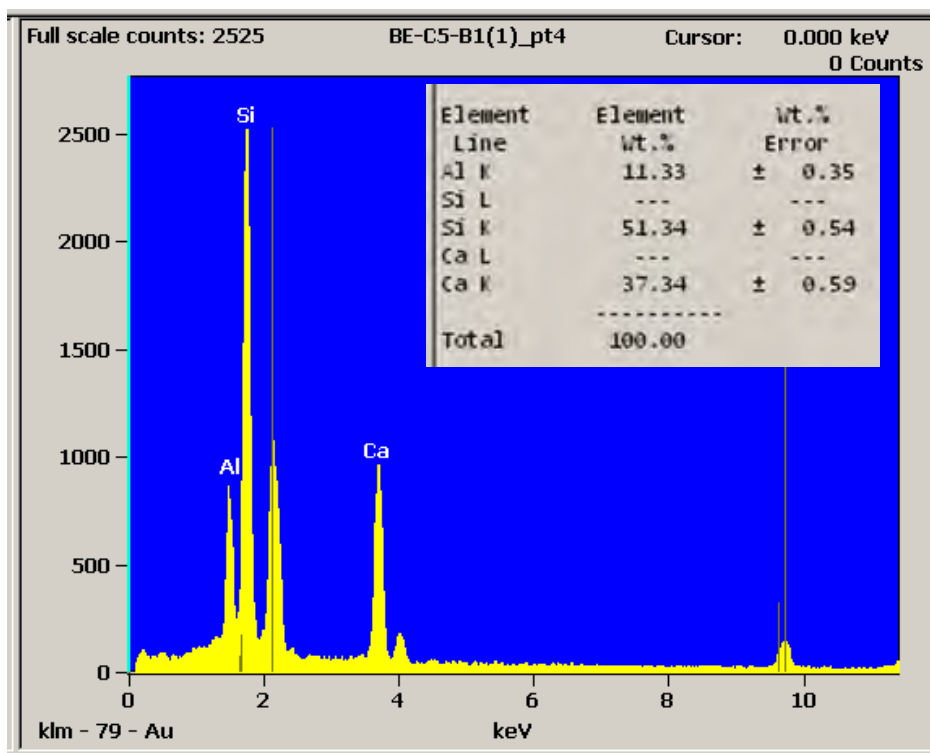
Fig. 120. BE_CE_B1-1 pt. 4 gold not included. Yielded Al, Si and Ca.
