FINAL PROJECT REPORT #00059416

Durability of GFRP Bar Reinforcement Extracted from In-service Concrete Structures

Participating Consortium Member:
Missouri University of Science and Technology

RE-CAST:
REsearch on Concrete Applications for
Sustainable Transportation
Tier 1 University Transportation Center

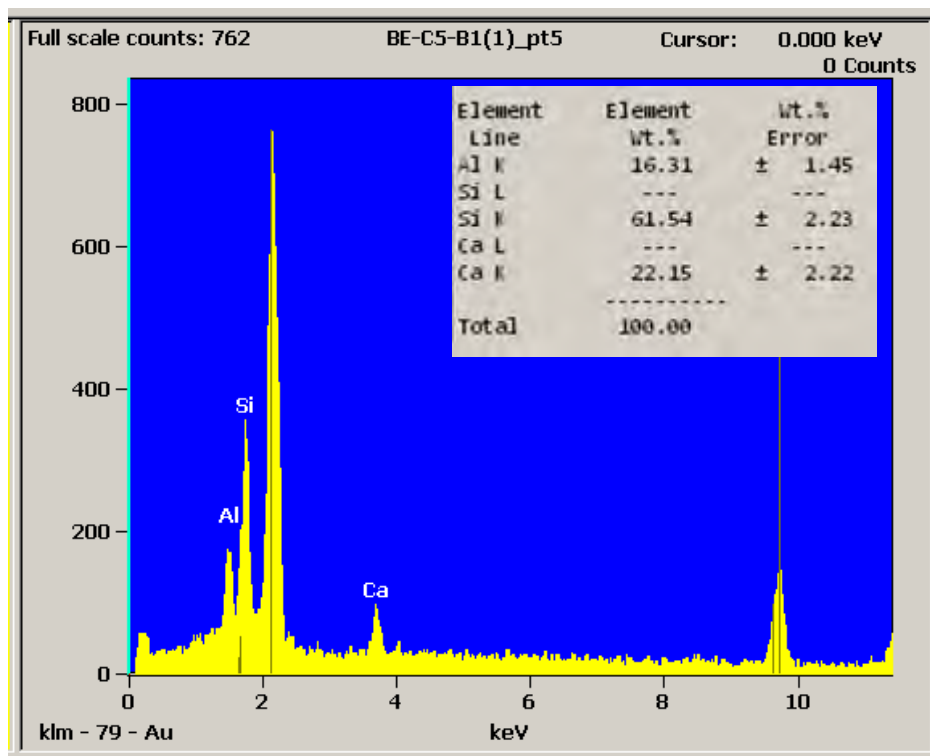
Fig. 121. BE_C5_C1-1 pt 5 no gold included. Yielded less Al, Si and Ca.

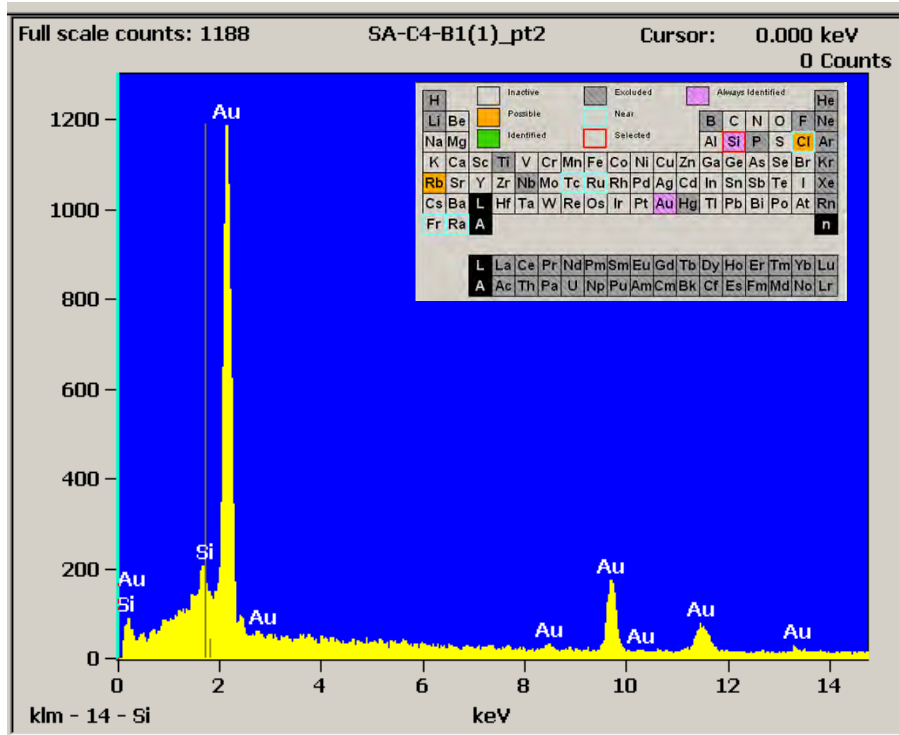
Fig. 142. SA_C4_B1-1 pt. 2

EDS for *Salem Ave. Bridge* was performed at the University of Miami using the method described in Section 4.1.5. Results are shown Fig. 132 through Fig. 143.

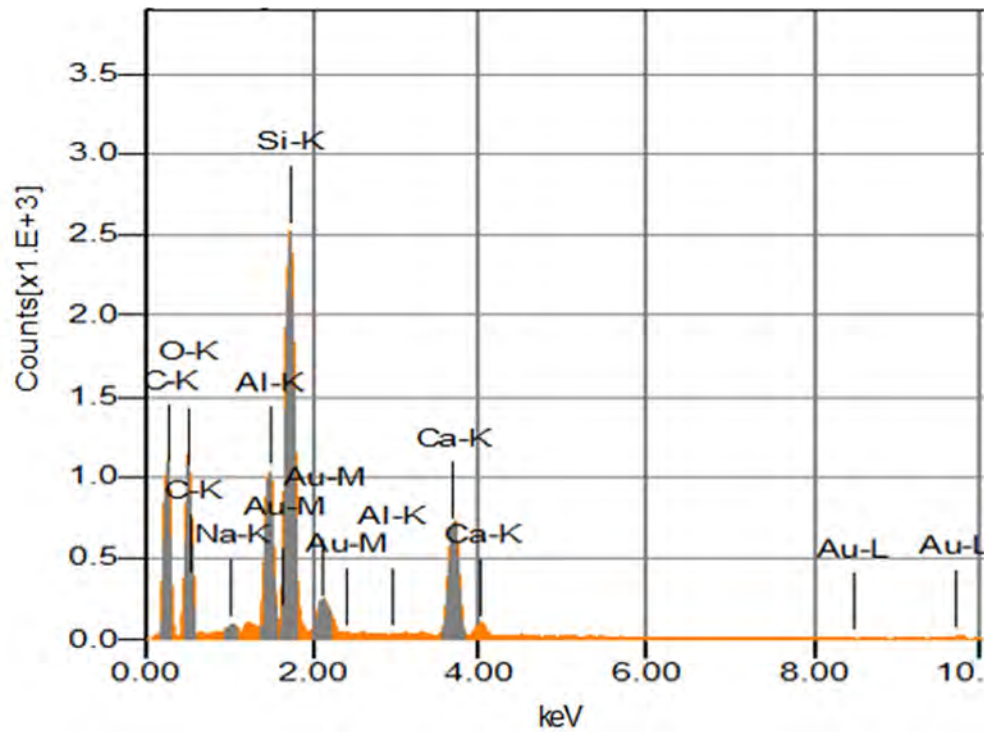
Fig. 144. *Sierrita de la Cruz Creek* result of the EDS analysis performed on GFRP bars after 15 years of service

Si, Al, Ca (from glass fibers) and C (from the matrix) were the predominant chemical elements in the extracted samples, which were also identical to the control samples. Although, there is a variation in fiber/resin constituents for GFRP bars produced in 2015 compared to the ones manufactured in 2000, the only difference in detected elements between the two, was the presence of Mg in the control samples, which was not found in extracted bars. Additionally, the presence of Na was observed in both control and extracted samples and may be due to contamination during sample preparation. Comparing the result of EDS analysis performed on the extracted and control samples confirmed that no change in chemical composition of fiber and matrix occurred after 15 years of service.

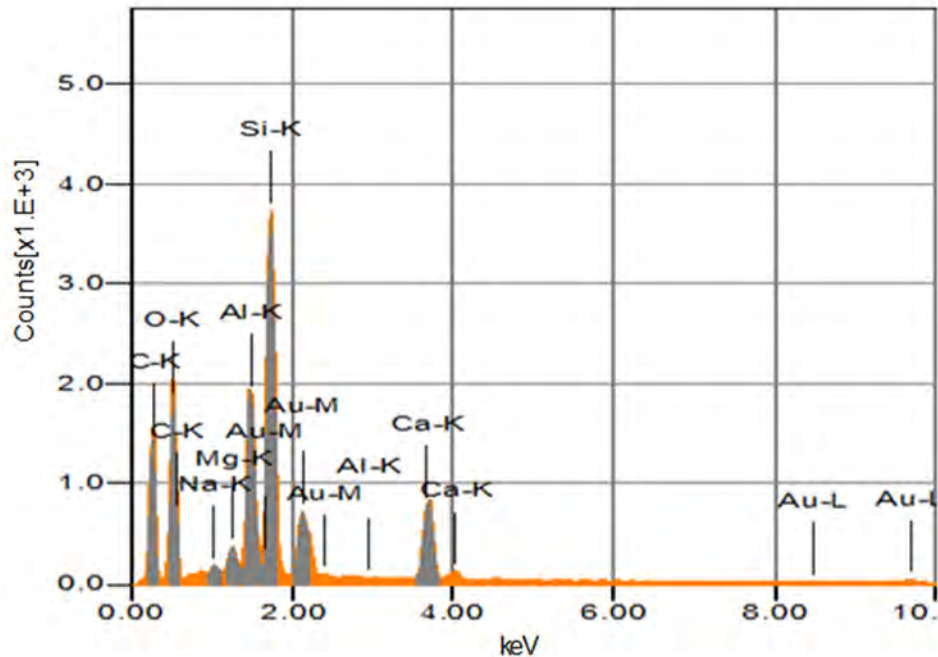
Fig. 145. Sierrita de la Cruz Creke results of the EDS analysis performed on control GFRP samples produced in 2015

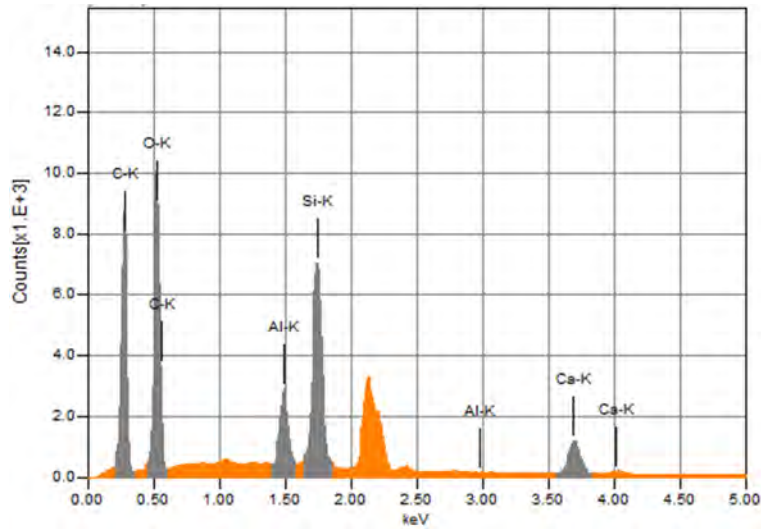
EDS for *Walker Box Culvert Bridge* was performed at the University of Miami using the method described in Section 4.1.5. The result of EDS analysis is shown in Fig. 146. Si, Al, Ca (from glass fibers) and C (from the matrix) were the predominant chemical elements in the extracted samples. No apparent sign of any chemical attack was observed in the bars.

Fig. 146. Result of the EDS analysis performed on GFRP samples extracted from Walker Bridge

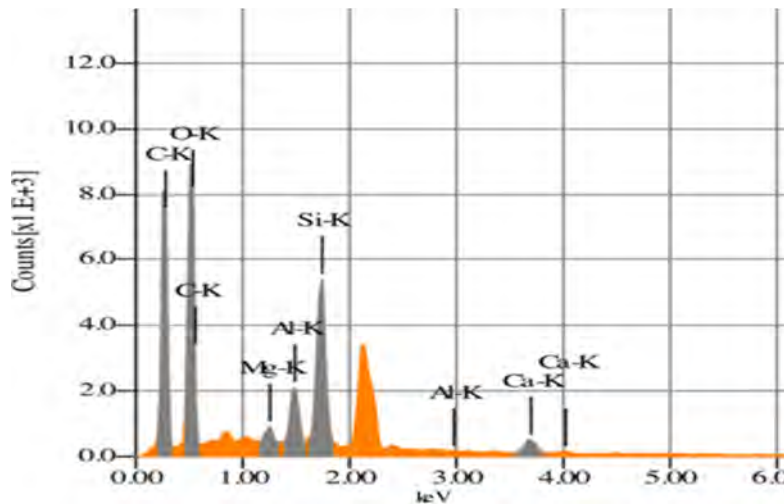
The result of EDS analysis is shown in Fig. 147. Si, Al, Ca (from glass fibers) and C (from the matrix) were the predominant chemical elements in the extracted samples. No apparent sign of any chemical attack was observed in the bars.

Fig. 147. Result of the EDS analysis performed on GFRP samples extracted from Southview Bridge

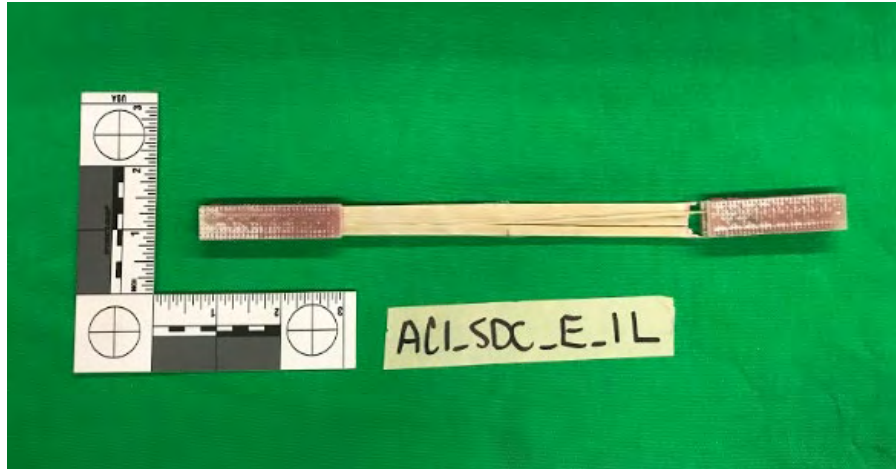
Fig. 4. E_1L after failure

Sierrita de la Cruz Creek coupon 1 from the left side of the rebar failed at the lateral grip on the top at a peak load of 2,732 lbs. (12 kN) and a peak strain of $10,000 \times 10^{-6}$. The coupon before testing and test set up are shown in Fig. 2 and Fig. 3, respectively. The failed coupon and the stress strain curve are shown in Fig. 4 and Fig. 5, respectively. The strain values were recorded with both strain gauges and extensometer; however, the extensometer was removed at 2,500 lbs. Therefore, the stress strain curve uses the values obtained from the strain gauge. A summary of the tensile test results is shown in Table 1.

Since the failure of this coupon happened at the location of the tab, the test is rejected.

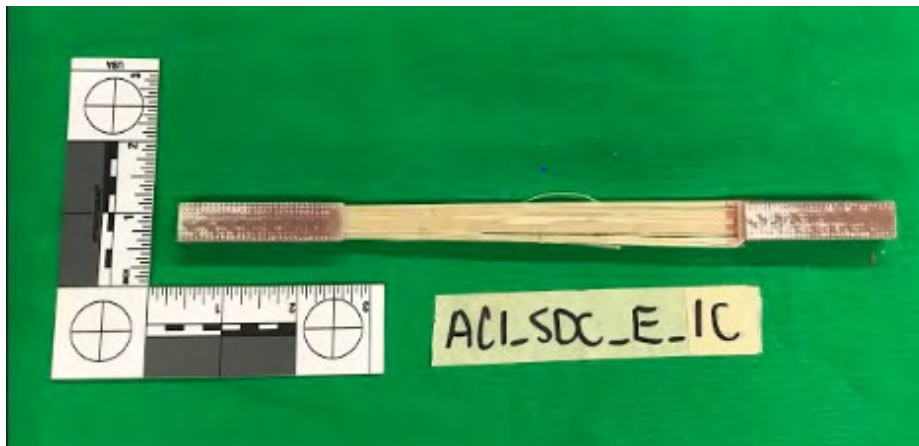
Fig. 7. Coupon E_1C after failure

Sierrita de la Cruz Creek coupon 1 from the center of the rebar failed with the splitting of gage at various points at a peak load of 4,140 lbs. (18 kN) and a peak strain of $12,300 \times 10^{-6}$. The coupon before testing and after failure are shown in Fig. 6 and Fig. 7, respectively. The strain values were recorded with both strain gauges and extensometer; however, the extensometer was removed at 3,500 lbs. Therefore, the stress strain curve uses the values obtained from the strain gauge. The strain gauge recorded inaccurate values at stresses higher than about 77,000 psi. The stress strain curve for this bar is shown in Fig. 8. A summary of the tensile test results is shown in Table 2.

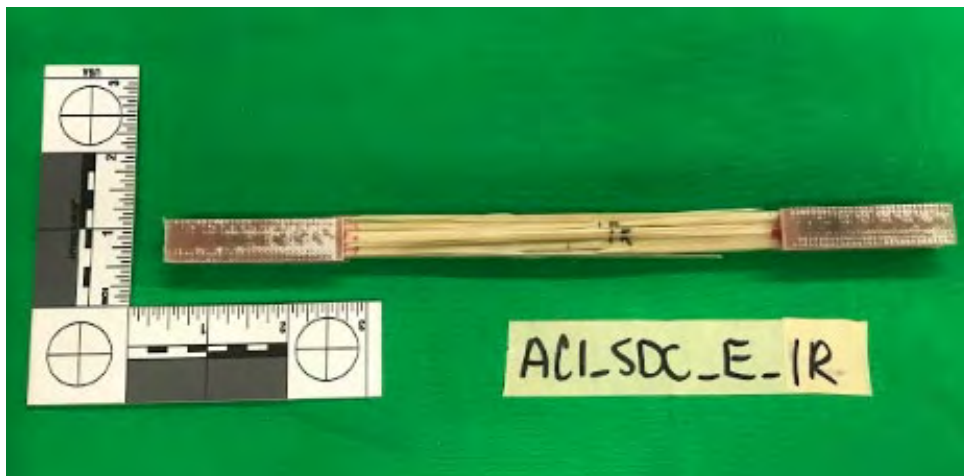
Fig. 10. Coupon E_1R after failure

Sierrita de la Cruz Creek coupon 1 from the of the right side of the rebar failed with the splitting of gage at various points at a peak load of 5,038 lbs. (22kN) and a peak strain of 12,000x10⁻⁶. The coupon before testing and after failure are shown in Fig. 9 and Fig. 10, respectively. The strain values were recorded with both strain gauges and extensometer; however, the extensometer was removed at 2,250 lbs. Therefore, the stress strain curve uses the values obtained from the strain gauge. The strain gauge recorded inaccurate values at stresses higher than about 90,000 psi. The stress strain curve for this bar is shown in Fig. 11. A summary of the tensile test results is shown in Table 3.

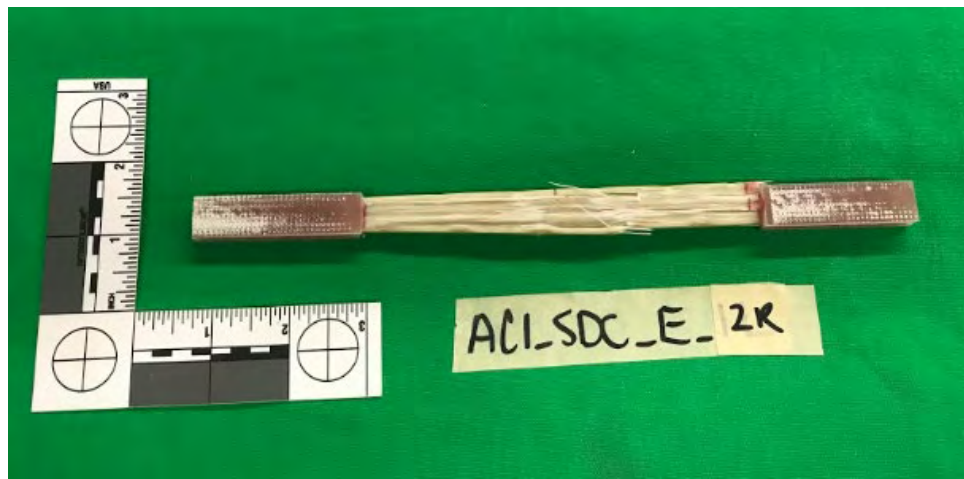
Fig. 19. Coupon E_2R after failure

Sierrita de la Cruz Creek coupon 2 from the right side of the rebar failed with the splitting of gage at various points at a peak load of 4,597 lbs. (20 kN) and a peak strain of 13,000x10⁻⁶. The coupon before testing and after failure are shown in Fig. 18 and Fig. 19, respectively. The strain values were recorded with both strain gauges and extensometer; however, the extensometer was removed at 3,500 lbs. Therefore, the stress strain curve uses the values obtained from the strain gauge. The stress strain curve for this bar is shown in Fig. 20. A summary of the tensile test results is shown in Table 6.

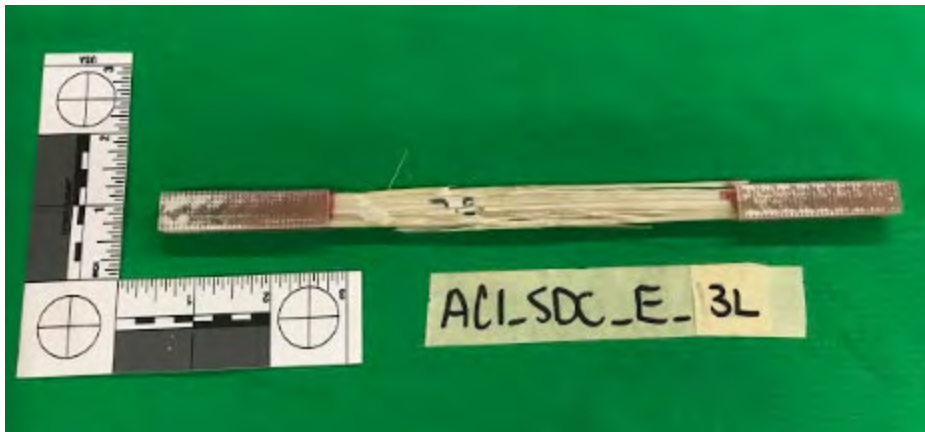
Fig. 22. Coupon E_3L after failure

Sierrita de la Cruz Creek coupon 3 from the left side of the rebar failed with the splitting of gage at various points at a peak load of 2,992 lbs. (13 kN) The coupon before testing and after failure are shown in Fig. 21 and Fig. 22, respectively. Due to test issues, the strain for this bar could not be recorded, however, a stress curve is shown in Fig. 23. A summary of the tensile test results is shown in Table 7.

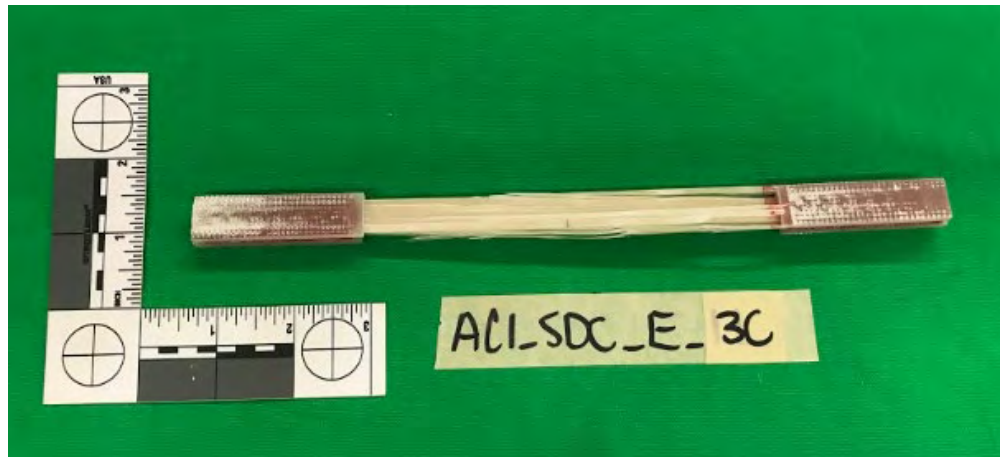
Fig. 25. Coupon E_3C after failure

Sierrita de la Cruz Creek coupon 3 from the center of the rebar failed with the splitting of gage at various points at a peak load of 4,621 lbs. (21 kN). The coupon before testing and after failure are shown in Fig. 24 and Fig. 25, respectively. Due to test issues, the strain for this bar could not be recorded, however, a stress curve is shown in Fig. 26. A summary of the tensile test results is shown in Table 8.

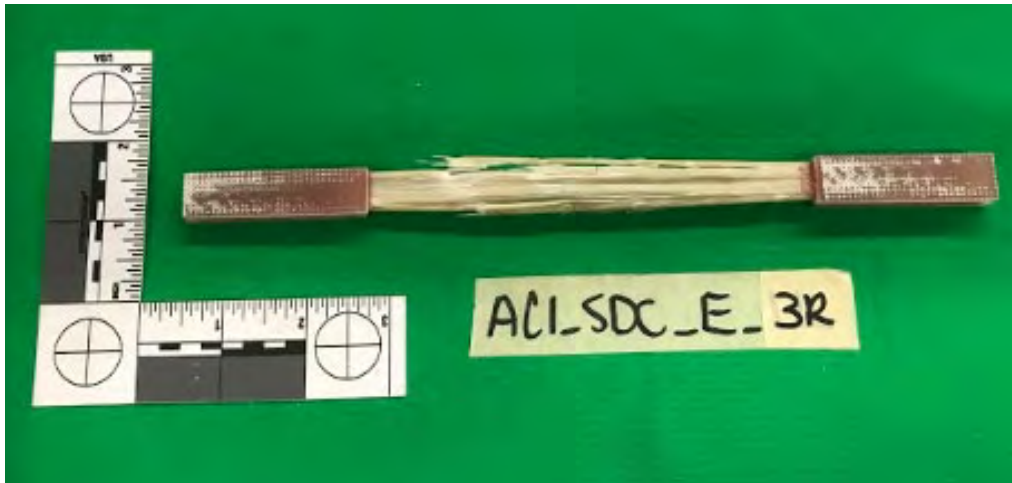
Fig. 28. Coupon E_3R after failure

Sierrita de la Cruz Creek coupon 3 from the right side of the rebar failed with the splitting of gage at various points at a peak load of 4,330 lbs. (19 kN) and a peak strain of $13,112 \times 10^{-6}$. The coupon before testing and after failure are shown in Fig. 27 and Fig. 28, respectively. The strain values were recorded with both strain gauges and extensometer; however, the extensometer was removed at 3,500 lbs. Therefore, the stress strain curve uses the values obtained from the strain gauge. The stress strain curve for this bar is shown in Fig. 29. A summary of the tensile test results is shown in Table 9.

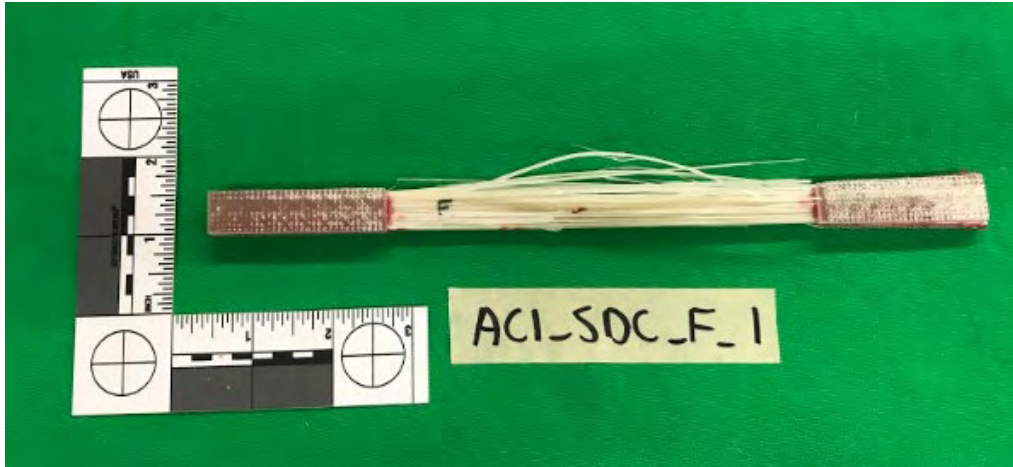
Fig. 31. Coupon F_1 after failure

Pristine coupon 1 failed with the splitting of gage at various points at a peak load of 4,929 lbs (22kN) and a peak strain of $17,900 \times 10^{-6}$. The coupon after failure is shown in Fig. 31. The strain values were recorded with both strain gauges and extensometer; however, the extensometer was removed at 4,000 lbs. Therefore, the stress strain curve uses the values obtained from the strain gauge. The stress strain curve for this bar is shown in Fig. 32. A summary of the tensile test results is shown in Table 10.

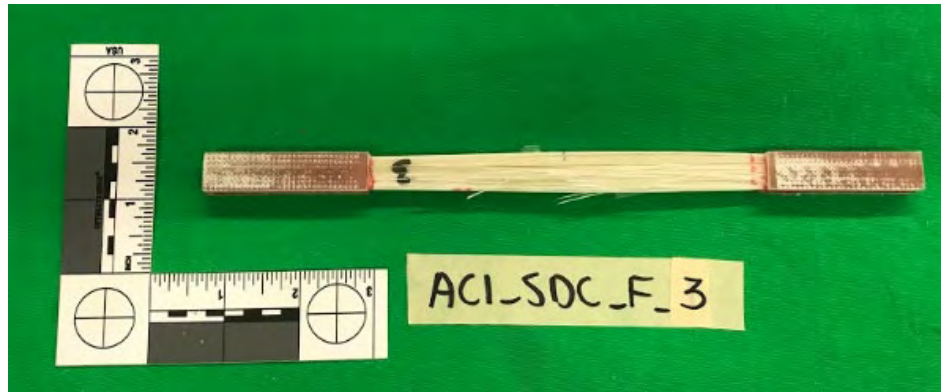
Fig. 35. Coupon F_3 after failure

Pristine coupon 3 failed with the splitting of gage at various points at a peak load of 4,894 lbs. (12 kN) and peak strain of $15,000 \times 10^{-6}$. The coupon after failure is shown in Fig. 35. The strain values were recorded with both strain gauges and extensometer; however, the extensometer was removed at 4,000 lbs. Therefore, the stress strain curve uses the values obtained from the strain gauge. The stress strain curve for this bar is shown in Fig. 36. A summary of the tensile test results is shown in Table 12.

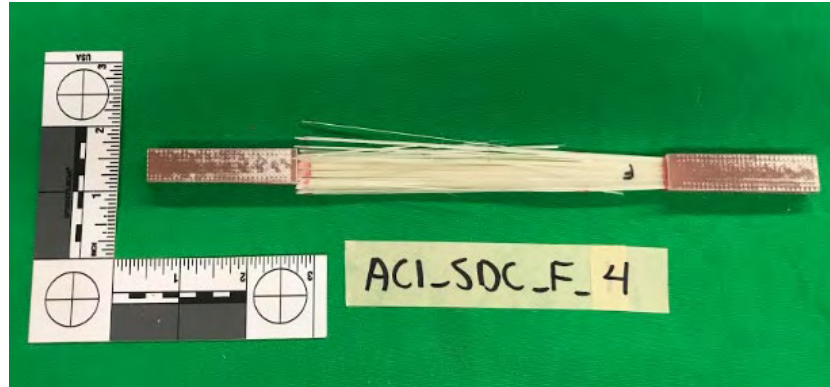
Fig. 37. Coupon F_4 after failure

Pristine coupon 4 failed with the splitting of gage at various points at a peak load of 4,538 lbs. (20 kN) and a maximum strain of 15,500x10⁻⁶. The coupon after failure is shown in Fig. 37. The strain values were recorded with both strain gauges and extensometer; however, the extensometer was removed at 4,000 lbs. Therefore, the stress strain curve uses the values obtained from the strain gauge. The strain gauge recorded inaccurate values at stresses higher than about 98,000 psi. The stress strain curve for this bar is shown in Fig. 38. A summary of the tensile test results is shown in Table 13.

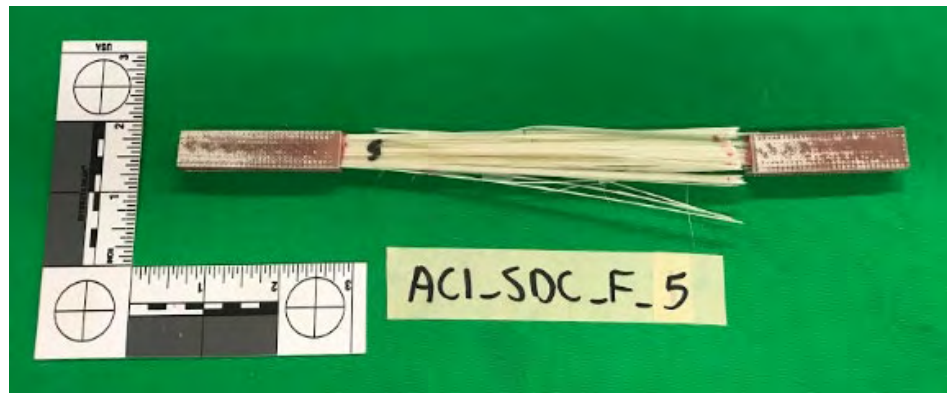
Fig. 39. Coupon F_5 after failure

Pristine coupon 5 failed with the splitting of gage at various points at a peak load of 5,321 lbs. (24 kN) and a maximum strain of $19,400 \times 10^{-6}$. The coupon after failure is shown in Fig. 39. The strain values were recorded with both strain gauges and extensometer; however, the extensometer was removed at 4,000 lbs. Therefore, the stress strain curve uses the values obtained from the strain gauge. The stress strain curve for this bar is shown in Fig. 40. A summary of the tensile test results is shown in Table 14.

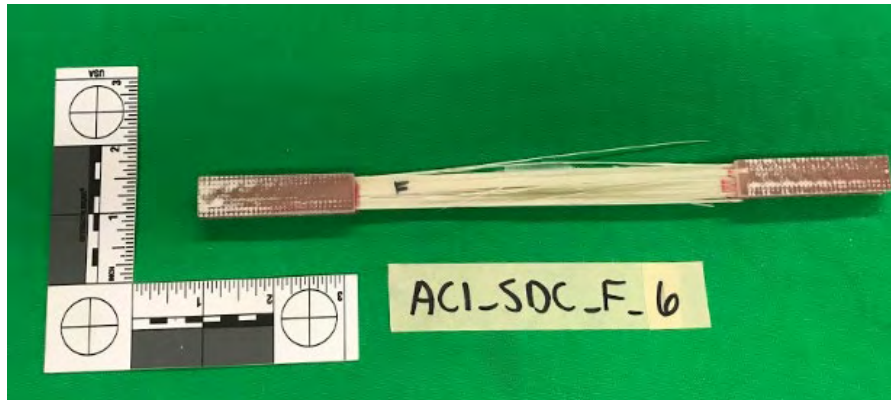
Fig. 41. Coupon F_6 after failure

Pristine coupon 6 failed with the splitting of gage at various points at a peak load of 4,065 lbs. and a maximum strain of $14,077 \times 10^{-6}$. The coupon after failure is shown in Fig. 41. The strain values were recorded with both strain gauges and extensometer; however, the extensometer was removed at 4,000 lbs. Therefore, the stress strain curve uses the values obtained from the strain gauge. The stress strain curve for this bar is shown in Fig. 42. A summary of the tensile test results is shown in Table 15.

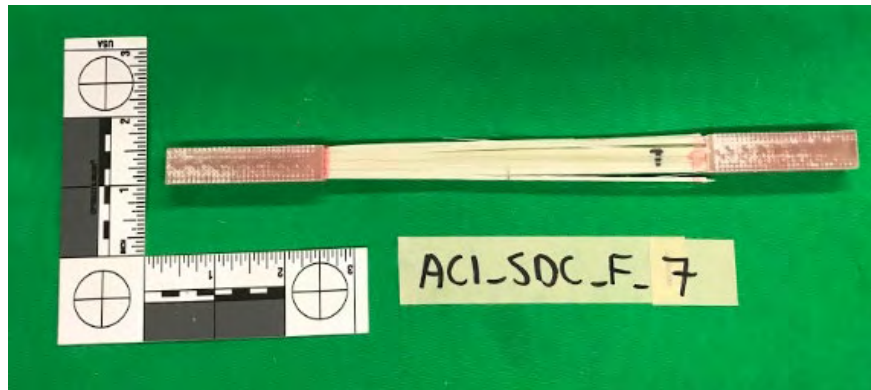
Fig. 43. Coupon F_7 after failure

Pristine coupon 7 failed with the splitting of gage at various points at a peak load of 4,110 lbs. (18 kN) and strain of 15,300x10⁻⁶. The coupon after failure is shown in Fig. 43. The stress strain curve for this bar is shown in Fig. 44. The strain values were recorded with both strain gauges and extensometer; however, the extensometer was removed at 4,000 lbs. Therefore, the stress strain curve uses the values obtained from the strain gauge. A summary of the tensile test results is shown in Table 16.

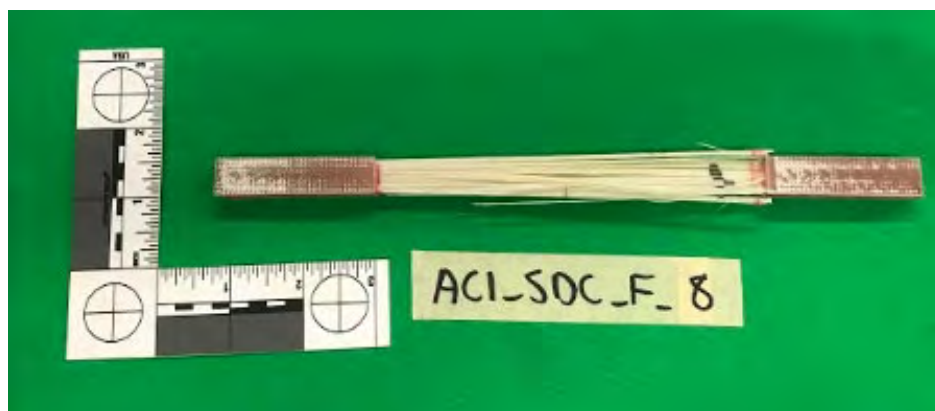
Fig. 45. Coupon F_8 after failure

Pristine coupon 8 failed with the splitting of gage at various points at a peak load of 4,609 lbs. (20 kN) and a maximum strain of $15,900 \times 10^{-6}$. The coupon after failure is shown in Fig. 45. The stress strain curve for this bar is shown in Fig. 46. The strain values were recorded with both strain gauges and extensometer; however, the extensometer was removed at 4,000 lbs. Therefore, the stress strain curve uses the values obtained from the strain gauge. A summary of the tensile test results is shown in Table 17.

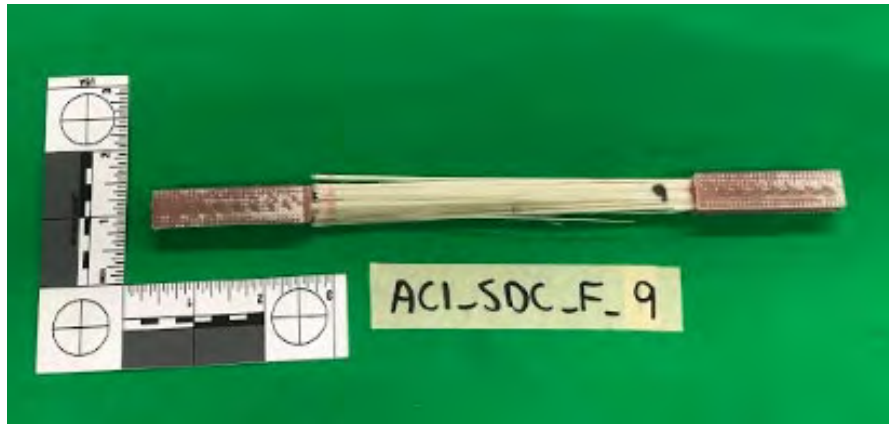
Fig. 47. Coupon F_9 after failure

Pristine coupon 9 failed with the splitting of gage at various points at a peak load of 5,207 lbs. (23 kN) and a maximum strain of $15,600 \times 10^{-6}$. The coupon after failure is shown in Fig. 47. The stress strain curve for this bar is shown in Fig. 48. The coupon before testing and test set up are shown in Fig. 2 and Fig. 3, respectively. The failed coupon and the stress strain curve shown in Fig. 4 and Fig. 5, respectively. The strain values were recorded with both strain gauges and extensometer; however, the extensometer was removed at 4,000 lbs. Therefore, the stress strain curve uses the values obtained from the strain gauge. A summary of the tensile test results is shown in Table 18.

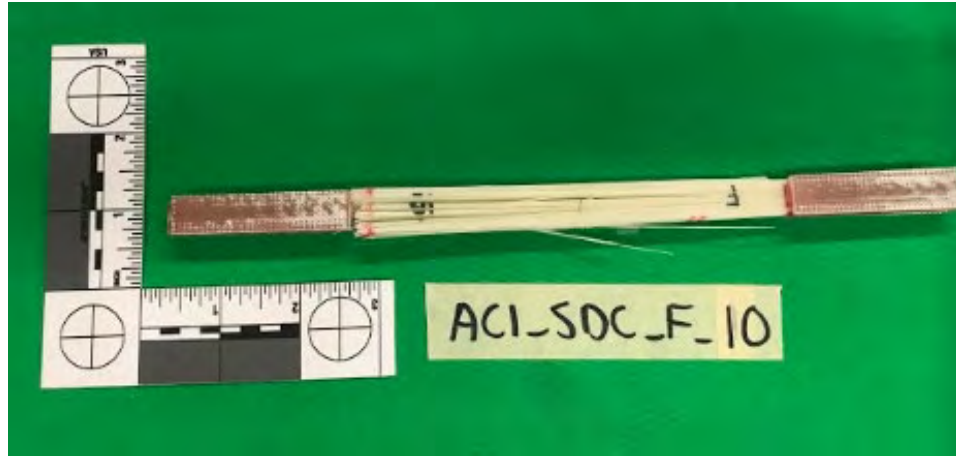
Fig. 49. Coupon F_10 after failure

Pristine coupon 10 failed with the splitting of gage at various points at a peak load of 4,618 lbs. (21 kN) and a maximum strain of 16,500x10⁻⁶. The coupon after failure is shown in Fig. 49. The stress strain curve for this bar is shown in Fig. 50. The strain values were recorded with both strain gauges and extensometer; however, the extensometer was removed at 4,000 lbs. Therefore, the stress strain curve uses the values obtained from the strain gauge. A summary of the tensile test results is shown in Table 19.

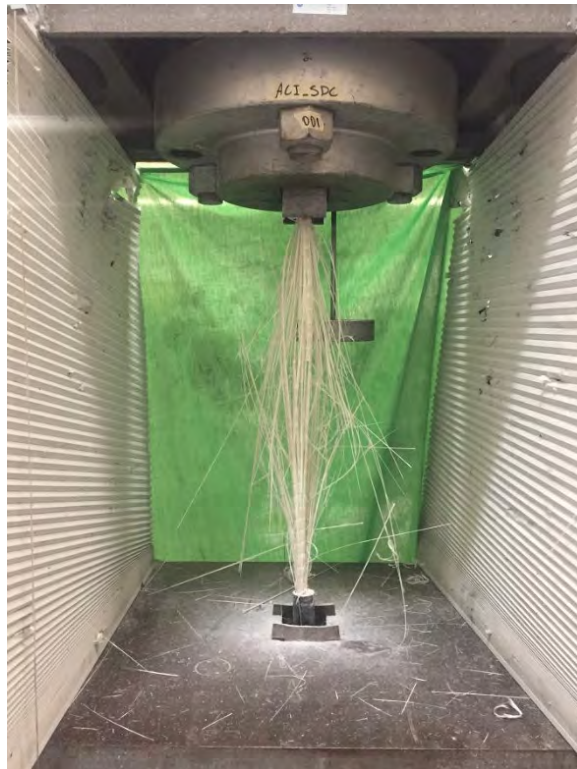
Fig. 52. Bar 001 after failure

Pristine bar 001 failed at a peak load of 37,312 lbs. (166 kN). The test set up is shown in Fig. 51 and the bar after failure is shown in Fig. 52. The extensometer was removed at a load of 11,620 lbs., and therefore, the maximum strain could not be determined. The stress strain curve for this bar is shown in Fig. 53. A summary of the tensile test results is shown in Table 21.

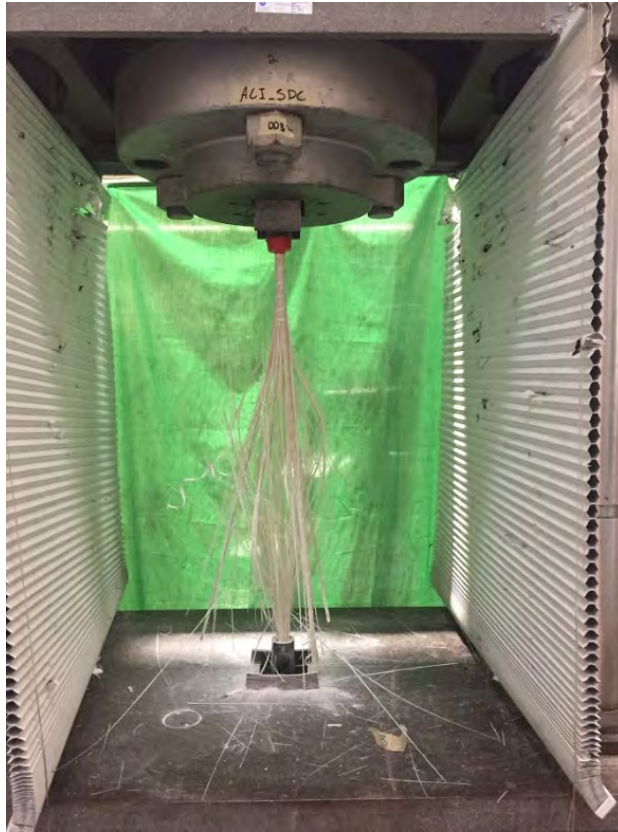
Fig. 55. Bar 003 after failure

Pristine bar 003 failed at a peak load of 35,608 lbs. (159 kN). A photograph of the bar after failure is shown in Fig. 55. The extensometer was removed at a load of 11,690 lbs., and therefore, the maximum strain could not be determined. The stress strain curve for this bar is shown in Fig. 56. Due to initial manipulation of the extensometer, initial conditions show initial deflection at load zero. This curve has A summary of the tensile test results is shown in Table 23.

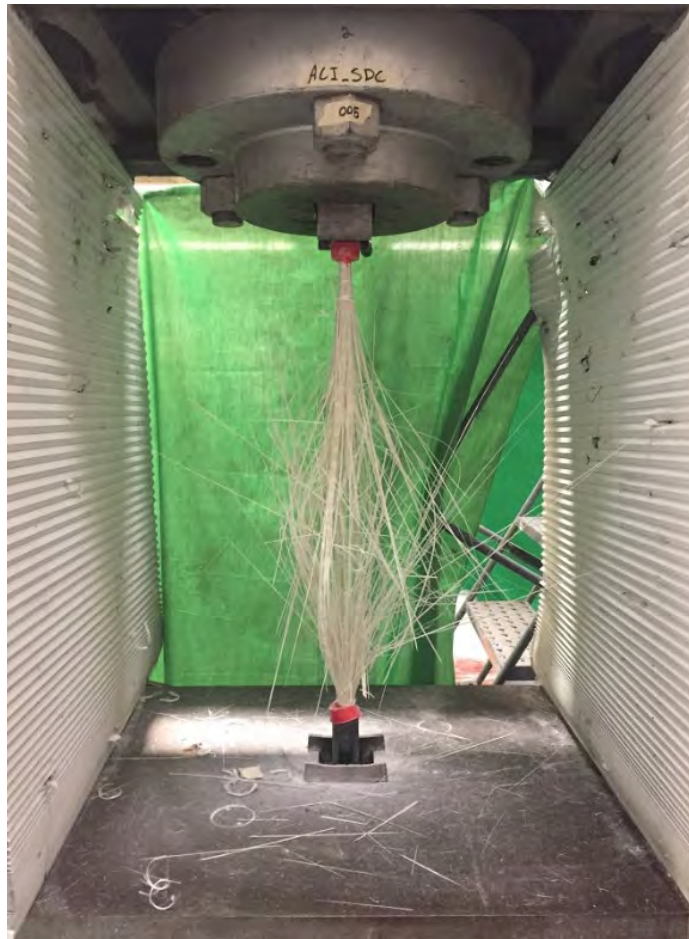
Fig. 58. Bar 005 after failure

Pristine bar 005 failed at a peak load of 38,186 lbs. (170 kN). A photograph of the bar after failure is shown in Fig. 58. The extensometer was removed at a load of 12,150 lbs., and therefore, the maximum strain could not be determined. The stress strain curve for this bar is shown in Fig. 59. A summary of the tensile test results is shown in Table 25.

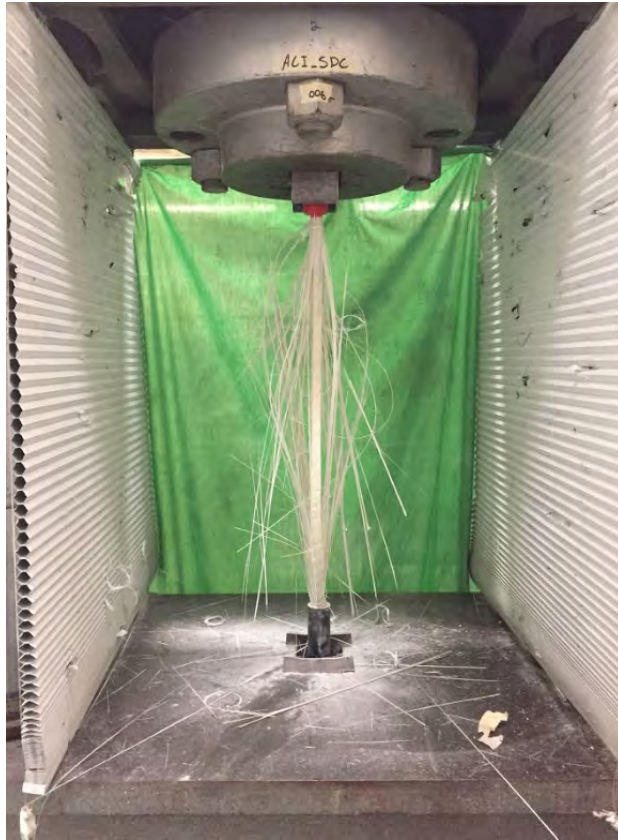
Fig. 60. Bar 006 after failure

Pristine bar 006 failed at a peak load of 35,264 lbs. (157 kN). A photograph of the bar after failure is shown in Fig. 60. The extensometer was removed at a load of 13,360 lbs., and therefore, the maximum strain could not be determined. The stress strain curve for this bar is shown in Fig. 61. A summary of the tensile test results is shown in Table 26.

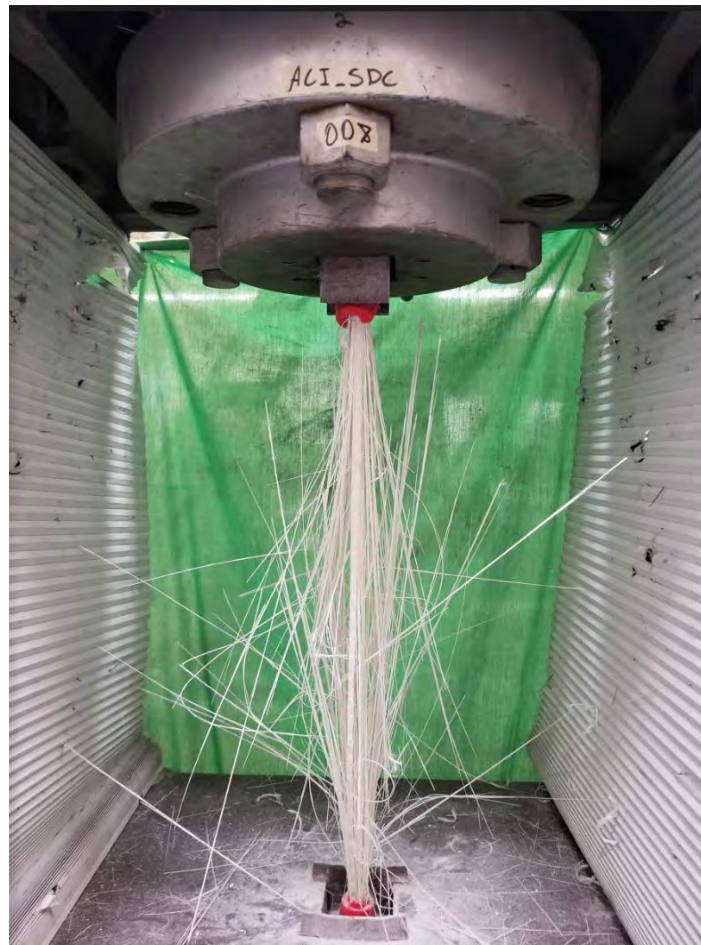
Fig. 63. Bar 008 after failure

Pristine bar 008 failed at a peak load of 37,212 lbs. (166 kN). The extensometer was removed at a load of 11,880 lbs., and therefore, the maximum strain could not be determined. The bar after failure is shown in Fig. 63 and the stress strain curve for this bar is shown in Fig. 64. A summary of the tensile test results is shown in Table 28.

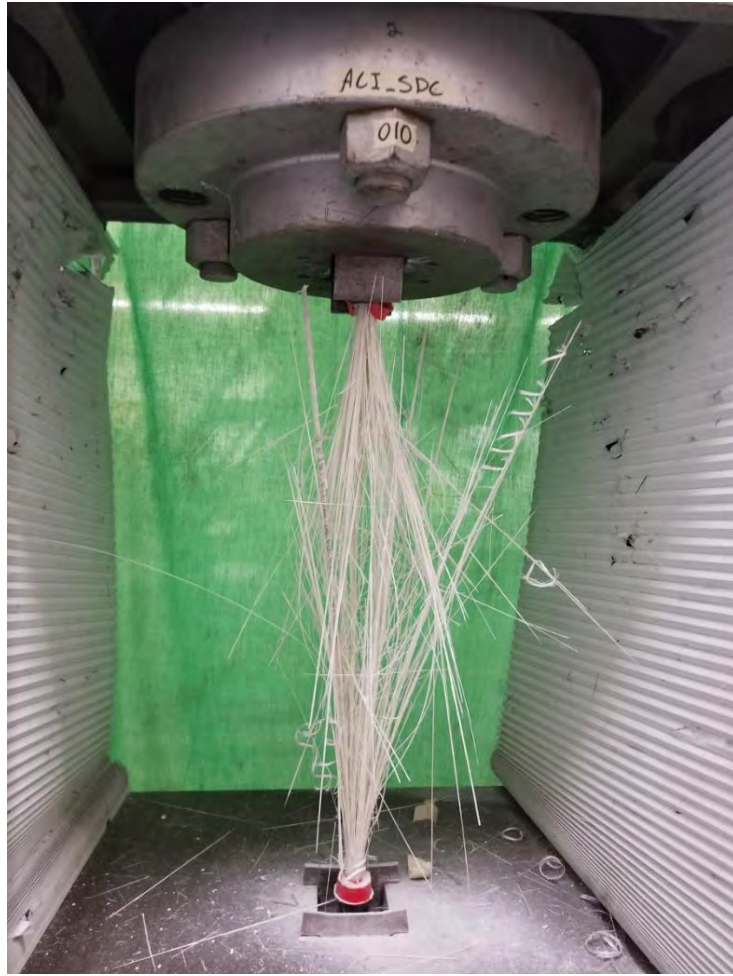
Fig. 66. Bar 010 after failure

Pristine bar 009 failed at a peak load of 36,972 lbs. (165 kN). The extensometer was removed at a load of 12,100 lbs., and therefore, the maximum strain could not be determined. The bar after failure is shown in Fig. 66 and the stress strain curve for this bar is shown in Fig. 67. Due to initial manipulation of the extensometer, initial conditions show initial deflection at load zero. A summary of the tensile test results is shown in Table 30.
